City of Johannesburg Organic Waste to Biomethane for Bus Fuel Plant

Annexure R: Management Offices Brief

ENERGIDROP (PTY) LTD

City of Johannesburg

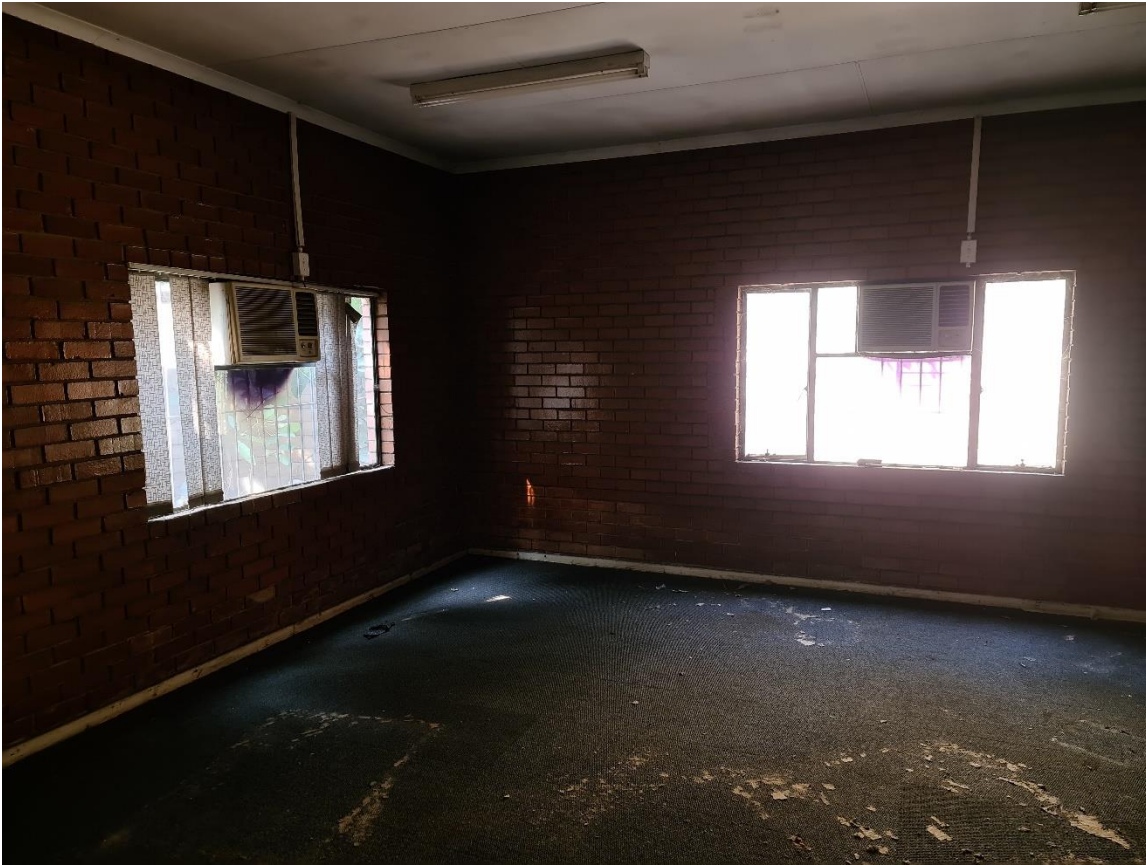
Figure 5: Large room to be split into two. Currently carpeted, to be tiled.

All carpeted floors shall be retiled with industrial grade tiles for ease of cleaning. See pictures for existing tile type.

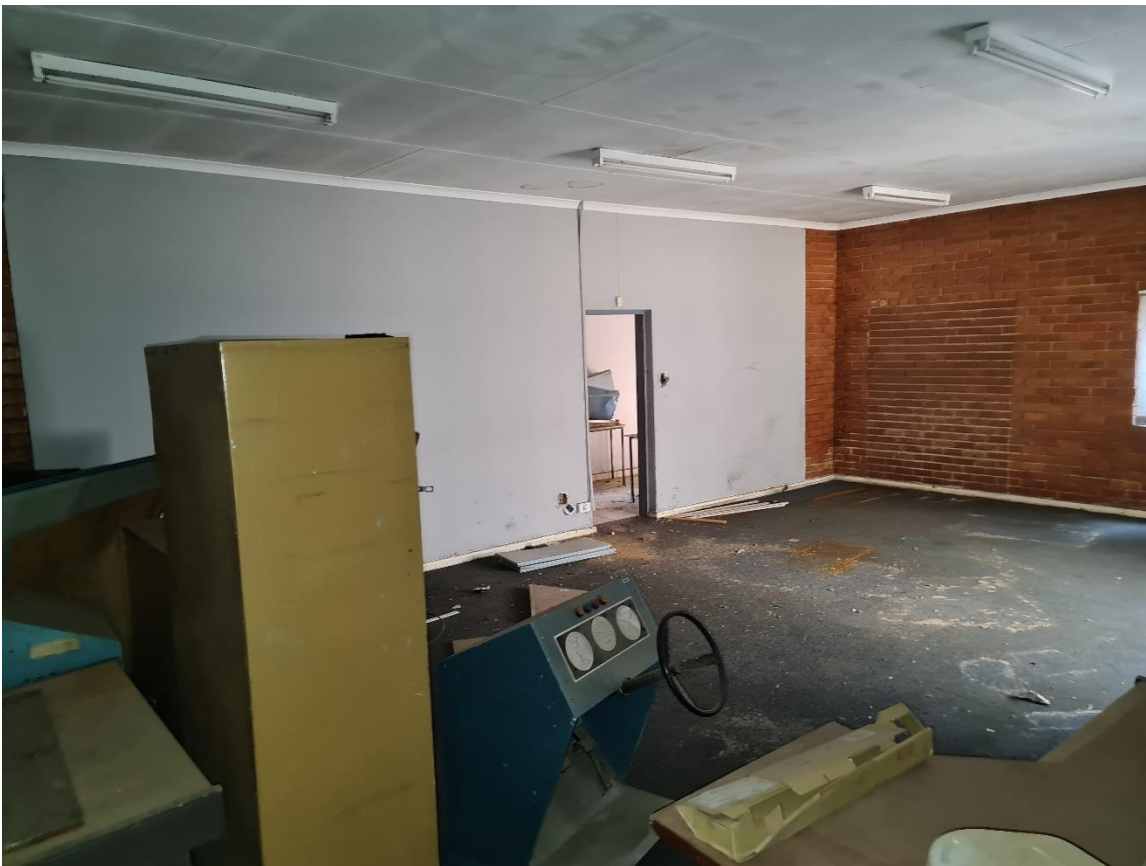
Figure 6: Large room showing damaged carpets.

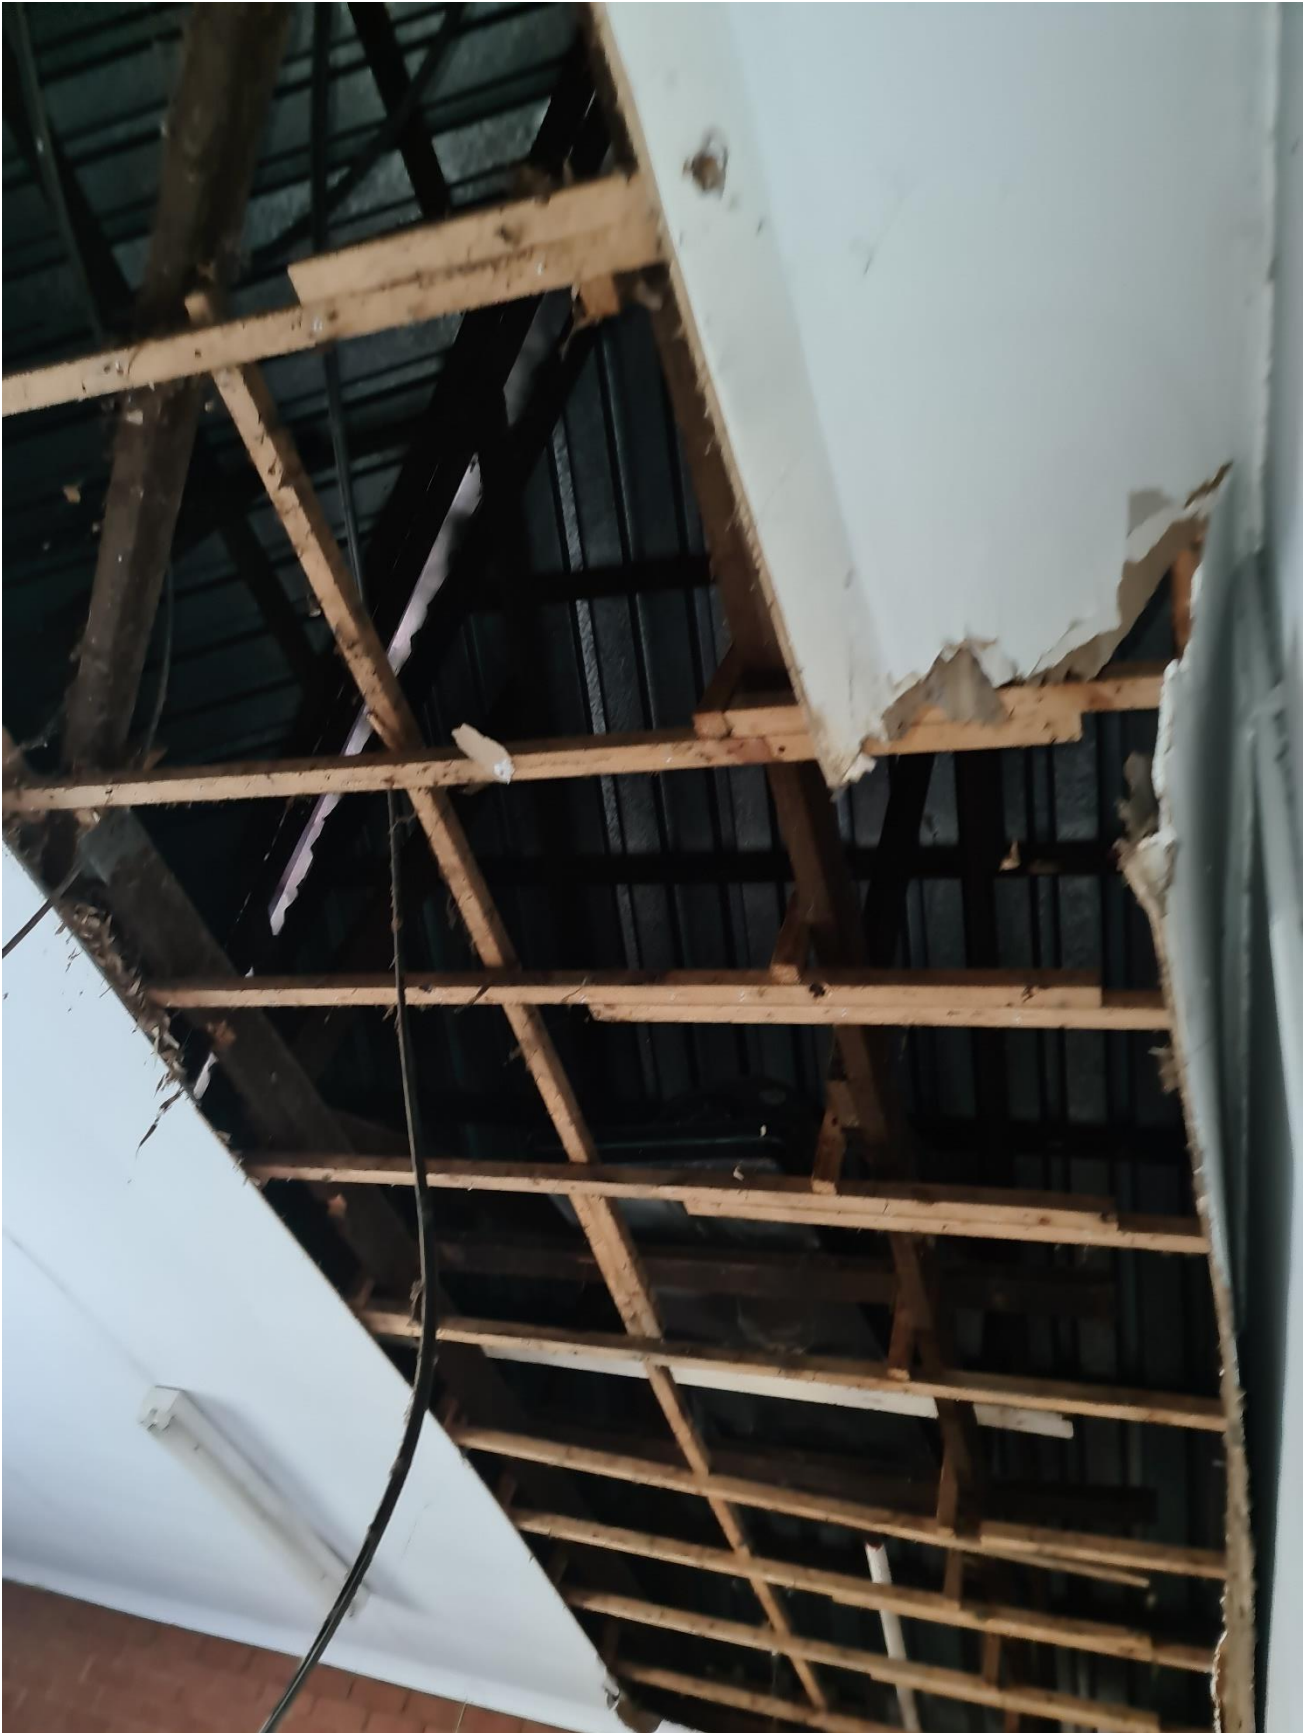
Figure 8: Damaged ceiling in office room.

Ceilings need to be replaced in the entire building.

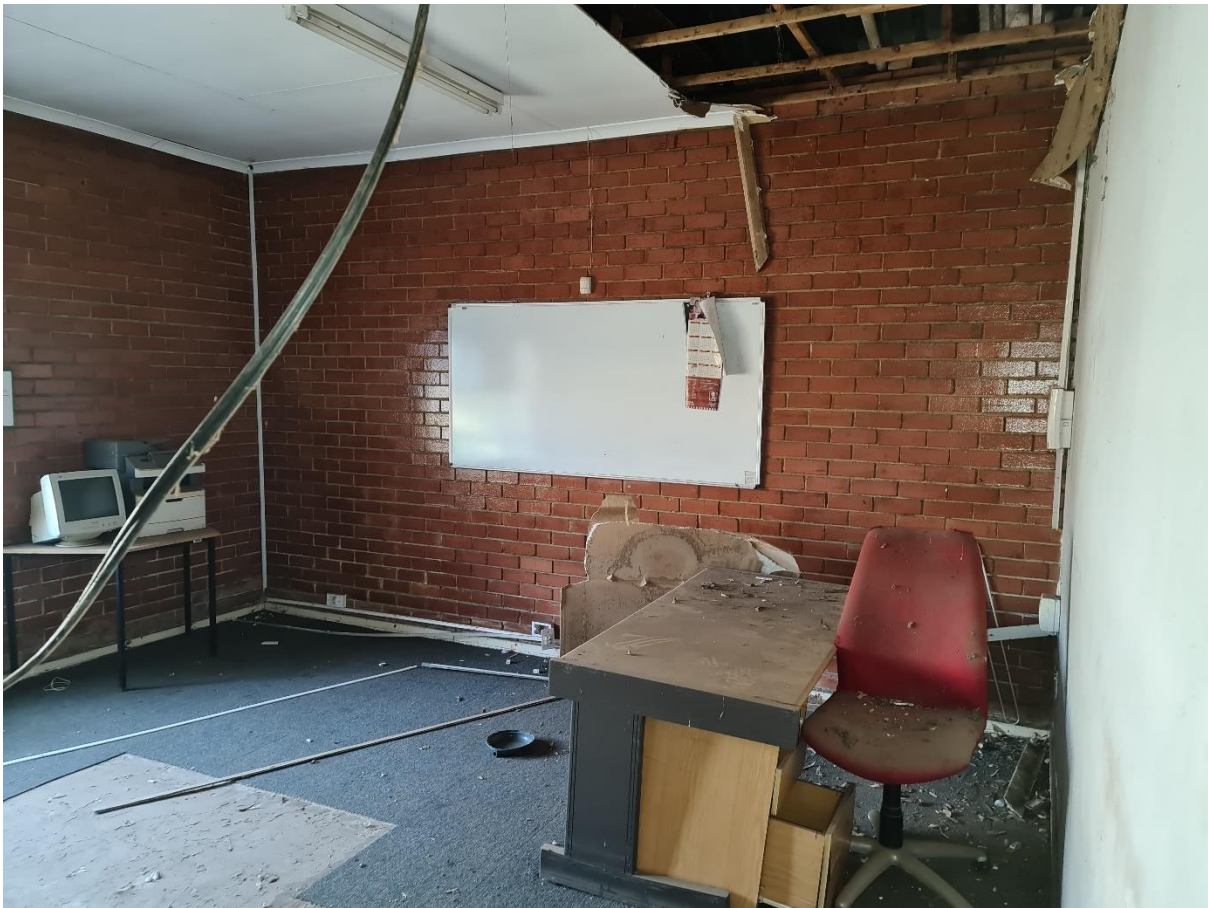
Figure 9: Office room. Carpet to be replaced with tiles.

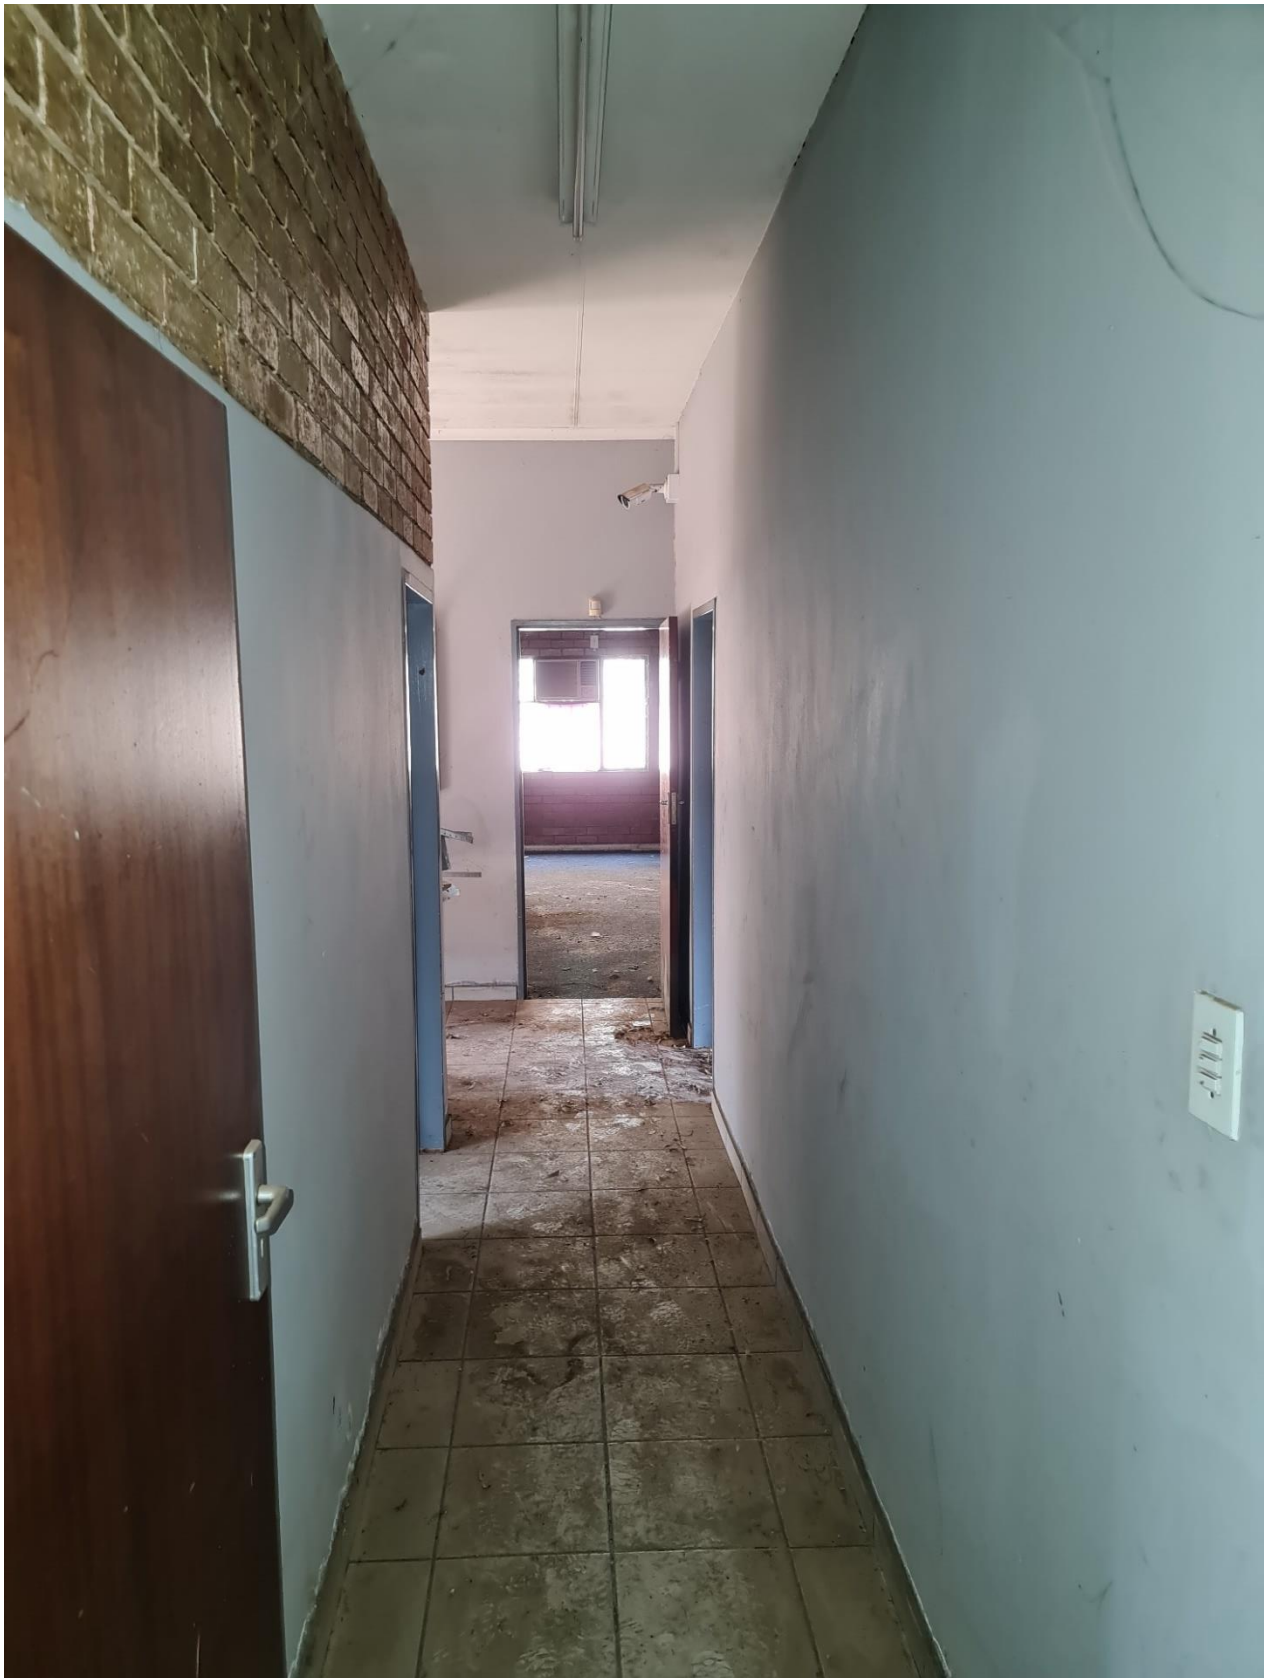
Figure 10: Hallway to kitchen and ablutions. Exiting tiles evident.

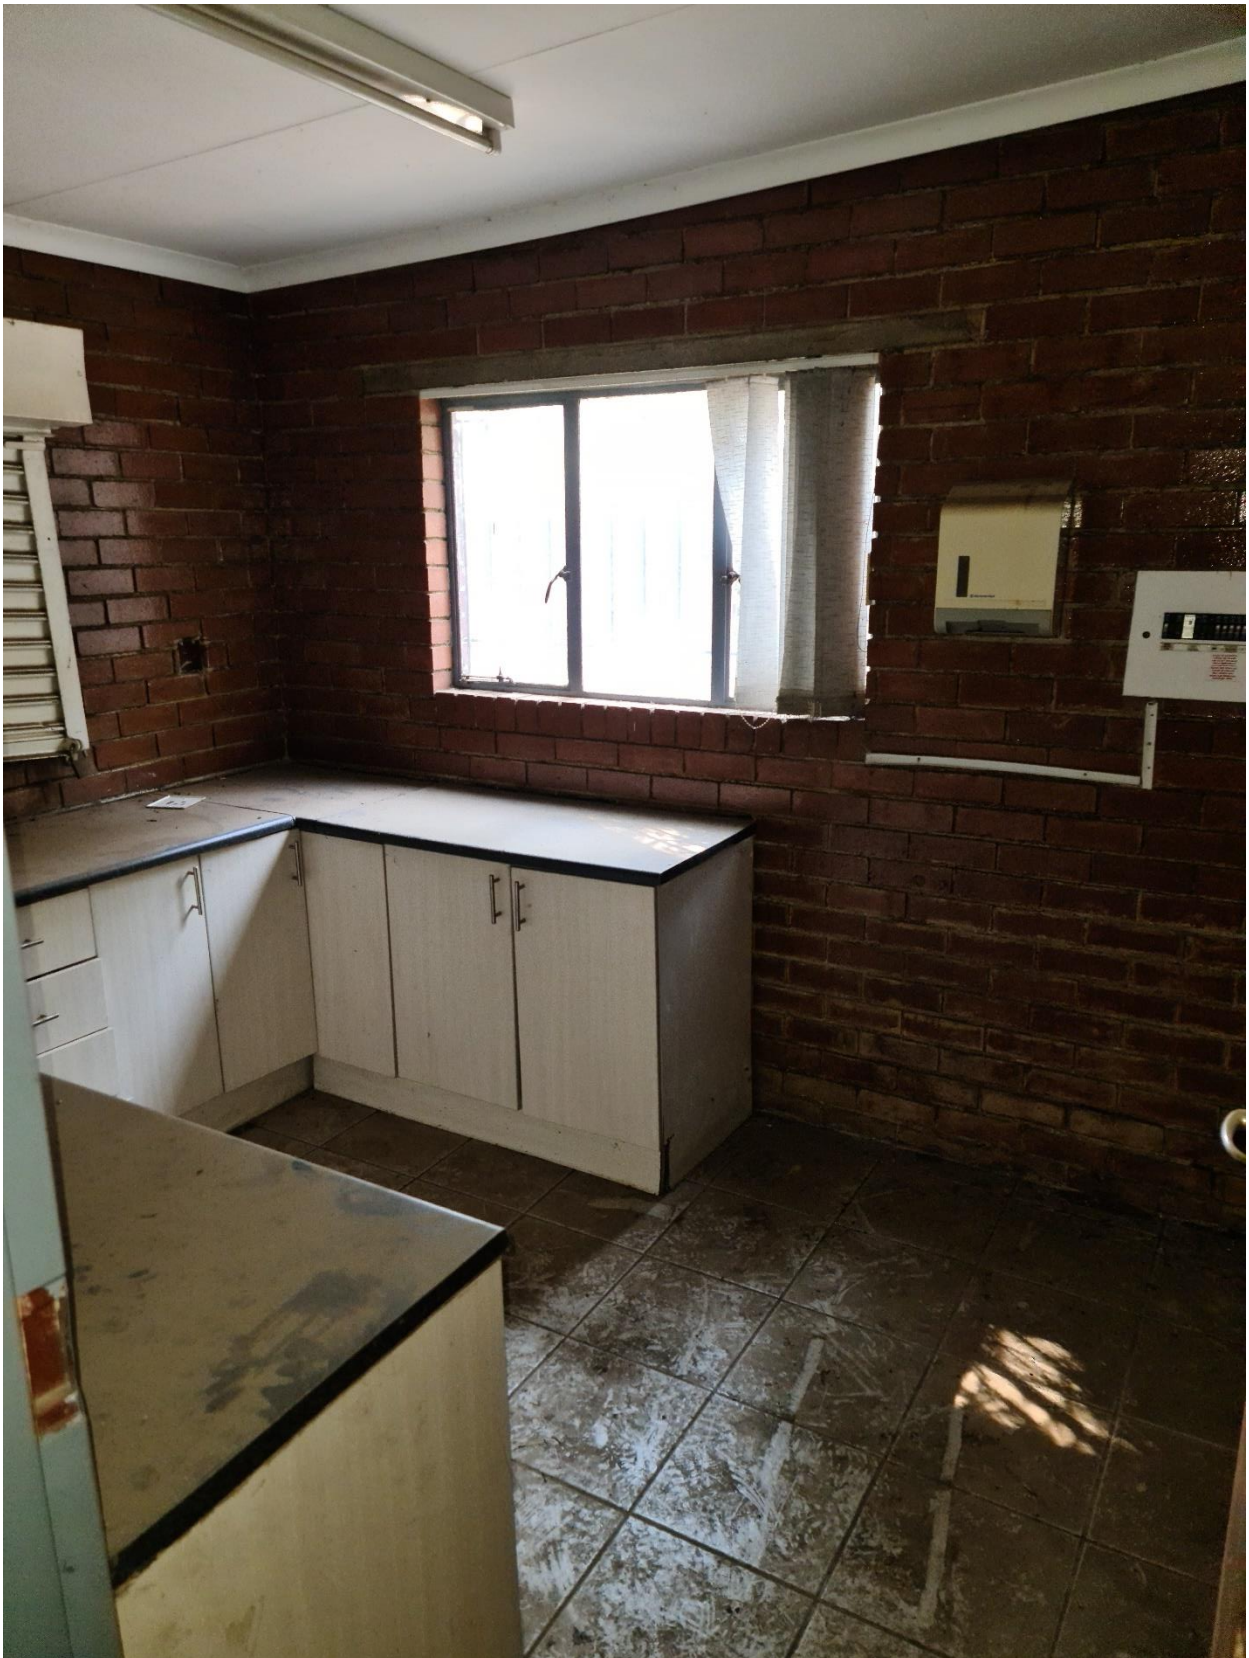
Figure 11: Existing kitchen. The roller shutter door to the outside needs to be repaired.

The small roller shutter door leading to the outside from the kitchen should be replaced.

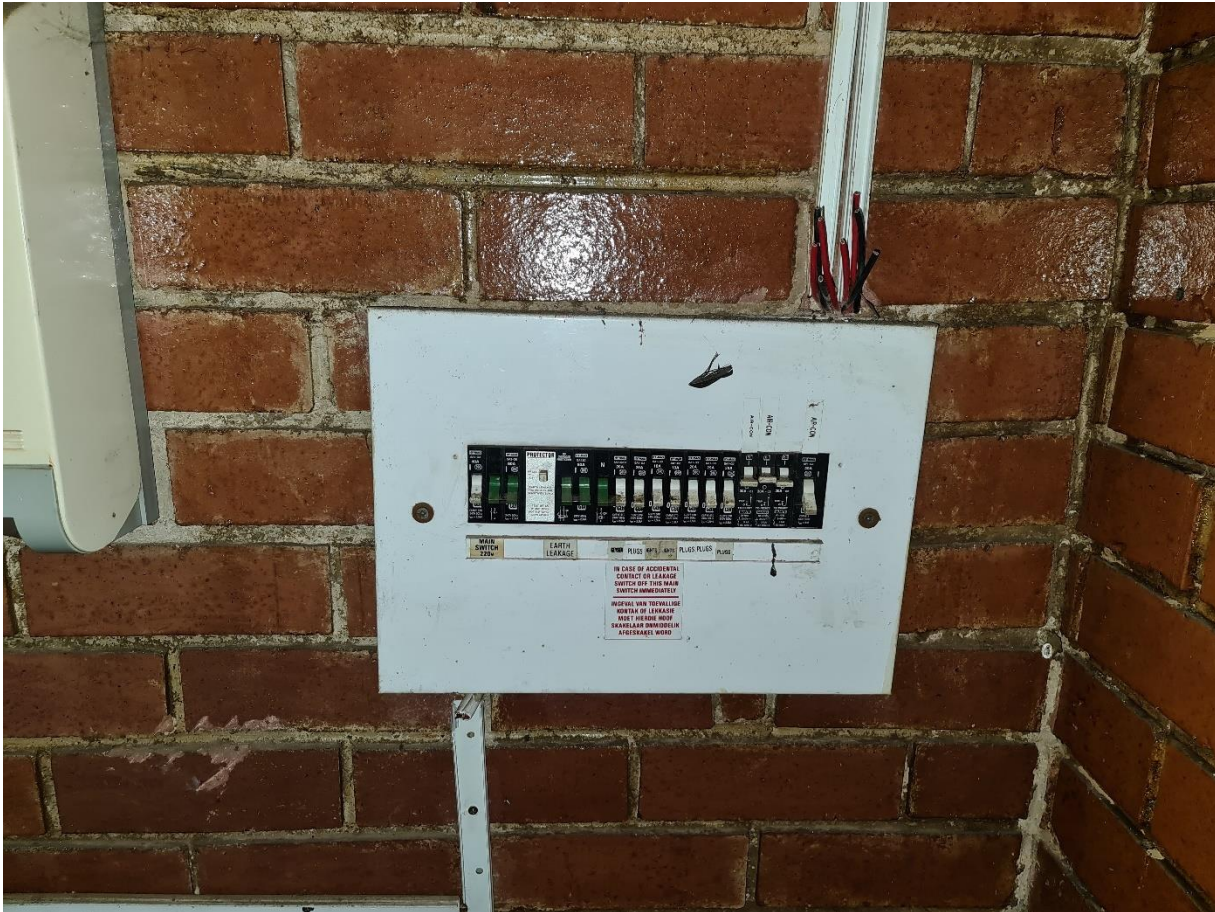
The electrical reticulation in the building has been gutted. It is safe to assume that new electrical infrastructure needs to be installed to all plug points, lights, switches and the connection to the new Distribution Board for the new facility.

Figure 12: Existing distribution board. Electrical wiring to be redone.

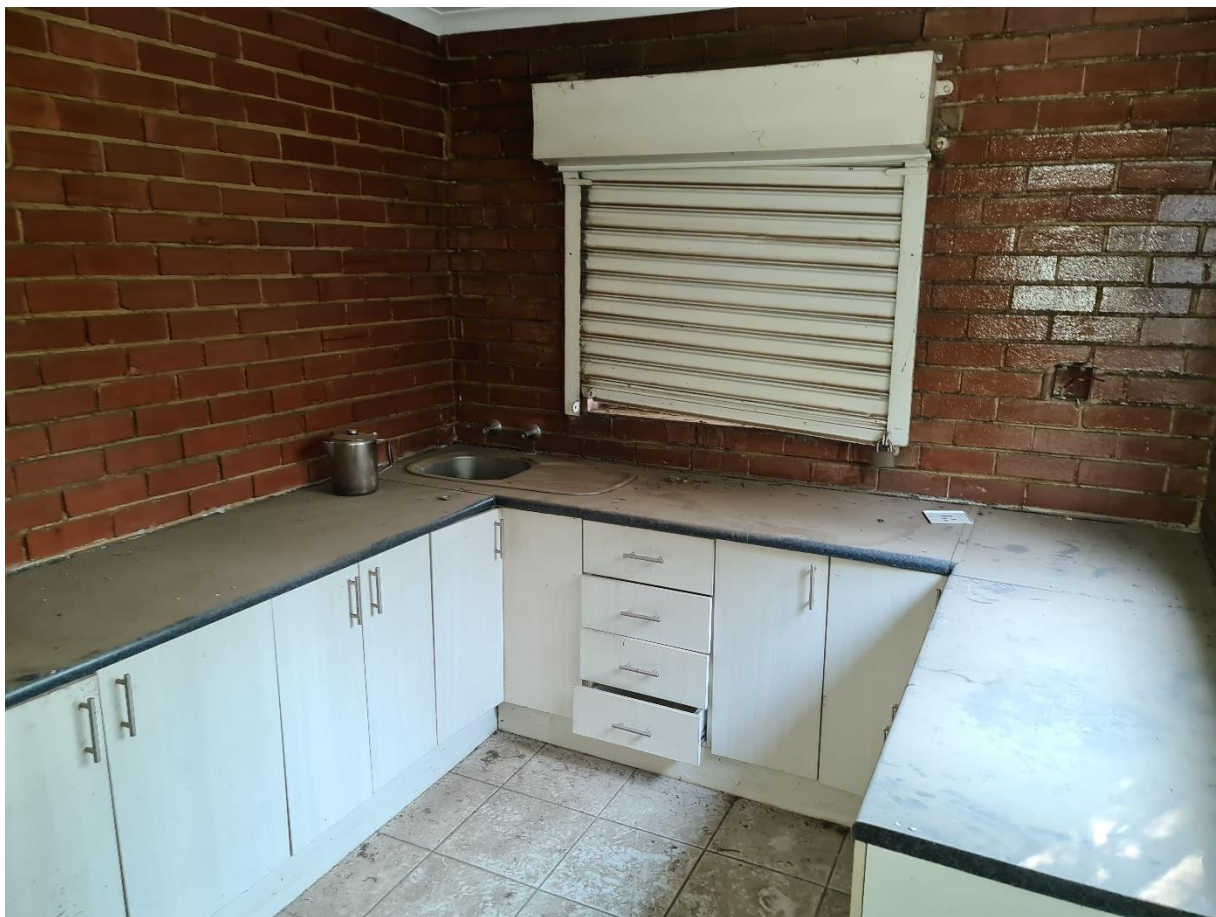
Figure 13: Some water damage in kitchen cupboards may require replacement.

The kitchen cupboards need to be replaced due to water damage.

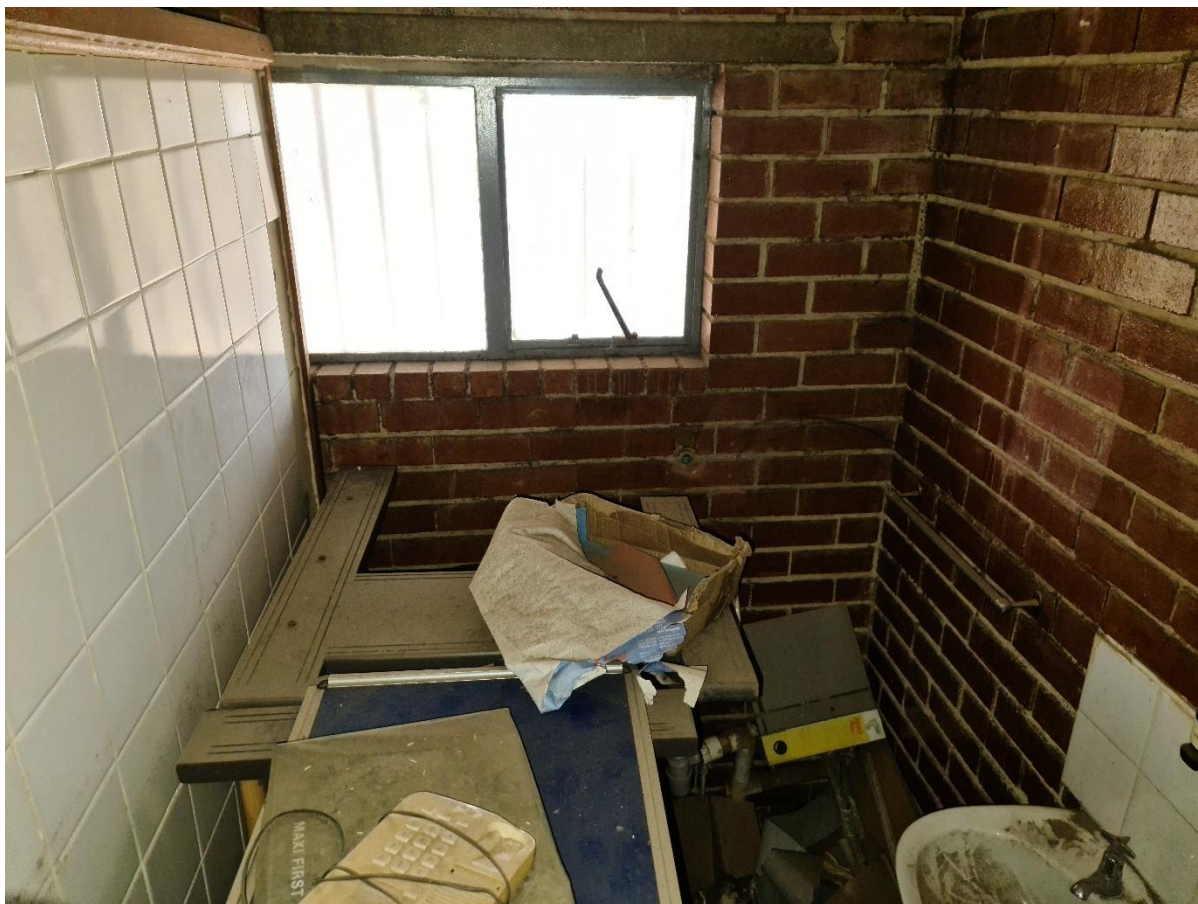
Figure 15: Male urinal area.

The sewer connection seems intact. Toilets (x3), urinals (x2) and washbasins (x2) to be replaced (including water connections and taps). Hand drying and sanitation to be supplied.

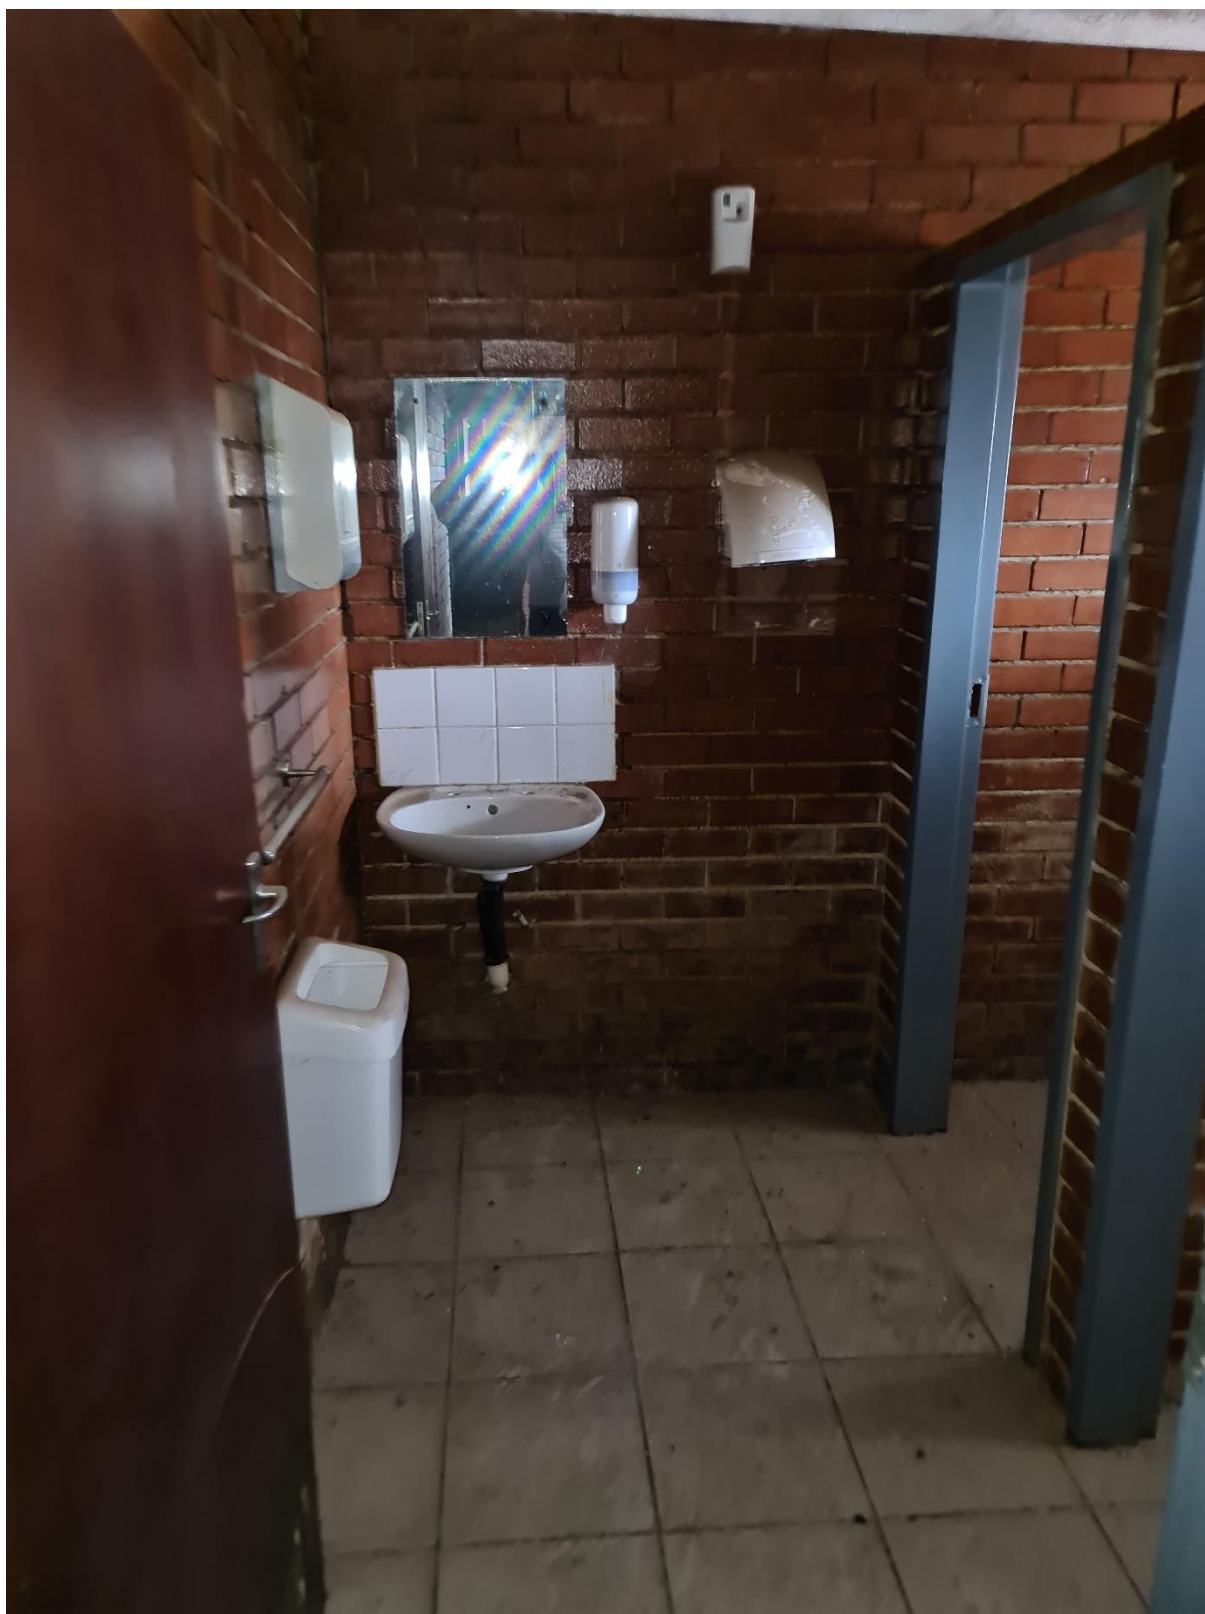
Figure 16: Female ablutions.

20 m² of tiling should be allowed for in the ablutions with white tiles.

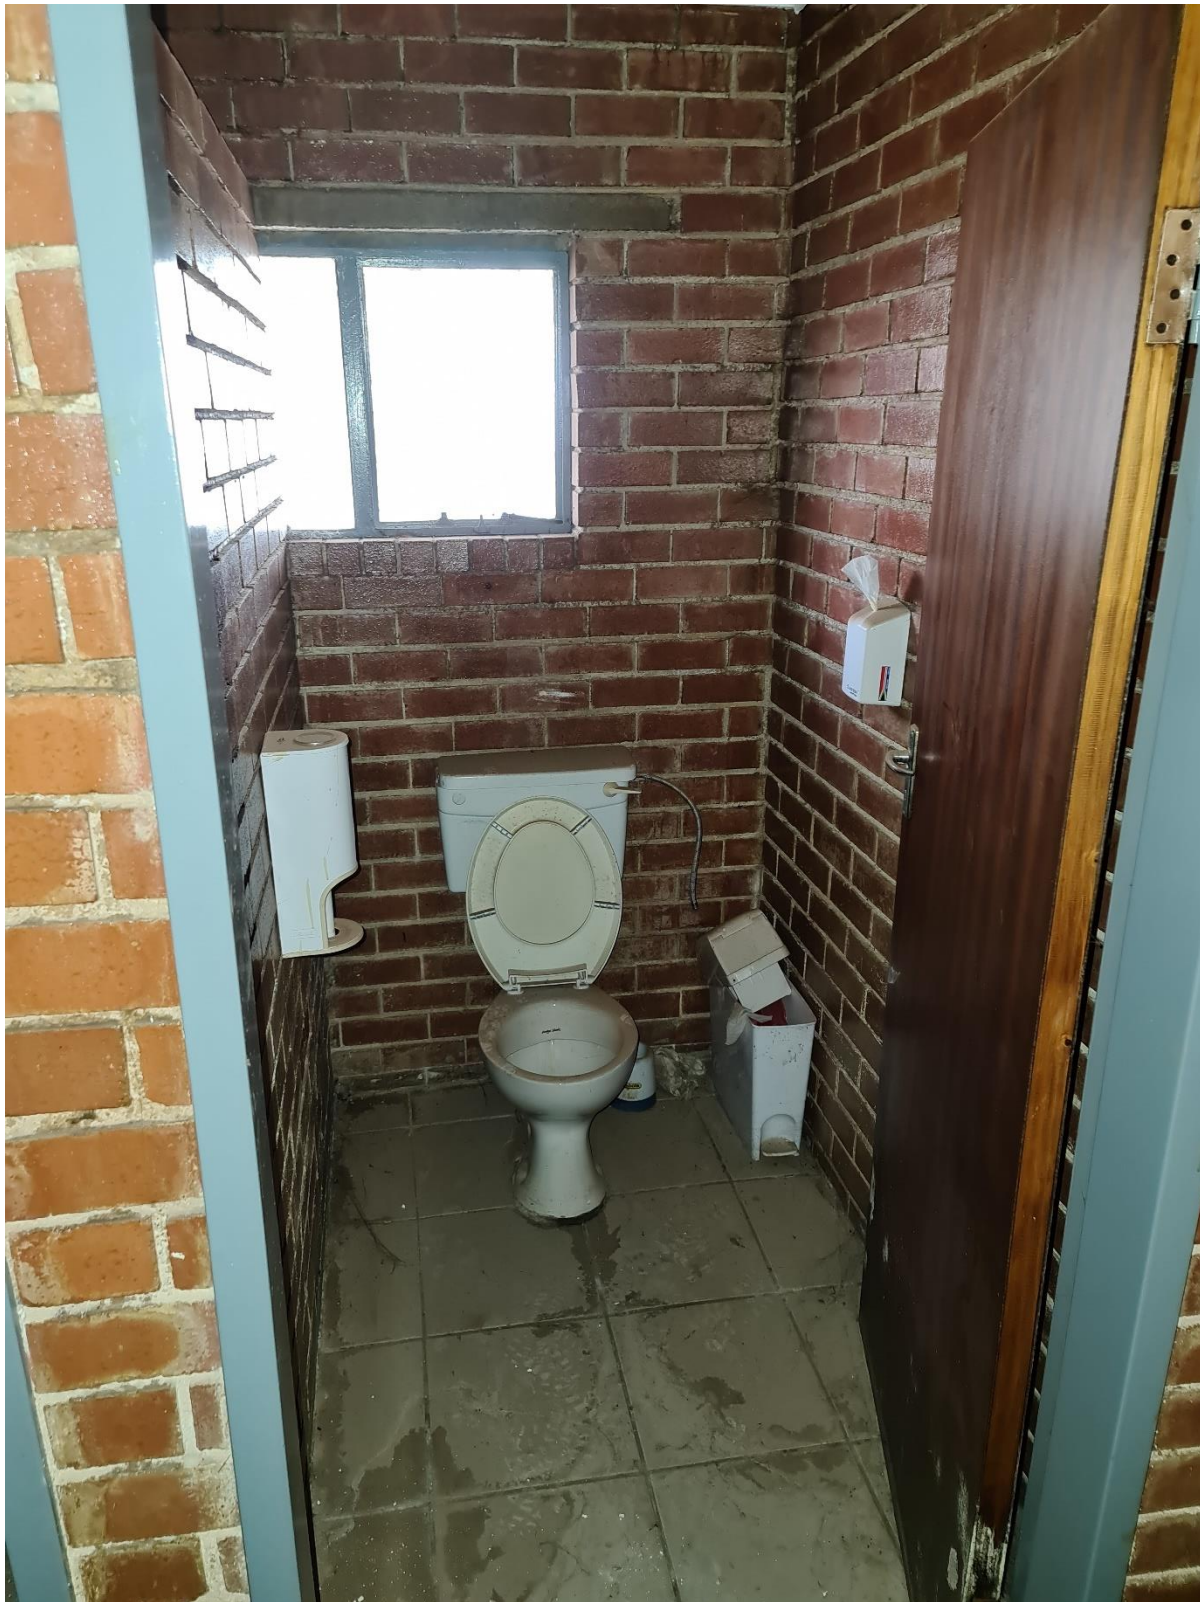
Figure 17: Toilet in female bathroom.

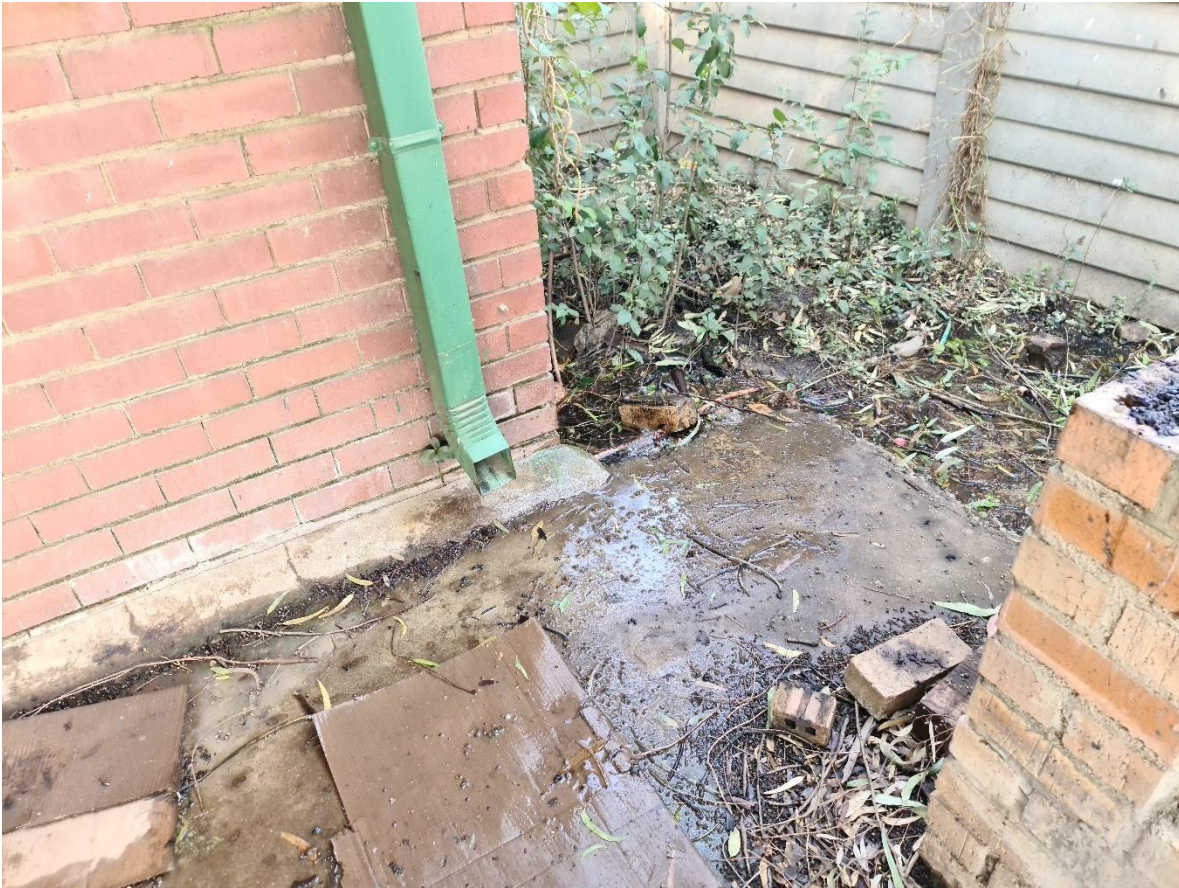
Potable water is available at this building, but leaks have been noticed at the water connection at the side of the building. It can be assumed that all hot and cold water systems and piping will need to be replaced.

Figure 18: Outside water supply pipe leak.

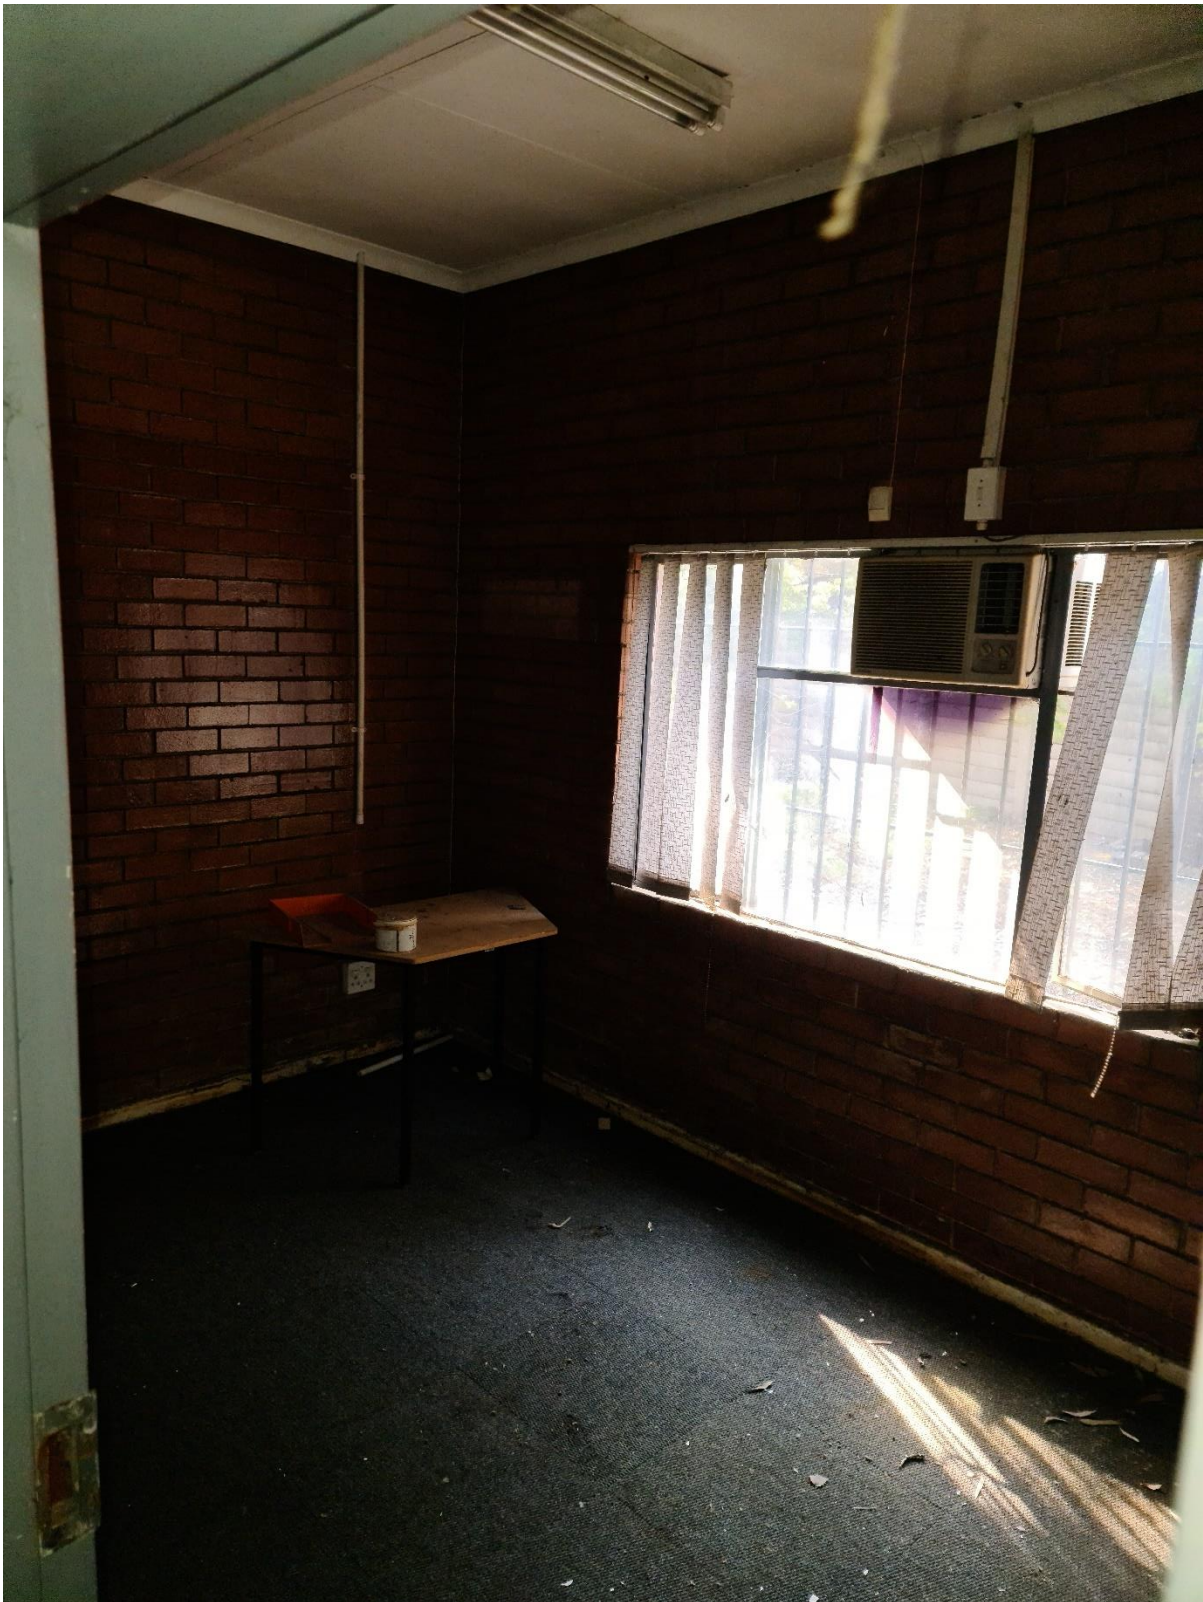
Figure 20: Infirmary room. Carpets to be removed and tiles put in.

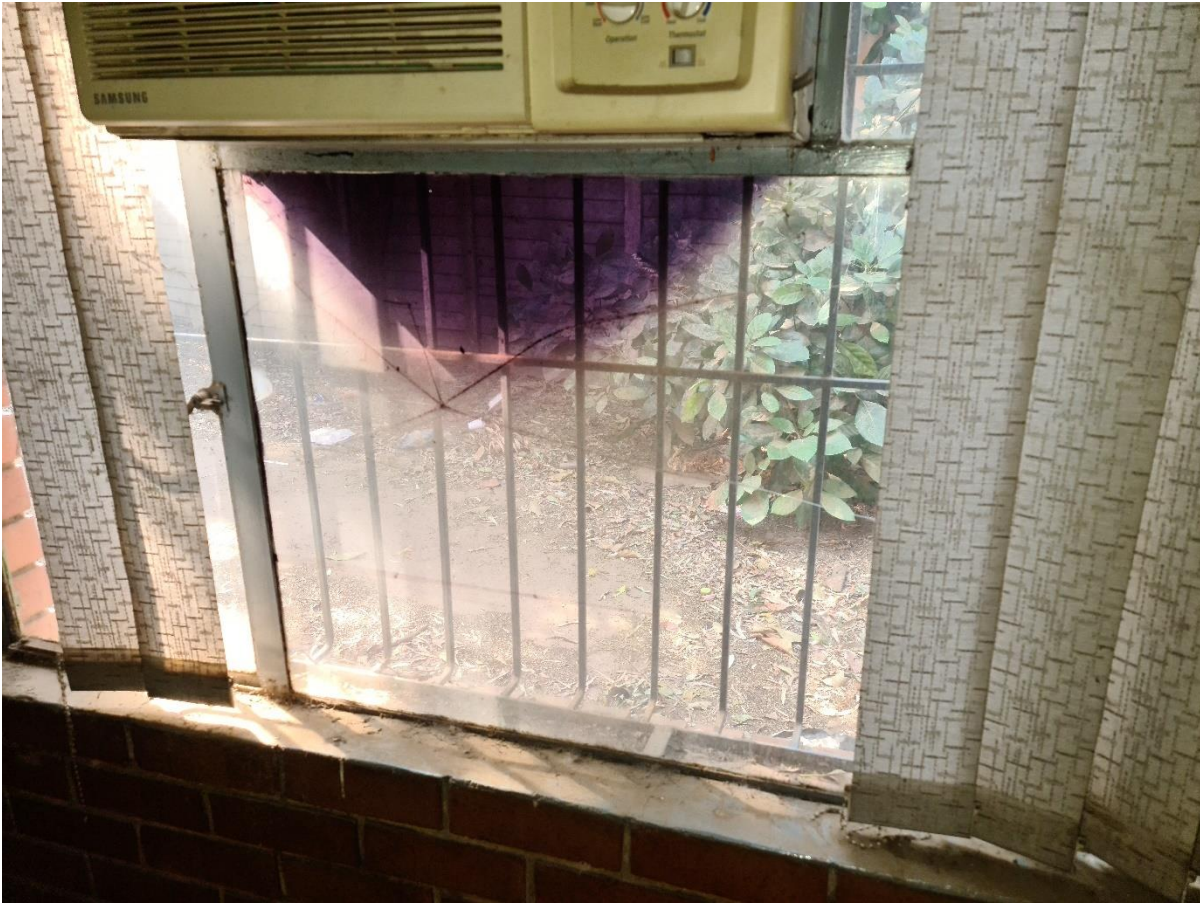
Figure 21: Some windows are tinted, and minimal broken glass is present. Burglar bars are on windows.

Allowance for replacement of 3 x 1x 1m windows should be made. Actual window dimensions to be confirmed by contractor on site.
