Project: CONDITION ASSESSMENT
KGAUHELO PRIMARY SCHOOL

Drawing description:
SITE DEVELOPMENT PLAN

FOR INFORMATION
Drawing Number: 082-KPS-100
Revision: A

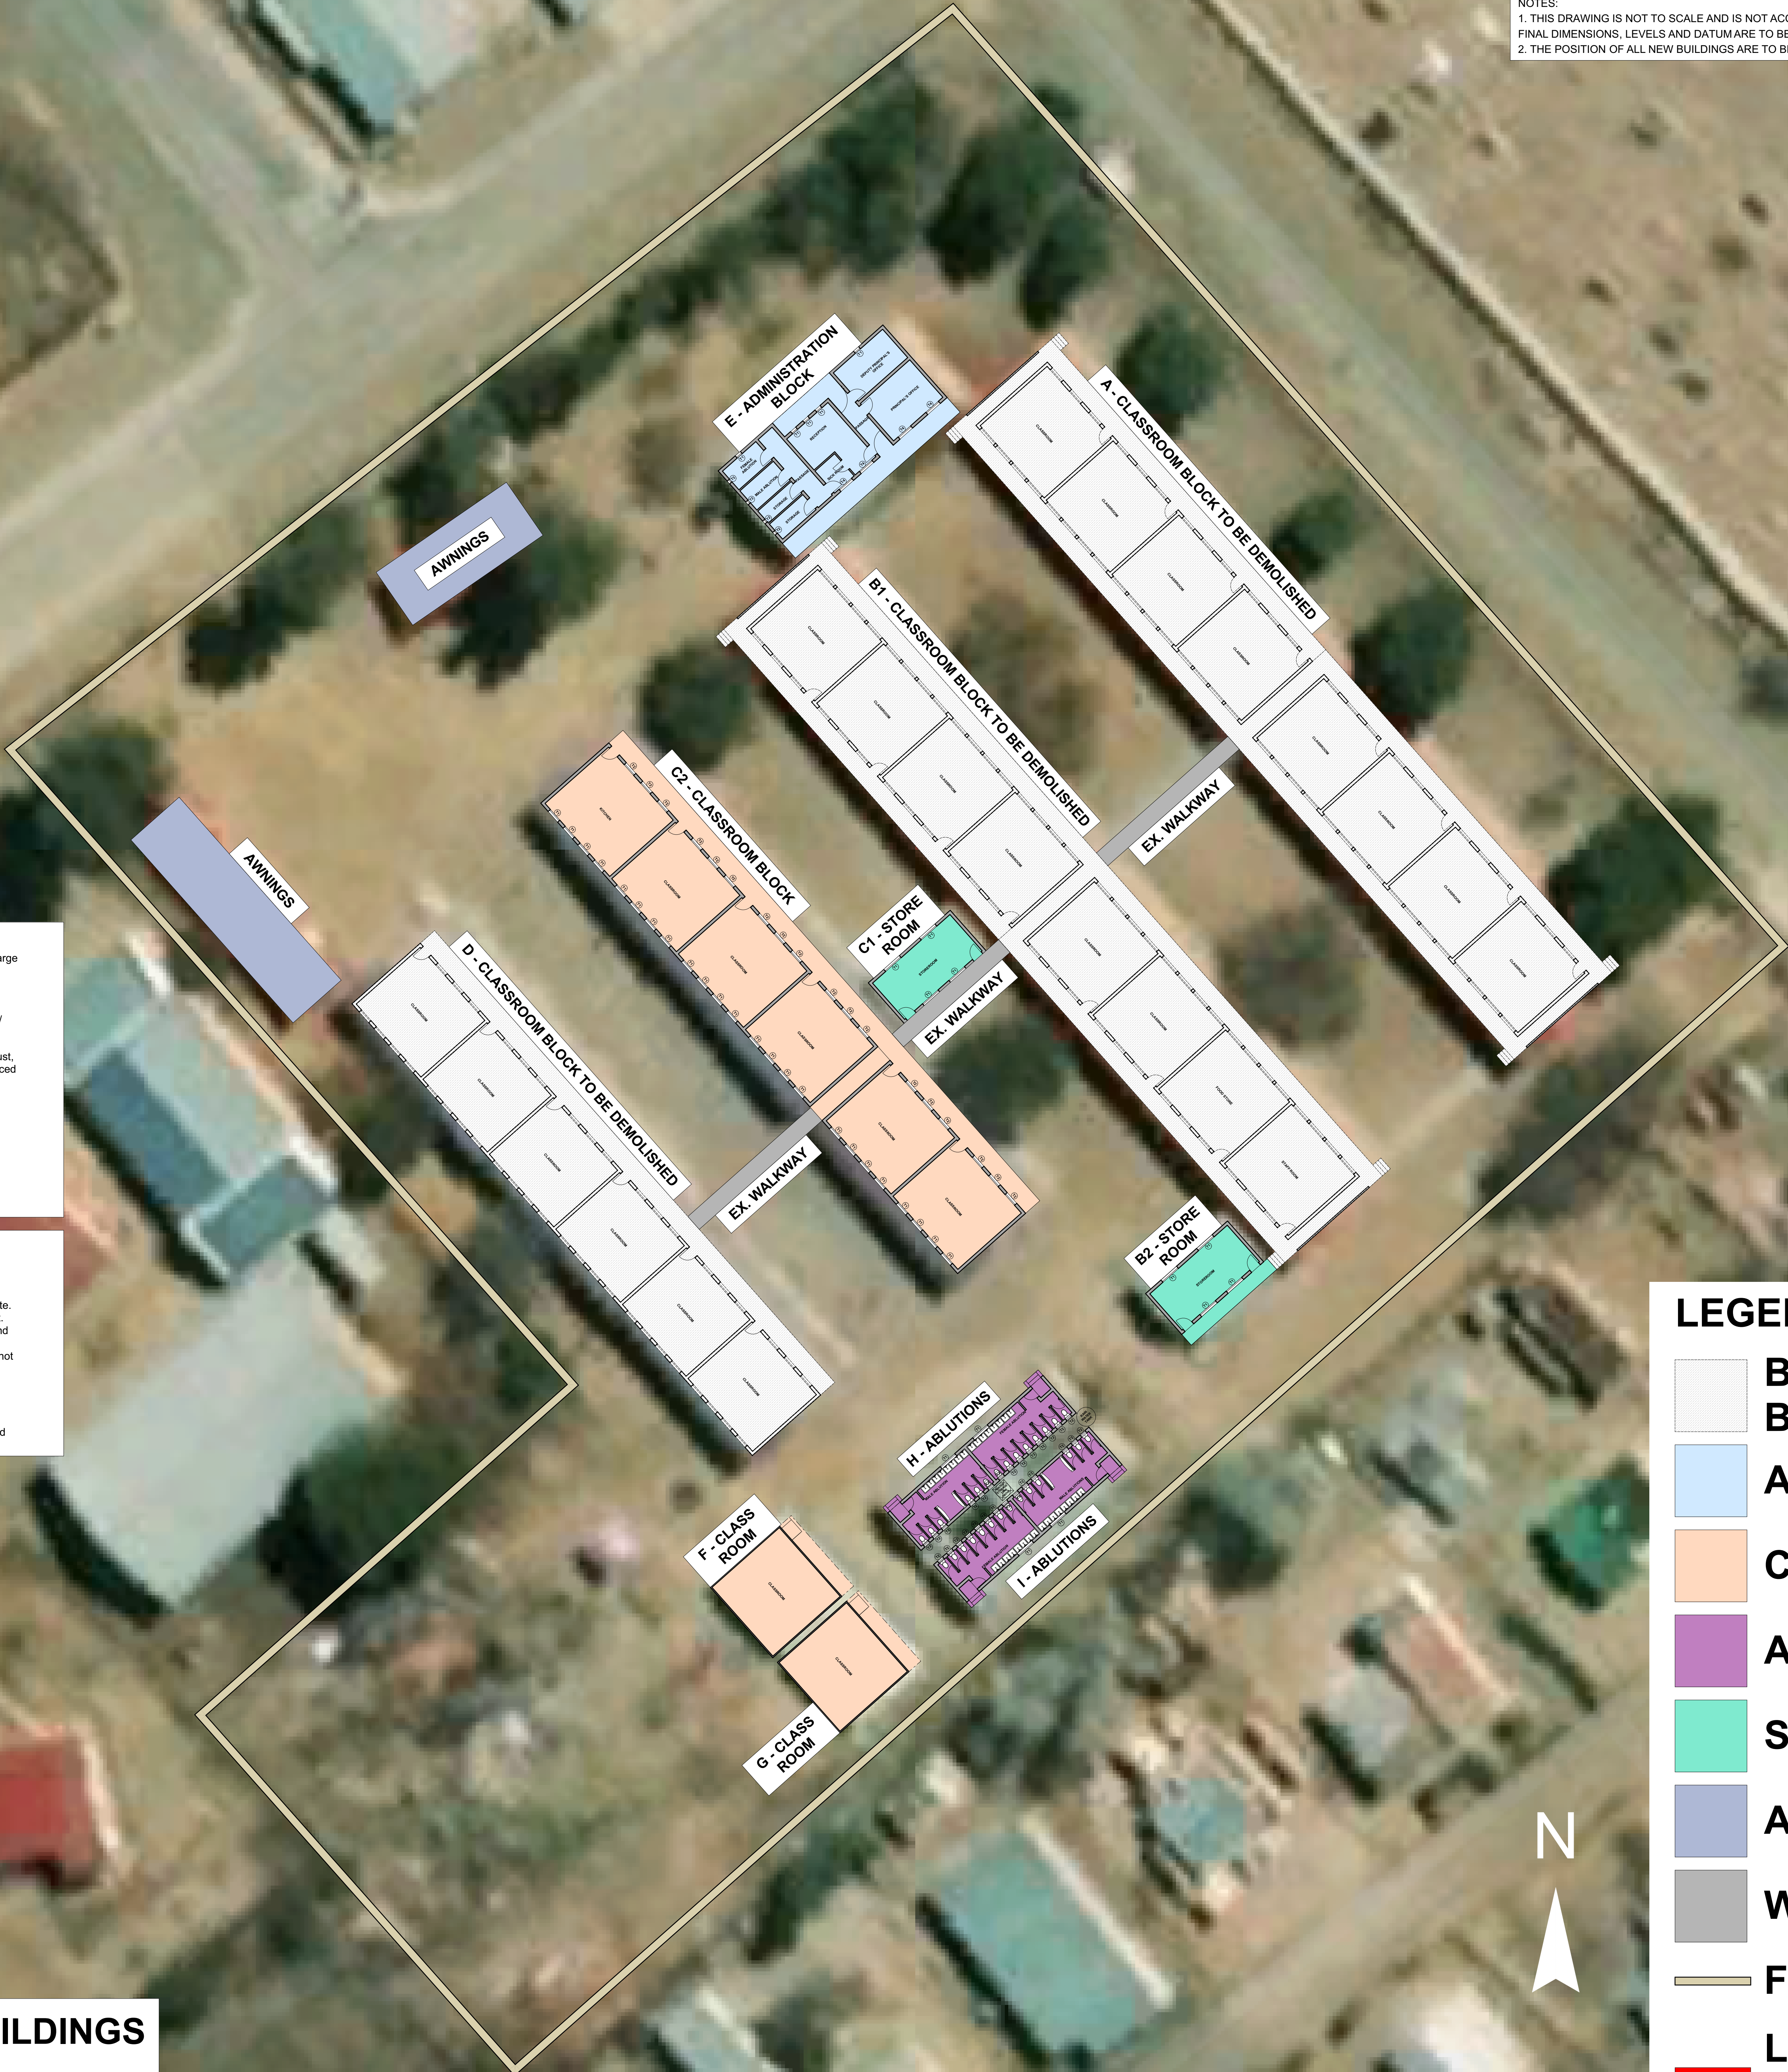
SITE PLAN - EXISTING BUILDINGS
SCALE - 1:200

Scope of Works as per Stage 2 Assessment Report:
BLOCK B2 - STOREROOM:
- Entire roof is damaged. Remove sheeting & trusses and replace with new including gutters, fascia & barge boards and downpipes, to specialist's detail.
- Remove all ceilings and cornices and replace with new to match, including all skimming and painting. Light fittings and electrical cables to be reused where possible, where not possible, to be replaced if necessary.
- Timber entrance doors and frames in a bad condition. Remove and replace with similar.
- Windows in a bad condition. Remove and replace with new windows in a similar design.
- Install new shelving / cupboards for storage, detailed design to be carried out to explore options for optimising and installing new shelving depending on usage.

Scope of Works as per Stage 2 Assessment Report:
BLOCK C1 - STOREROOM:
- Entire roof is damaged. Remove sheeting & trusses and replace with new including gutters, fascia & barge boards and downpipes, to specialist's detail.

Scope of Works as per Stage 2 Assessment Report:
BLOCK C2 - CLASSROOMS:
- Entire roof is damaged. Remove sheeting & trusses and replace with new including gutters, fascia & barge boards and downpipes, to specialist's detail.

Scope of Works as per Stage 2 Assessment Report:
BLOCK E - ADMIN:
- Entire roof is damaged. Remove sheeting & trusses and replace with new including gutters, fascia & barge boards and downpipes, to specialist's detail.

Scope of Works as per Stage 2 Assessment Report:
BLOCKS H & I - ABLUTIONS:
Structural damage as per Structural Engineer's report.
- Roof sheeting, fascia + barge boards, gutters and downpipes to all be removed and replaced.

- Remove all ceilings and cornices and replace with new to match, including all skimming and painting. New light fittings and electrical cables to be installed according to Electrical Engineer's specifications.

- Replace 1 x broken window glazing panel.
- Existing shelving insufficient for needs. Remove and install new shelving / cupboards for storage, detailed design to be carried out to explore options for optimising and installing new shelving depending on usage.

- Corrosion to door frames, sand off as much rust, apply rust inhibiting primer to restore the steel, prime and paint. Where it cannot be restored, to be replaced with new to match existing.

- Timber door leaves in a poor condition. Rub down, prime and re- varnish. Install new door ironmongery including handles.
- Damaged brickwork – replace with similar and make good.

- Install new floor finishes & skirtings.

- Remove all ceilings and cornices and replace with new to match, including all skimming and painting. Light fittings and electrical cables to be reused where possible, where not possible, to be replaced if necessary.

- Exposed electrical cabling to side elevation facing road to be concealed within conduits.
- New 1m high balustrade with intermediate rails at 100mm or less to be installed along walkway edges where there are significant height differences.

- Mould on walls in kitchen to cleaned off and walls to be painted with an anti bacterial interior paint.
- Painted walls in classrooms in a poor condition. All internal painted portions of walls to be rubbed down, primed and repainted.

- Internal floor finishes deteriorating – to be removed, once structural work is complete, replace all internal floor finishes including skirtings.
- Corrosion to door frames and window frames, sand off as much rust, apply rust inhibiting primer to restore the steel, prime and paint. Where it cannot be restored, to be replaced with new to match existing.

- Timber door leaves in a poor condition. Rub down, prime and re- varnish. Install new door ironmongery including handles.
- Deteriorating window sills – rub down, prime and repaint.

- Broken and damaged cupboard doors in classrooms to be repaired.

- Brickwork at top of perimeter walls appear loose – replace bricks with similar and ensure best practice / make good.
- Replace 1 x broken window glazing.

- Corrosion / deterioration to door & window frames, burglar bars and security gates, sand off as much rust, apply rust inhibiting primer to restore the steel, prime and paint. Where it cannot be restored, to be replaced with new to match existing.

- Replace admin block signage on side elevation with new to match.
- Leaking external water tap – rectify leaks.
- Plaster and paint all unplastered brickwork once structural damage rectification is complete.

- Remove and install new internal floor finishes & skirting to entire block.
- Informal timber wall surrounding sick room in admin office in a poor condition, this wall to be formalised with a proper partition wall which is to be skimmed and painted, including a new door with ironmongery.

- Timber doors in a poor condition. Rub down, prime and re-varnish. Install new door ironmongery including handles.
- Sanware & plumbing in a poor condition – remove and replace all. Plumbing as per wet services engineer's details.

- Overgrown vegetation in service passage between ablutions: remove overgrown vegetation.
- Corroded steel frame at entrance to service passage to be removed and replaced with new security gate.

- External and internal paintwork in a poor condition. Recommend rubbing down paint, prime and repaint.
- Internal ablutions in a poor condition, recommend the following: Remove all sanware, fittings, ceiling and doors. Install new sanware, fittings, floor finishes + skirtings, doors and ceilings with light fittings.

- Leaks noted: all plumbing to be investigated and leaks to be found and rectified. Where rectification is not possible, replace plumbing to wet services engineer's details.

- All damaged entrance doors to be removed and replaced with new.
- Burglar screens to be installed over windows to prevent access.
Any non obscure window glazing above WC's to have new vinyl film installed to provide obscurity and privacy.

- Rainwater tank on plinth and surrounding gate at service passage corroded. Recommend removing and replacing water tank with proper feeder pipes from gutters. Plinth to be repaired.
