Project: **CONDITION ASSESSMENT
LIKUBU PRIMARY SCHOOL**

Drawing description: **EXISTING BLOCKS:
REFURBISHMENT SCOPE OF WORKS**

Drawing Number: 082-LPS-101	Revision: C
-----------------------------	-------------

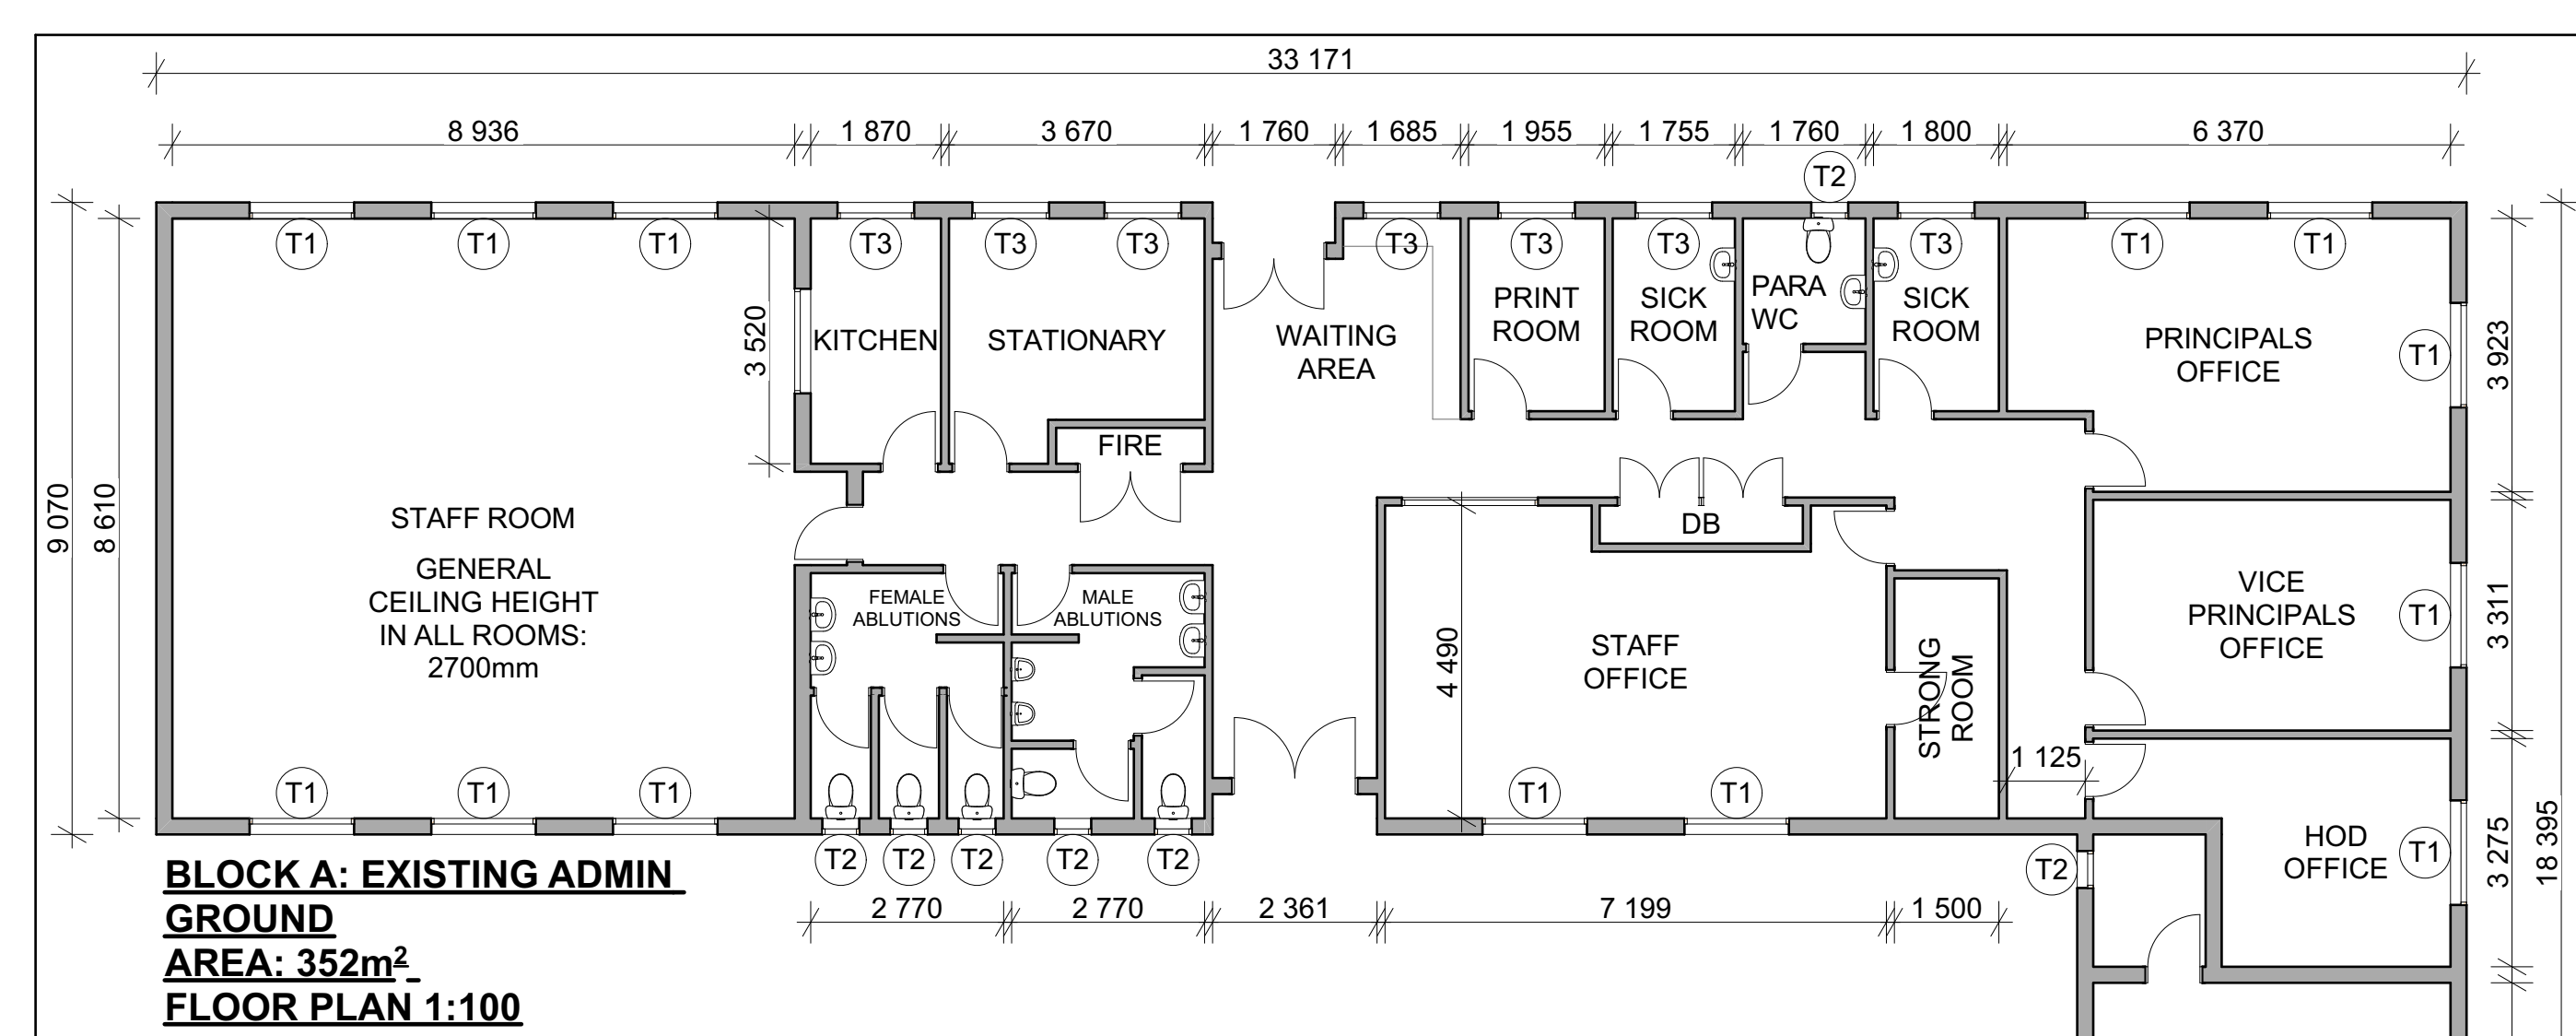
**BLOCK A: EXISTING ADMIN
GROUND
AREA: 352m²
FLOOR PLAN 1:100**

1. Structural Damage noted, refer to Structural Engineer's report.
2. Damaged walkway plasterboard ceiling boards - remove and replace damaged boards with new to match existing. (REFER TO TYPICAL DETAILS).

3. Warped and water damaged plasterboard ceiling boards in passage - remove and replace with new to match. (REFER TO TYPICAL DETAILS).
4. Internal structural damage and cracks - once structural damage repairs are complete, prime and repaint walls to match. (REFER TO TYPICAL DETAILS).

5. Paraplegic abluition missing grabrails to door, install 2 x new grabrails as per SANS 10400 Part S. (SEE BELOW SPECIFICATION FOR GRABRAILS).
6. Water damage behind WHB - locate leaks and repair or replace if necessary.

7. Cracked or damaged ceiling cornices to be removed and replaced with new to match.
8. Any damaged window blinds to be repaired.
9. Make good chipped brickwork walls.

10. Loose and hanging electrical cables to be chased into walls or concealed within conduits.
11. Damaged vinyl floor finishes to be removed and replaced with new to match existing. (REFER TO TYPICAL DETAILS).

12. Water damage behind WHB and grabrail in paraplegic ablutions - locate leaks and repair or replace if necessary. Rub down walls, prime and repaint.
13. Missing ceiling trapdoor to be replaced with new to match. (SEE BELOW).

14. Missing light bulbs to be replaced with new to match.
15. Water damage to fire cupboard boards - remove and replace with new to match. (SEE BELOW FOR SPECIFICATION).

16. Missing / damaged electrical plugpoints to be replaced as per Electrical Engineer's details.

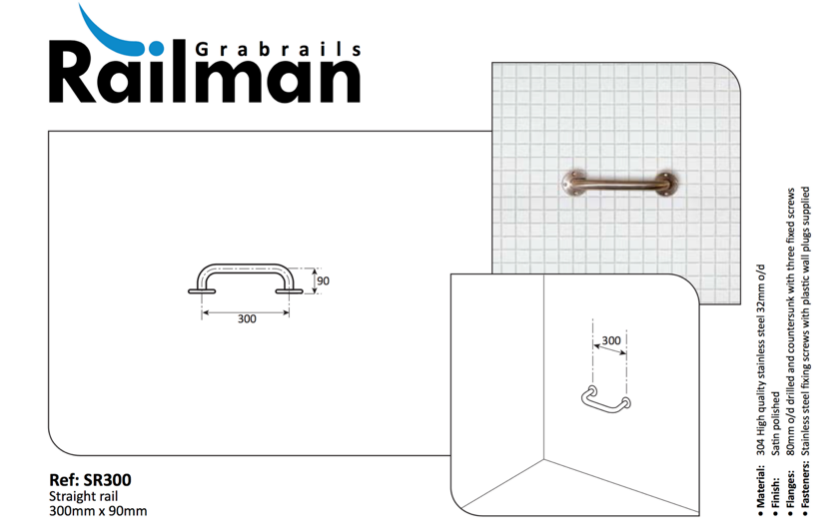
INSTALL MISSING GRABRAILS:

Install new grabrails onto existing door.

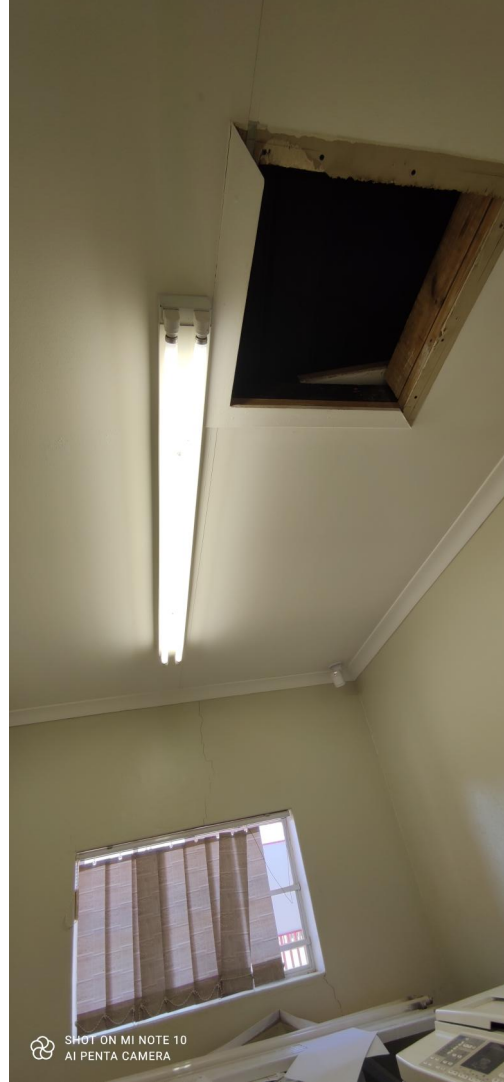
REPLACE MISSING CEILING TRAPDOOR:

Replace ceiling trapdoor to match existing.

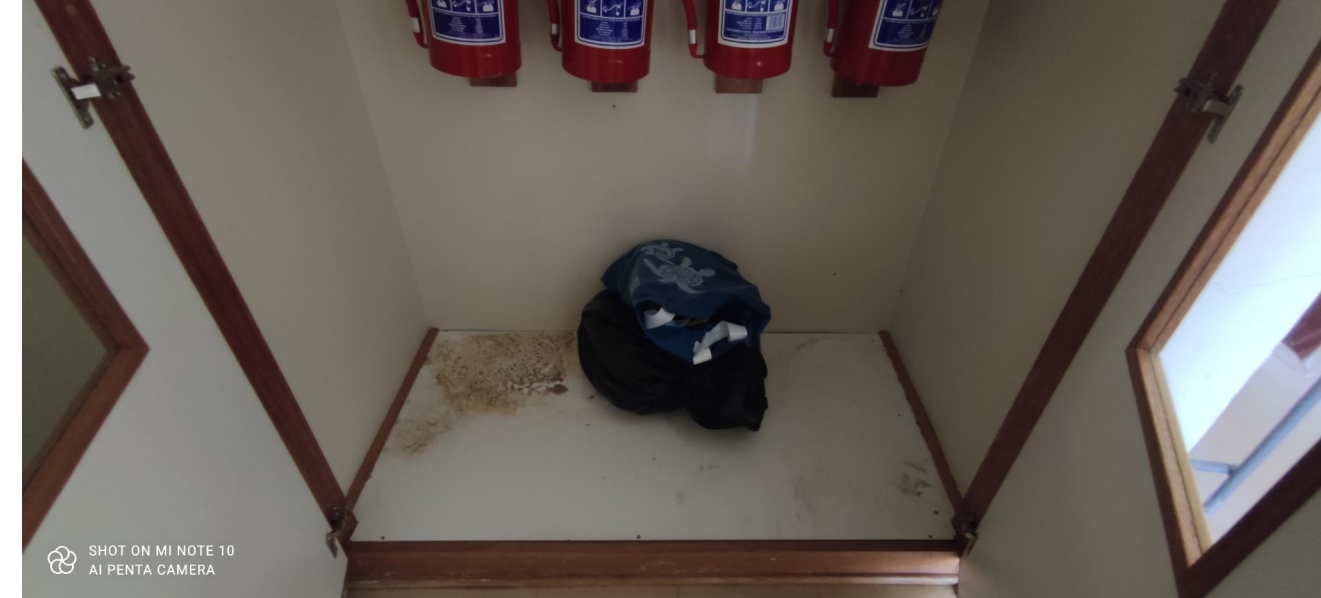
REPLACE DAMAGED CUPBOARD PANEL:

Remove and replace damaged board with new to match.

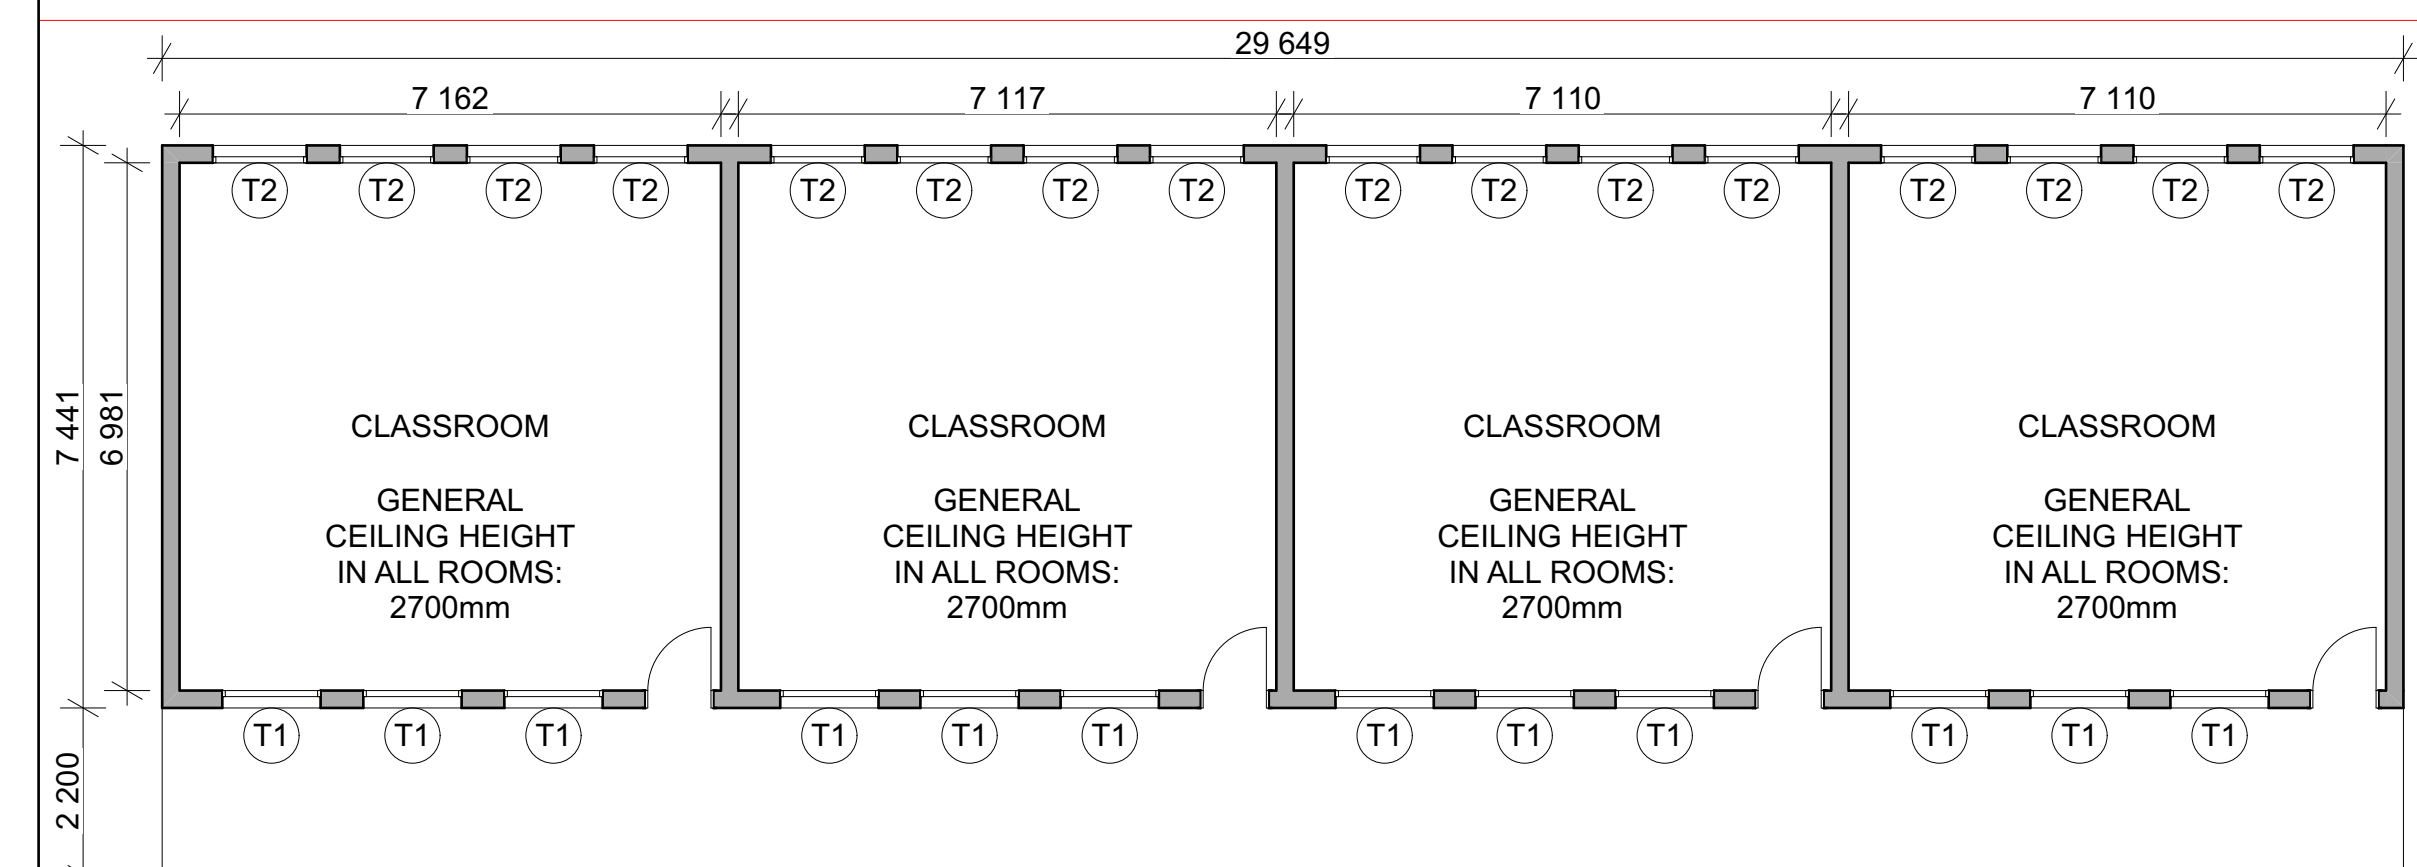
**BLOCK F: EXISTING CLASSROOM
GROUND FLOOR PLAN
SCALE - 1:100**

1. External paintwork in a poor condition, rub down walls, prime and repaint. (REFER TO TYPICAL DETAILS).
2. No gutters or downpipes installed. Install new to match existing on site or as per later detail. (REFER TO TYPICAL DETAILS).

3. External plasterboard walkway ceiling in a poor condition, remove and replace with new ceiling boards. (REFER TO TYPICAL DETAILS).
4. Roof to be checked for any leaks and repaired or replaced.

5. Internal paintwork in a poor condition, rub down walls, prime and repaint. (REFER TO TYPICAL DETAILS).
6. Internal plasterboard ceilings in a poor condition, remove and replace with new including cornices. (REFER TO TYPICAL DETAILS).

7. Internal vinyl floor finishes in a poor condition and to be removed. (REFER TO TYPICAL DETAILS).
8. Once structural work is complete, replace with new, including skirtings.

9. Structural Damage noted, refer to Structural Engineer's report.
10. Painted window panels: paint to be cleaned off glazing and new vinyl film to be installed only to portions of glazing that were painted.

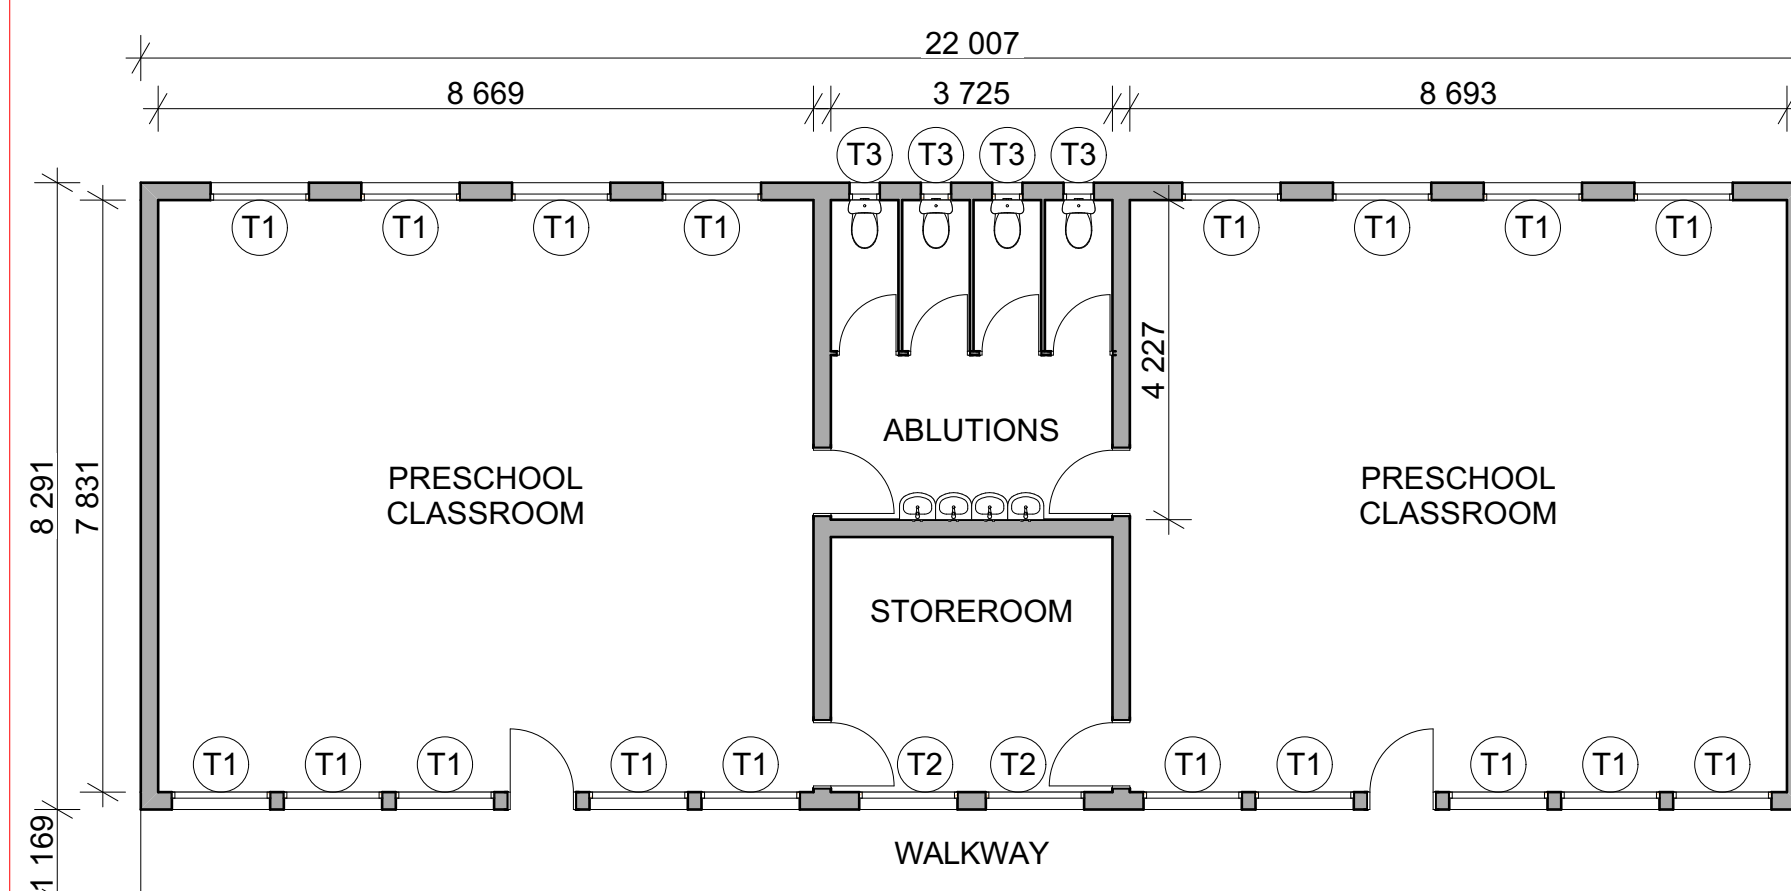
**BLOCK I: EXISTING CLASSROOM
GROUND FLOOR PLAN 1:100
AREAS: BUILDING: 169m²
WALKWAY: 39m²**

1. No gutters or downpipes installed. Install new to match existing on site or as per later detail. (REFER TO TYPICAL DETAILS).
2. Missing splashback tile next to sink to be replaced with new to match existing tiles. (SEE BELOW FOR SPECIFICATION).
3. Internal paintwork in a poor condition, rub down walls, prime and repaint. (REFER TO TYPICAL DETAILS).
4. Structural Damage noted, refer to Structural Engineer's report.
5. Some plasterboard internal ceilings in a poor condition - repaint where possible or remove and replace with new to match. (REFER TO TYPICAL DETAILS).
6. Internal vinyl / carpet floor finishes in a poor condition, remove and replace with new, including skirtings. (REFER TO TYPICAL DETAILS).

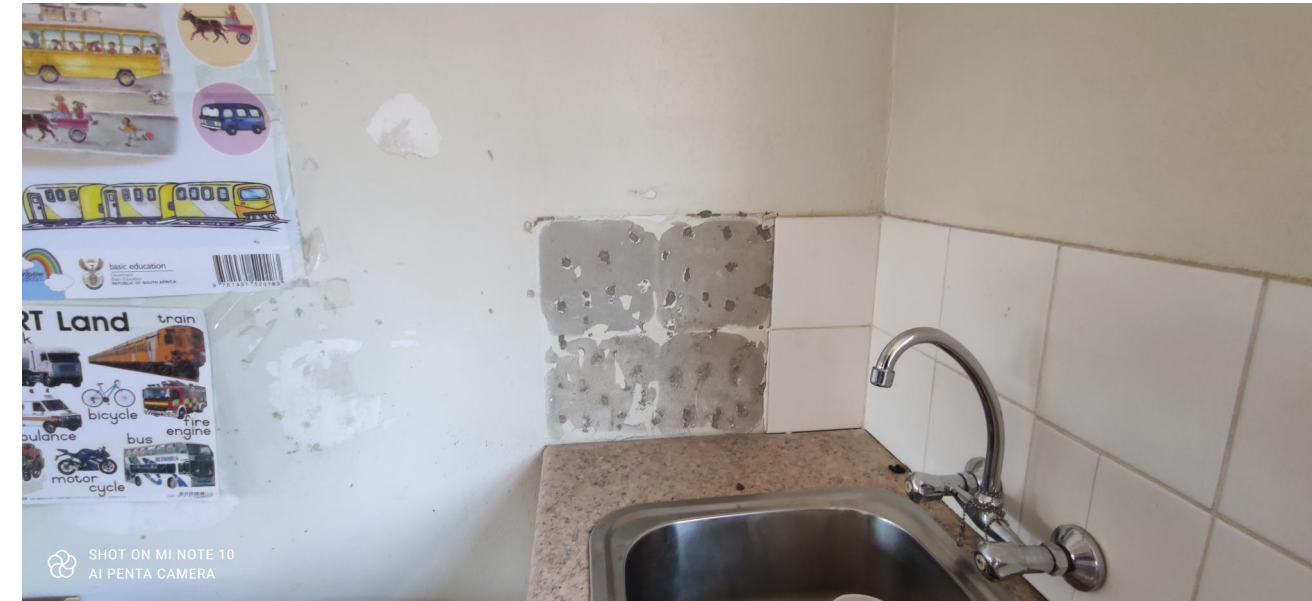
REPLACE MISSING WALL TILES:

Replace missing wall tiles with new to match existing.

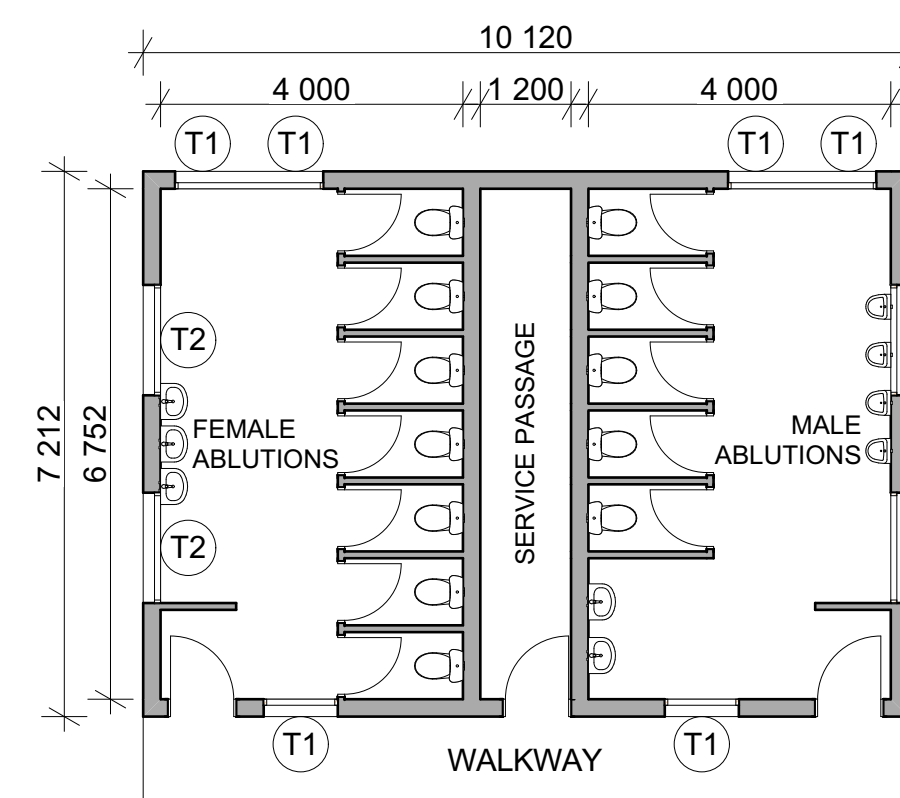
**BLOCK J AND K: EXISTING FEMALE
ABLUTIONS GROUND FLOOR PLAN 1:100
AREAS: BUILDING: 73m²**

1. Gutters and downpipes are damaged, install new to match existing on site or as per later detail. (REFER TO TYPICAL DETAILS).
2. Some barge boards missing, install new to match existing. (REFER TO TYPICAL DETAILS).

3. Corrosion to window frames, sand off as much rust as possible, apply rust inhibiting primer to restore the steel, prime and paint. Where it cannot be restored, to be replaced with new to match existing. (REFER TO TYPICAL DETAILS).

4. Internal paintwork in a poor condition, rub down walls, prime and repaint. (REFER TO TYPICAL DETAILS).
5. Internal tile floor finishes in a poor condition, remove and replace with new, including skirtings. (REFER TO TYPICAL DETAILS).

6. WC's are improperly constructed and in a poor condition. Recommend removing and replacing with new sanware to later detail. (SEE BELOW FOR SPECIFICATION).

7. Missing light fittings to be replaced with new.
8. Internal cubicle doors to be rubbed down, primed and repainted. (REFER TO TYPICAL DETAILS).
9. Damaged plumbing - repair or replace.

10. Stored furniture in service passage to be removed and all plumbing to be checked for any damage or leaks.
11. Any corroded window louvers to be repaired but if repair is not possible, replace with new to match.

12. Water damaged concrete plinth below urinals to be repaired and made good.
13. Service drain at back of toilets to be made good.

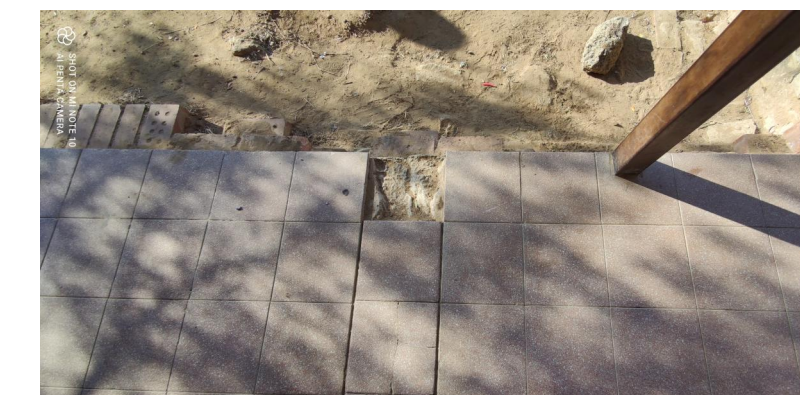
REPLACE MISSING EXTERNAL TILES:

Missing walkway tiles to be replaced with new to match existing.

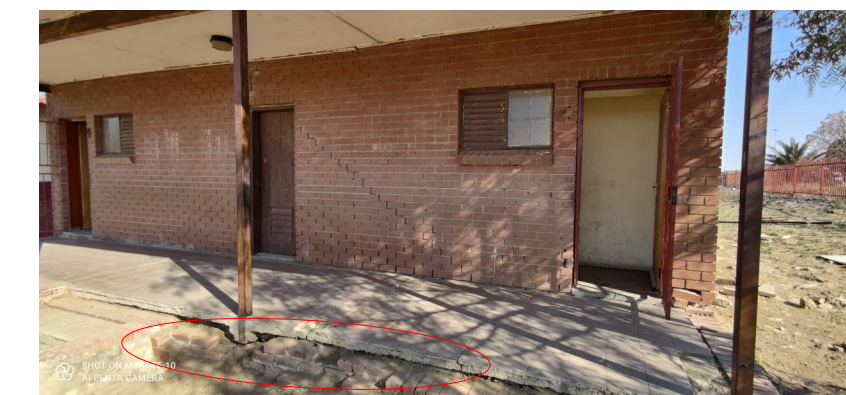
REPLACE MISSING BRICKWORK:

Replace and repair missing brickwork at edge of existing walkway - to match existing brickwork.
