CONDITION ASSESSMENT
LIKUBU PRIMARY SCHOOL

EXISTING BLOCKS:
REFURBISHMENT SCOPE OF WORKS

Drawing Number: 082-LPS-102

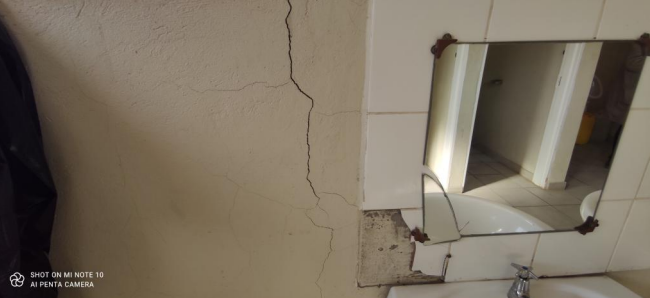
REPLACE DAMAGED TILES AND MIRROR:

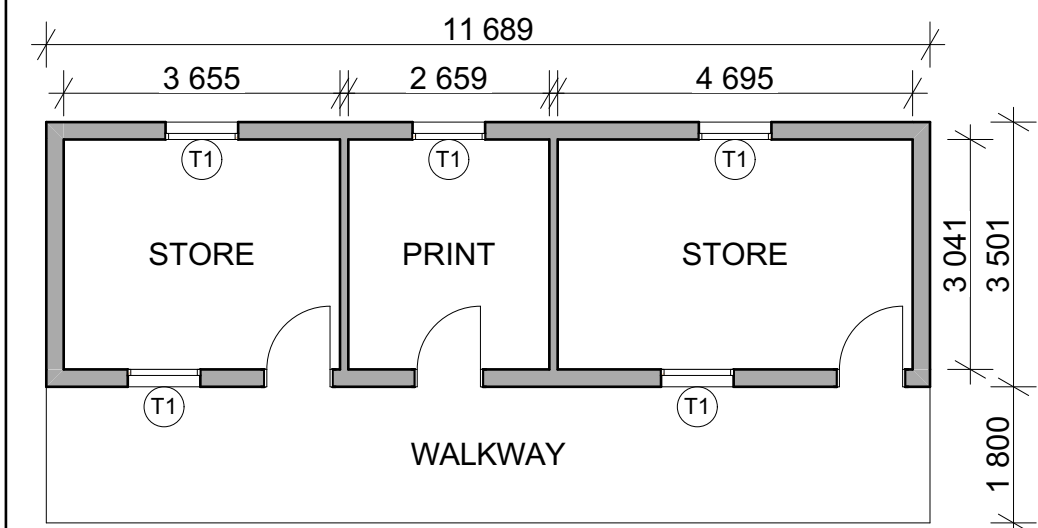
REPLACE ROOF SHEETING:

Safintra 0.55mm thick 700mm cover SAFLOK 700 'RAIN CLOUD' COLORPLUS interlocking concealed fix roof covering, fixed to timber purlins at 2112mm centres and end-span purlins at 1920mm centres (final spacing to be calculated by an engineer) by means of SL 700 Clip 21 clips secured to purlins in combination with a suitable class safintra approved wafer head self-tapping fasteners with roof insulation, all in accordance with the manufacturer's recommendations. All aspects to be in strict accordance with the manufacturer's latest published recommendations. Profile measurements and proportions must be in line with the latest product specification manual as published by Safintra SA. Sheet coating AZ150. Ridge cap to match roof sheeting.

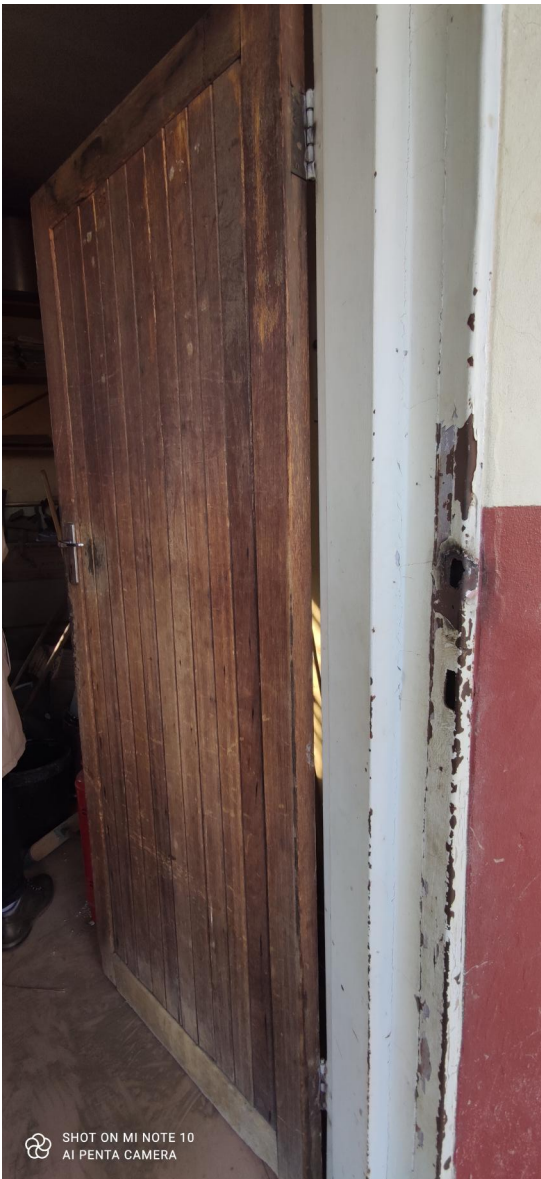
3 x EXTERNAL TIMBER DOORS TO BE RE-VARNISHED

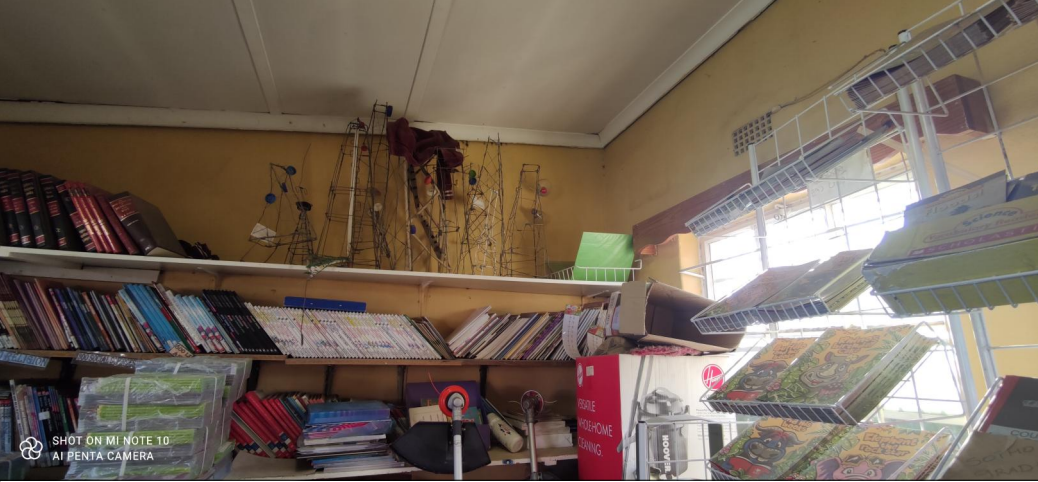
WARPED AND DAMAGED TIMBER SHELVING TO BE REMOVED AND REPLACED WITH NEW.

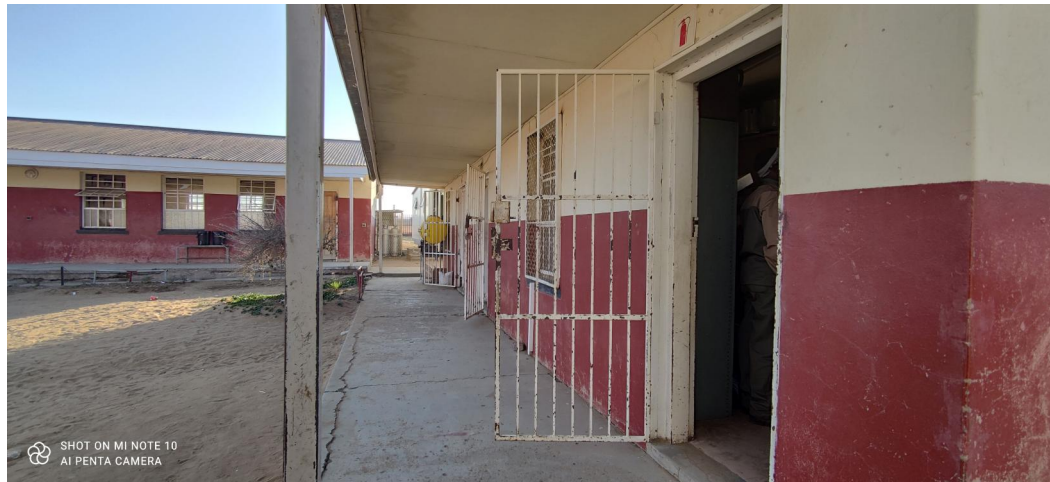
RUB DOWN EXISTING STEEL POSTS, PRIME AND REPAINT:

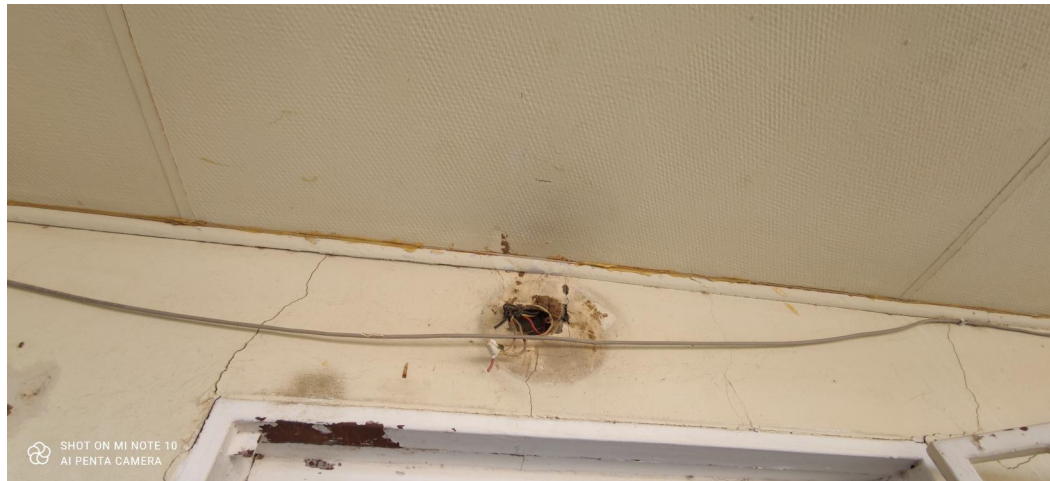
DAMAGED ELECTRICAL CONDUIT TO BE REPAIRED.

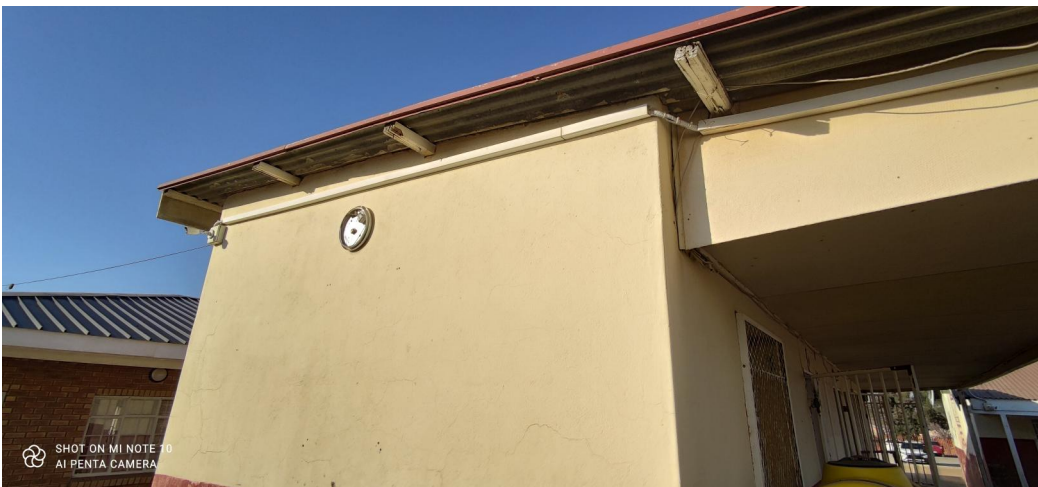
REPLACE 1 x EXTERNAL LIGHT FITTING.

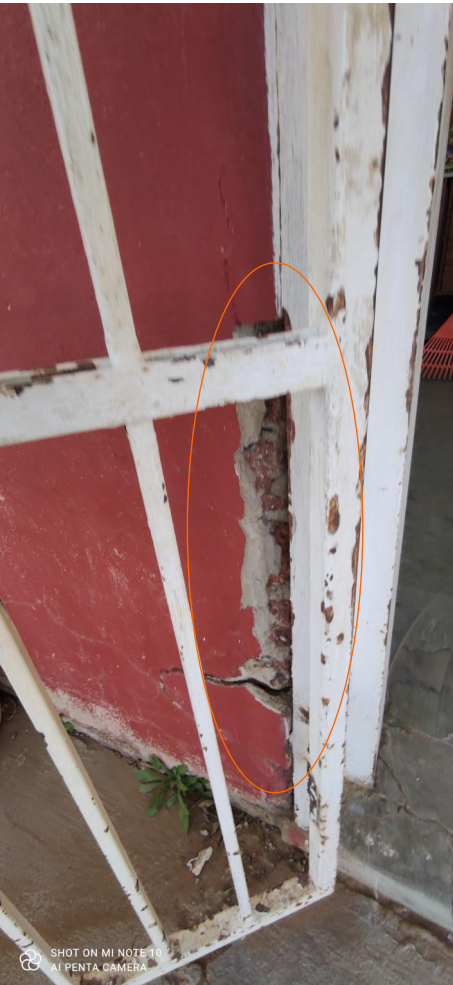
REPAIR DAMAGED PLASTERWORK AT 1 x DOOR.

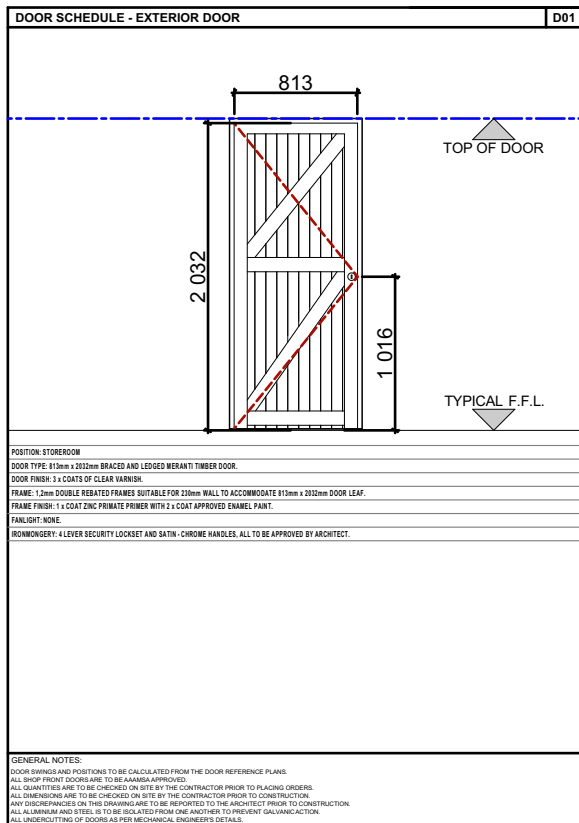
REMOVE AND REPLACE 4 x EXISTING TIMBER DOORS WITH NEW AS PER SCHEDULE BELOW.

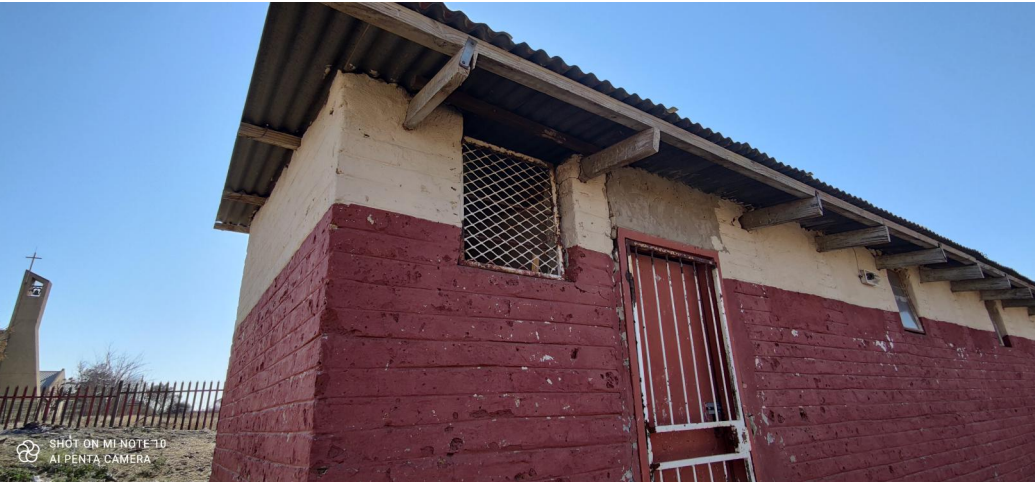
REPLACE 1 x DAMAGED T1 MESH WINDOW WITH NEW TO MATCH EXISTING.

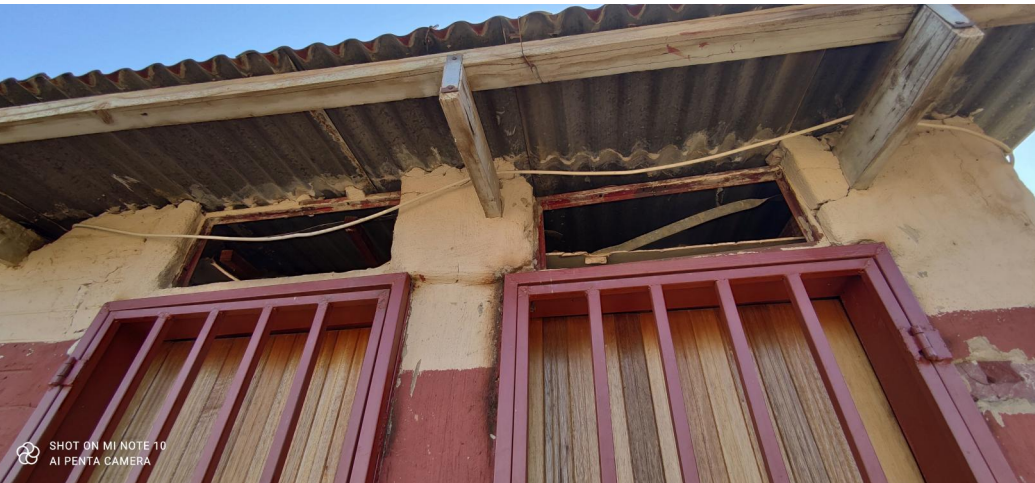
REPLACE 2 x MISSING T3 WINDOWS WITH NEW TO MATCH EXISTING.
