BLOCK P HOUSE:

Project: **CONDITION ASSESSMENT
LIKUBU PRIMARY SCHOOL**

Drawing description: **EXISTING BLOCKS:
REFURBISHMENT SCOPE OF WORKS**

Drawing Number: 682-LPS-107 Revision: B

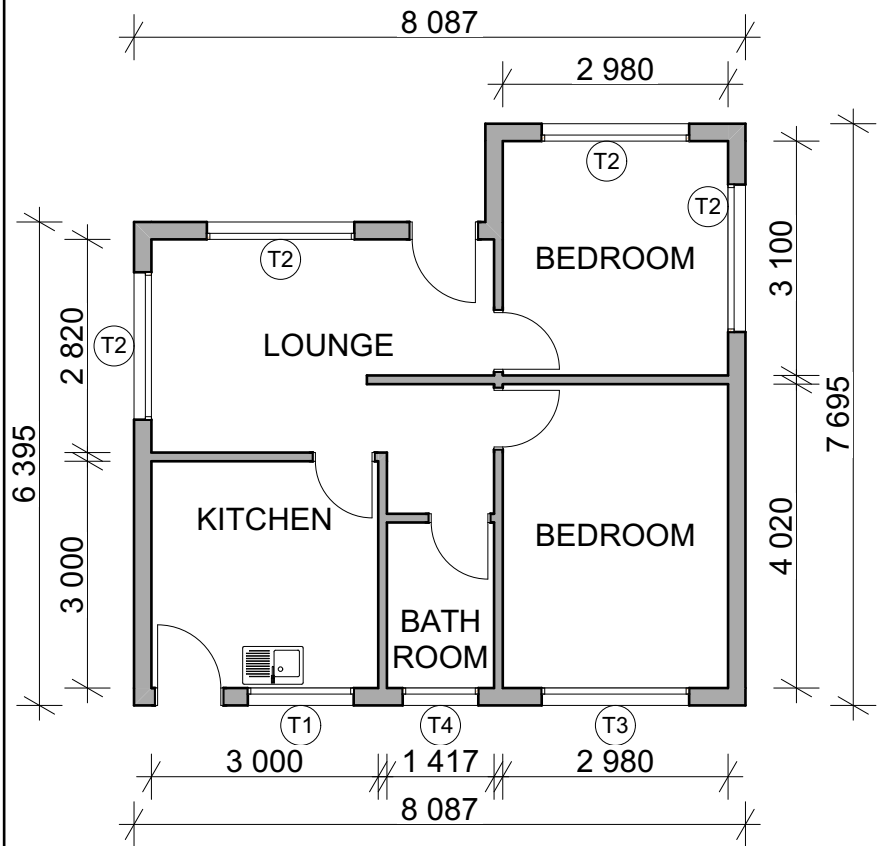
BLOCK P: HOUSE
GROUND FLOOR PLAN 1:100
AREAS: BUILDING: 62m²

- Fascia and barge boards damaged, remove, make good and install new to match existing on site or as per later detail. (REFER TO TYPICAL DETAILS).
- Timber roof structural members to be repaired or replaced as per Structural Engineer's recommendation.

- Corrosion to door and window frames & security gates, sand off as much rust as possible, apply rust inhibiting primer to restore the steel, prime and paint. Where it cannot be restored, to be replaced with new to match existing. (REFER TO TYPICAL DETAILS).

- Gutters and downpipes are damaged, install new to match existing on site or as per later detail. (REFER TO TYPICAL DETAILS).
- Replace 2 x cracked window glazing. (SEE BELOW FOR SPEC).

- Replace all internal ceilings, cornices and light fittings. (REFER TO TYPICAL DETAILS).
- Internal floor finishes in a poor condition, remove and replace with new, including skirtings. (REFER TO TYPICAL DETAILS).

- Replace kitchen cupboards and sink with new. (SEE BELOW FOR SPEC).
- Replace all internal timber doors with new. (SEE BELOW FOR SPEC).
- Internal paintwork in a poor condition, rub down walls, prime and repaint. (REFER TO TYPICAL DETAILS).

- Replace external verandah ceilings, cornices and light fittings with new. (REFER TO TYPICAL DETAILS).
- Replace 2 x timber entrance doors with new. (SEE BELOW FOR SPEC).

- Replace all bathroom fittings and tiles with new. (SEE BELOW FOR SPEC).
