Project:  
CONDITION ASSESSMENT  
THAKAMESO COMPREHENSIVE  
SECONDARY SCHOOL

REFURBISHMENT TO  
EXISTING BUILDINGS

082-TCSS-102

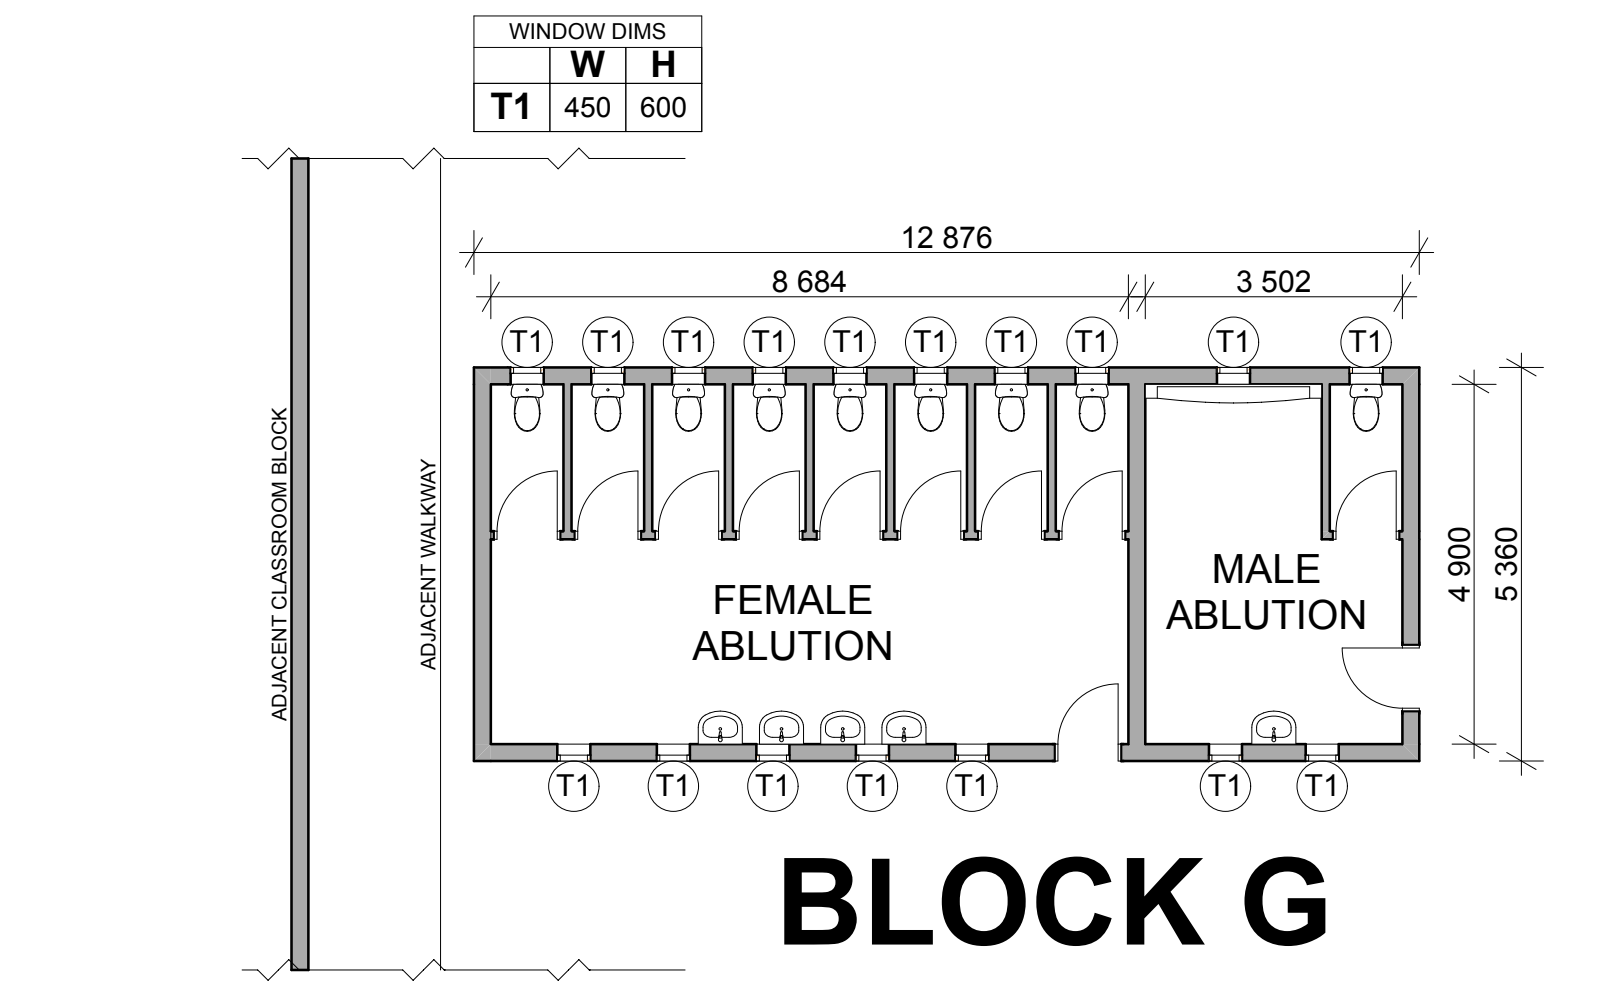
## BLOCK G ABLUTION BLOCK

BLOCK G: COMBINED ABLUTIONS: Scope of Works as per Stage 2 Assessment Report:

1. Brick filler to top of external perimeter walls / underside of roof, to ensure no gaps.
2. Replace 6 x damaged / missing glazed window panes. SEE BELOW SPECIFICATION.

3. Barge boards damaged or missing, remove and make good and install new to match existing on site or as per later detail. REFER TO TYPICAL DETAILS.
4. No floor finishes installed, install new floor finishes including skirtings. REFER TO TYPICAL DETAILS.

5. Fascia boards damaged, remove and make good and install new to match existing on site or as per later detail. REFER TO TYPICAL DETAILS.
6. 4 x WHB missing - install new to match existing WHB including new taps. Splashback tiles behind missing WHB is missing - install missing tiles to match existing. SEE BELOW SPECIFICATION.

7. External plumbing in a poor condition and leaks noted - recommend repairing / replacing all plumbing.
8. Clean all vandalism from external walls.
9. No gutters or downpipes installed. Install new to match existing on site or as per later detail.

10. Missing toilet seats / lids to be installed.
11. Noted 1 x missing ceiling trap door. Install new to match existing.
12. Some plasterboard internal ceilings damaged and in a poor condition. Recommend removing and installing new, include for skimming, painting, cornices and light fittings as per Electrical Engineer's details. REFER TO TYPICAL DETAILS.

13. Cracks noted on internal walls, refer to Structural Engineer's report for repair. Once repair work is done, prime and repaint. REFER TO TYPICAL DETAILS.

14. Rub down internal cubicle doors, prime and repaint.
15. Noted damaged air brick vents. Install new to match existing. SEE BELOW SPECIFICATION.

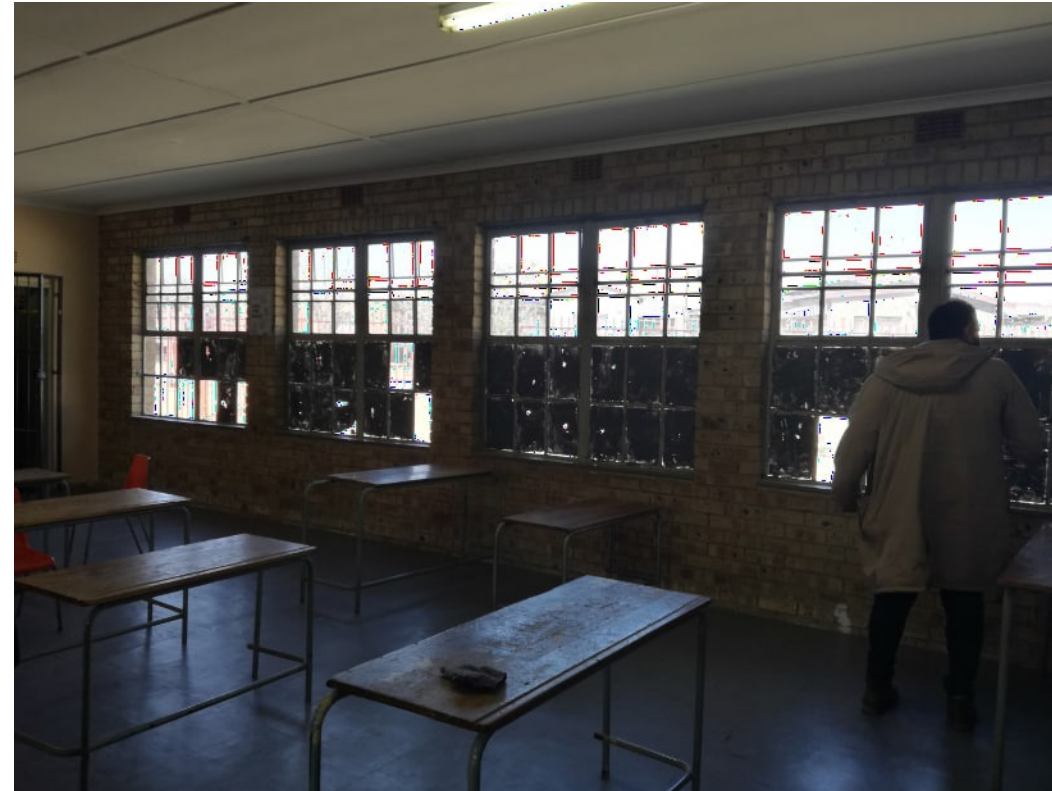
### PAINTED WINDOW PANELS:

3. Painted window panels: paint to be cleaned off glazing and new vinyl film to be installed to reduce glare. SEE BELOW FOR SPECIFICATION.
4. Make good chipped brickwork walls.

Paint on glazing to be removed and replaced with new vinyl film - to be applied to all windows (lower 2 rows of panes only).

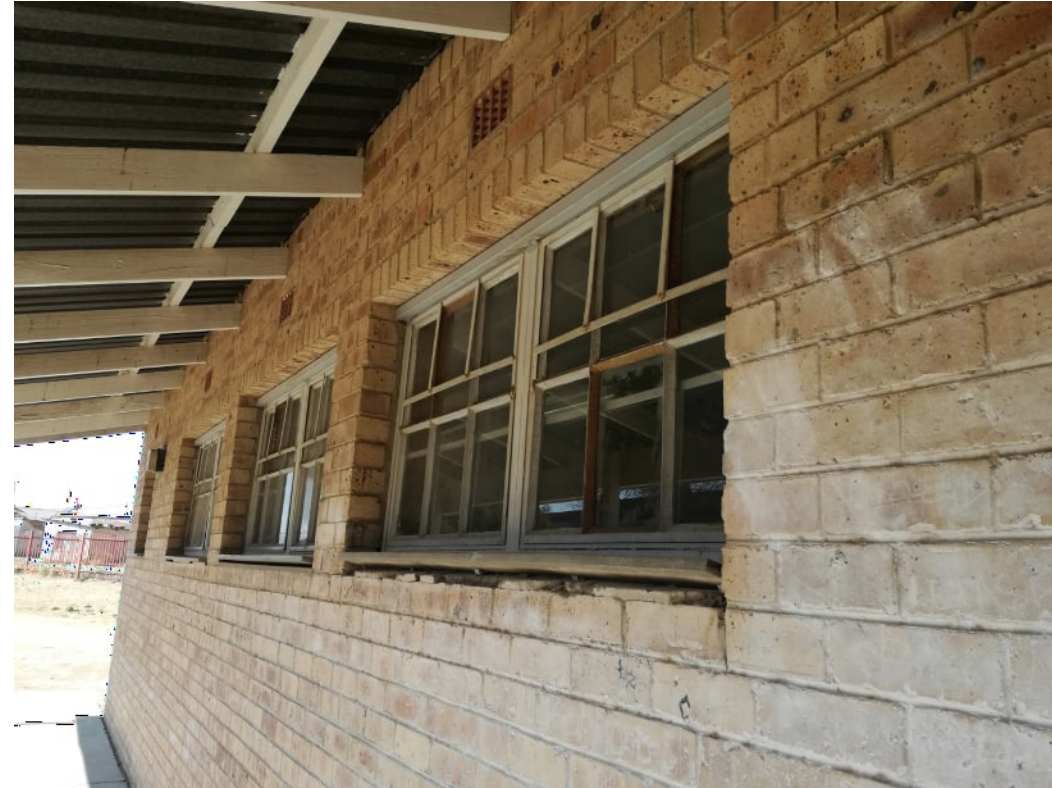
### REPLACEMENT OF DAMAGED WINDOW SILLS:

6. Paint to walkway purlins deteriorating, rub down paint, prime and repaint.
7. Window sills deteriorating / displaced. Replace damaged sills. SEE BELOW FOR SPECIFICATION.

Existing damaged window sills to be removed and replaced with new to match existing.

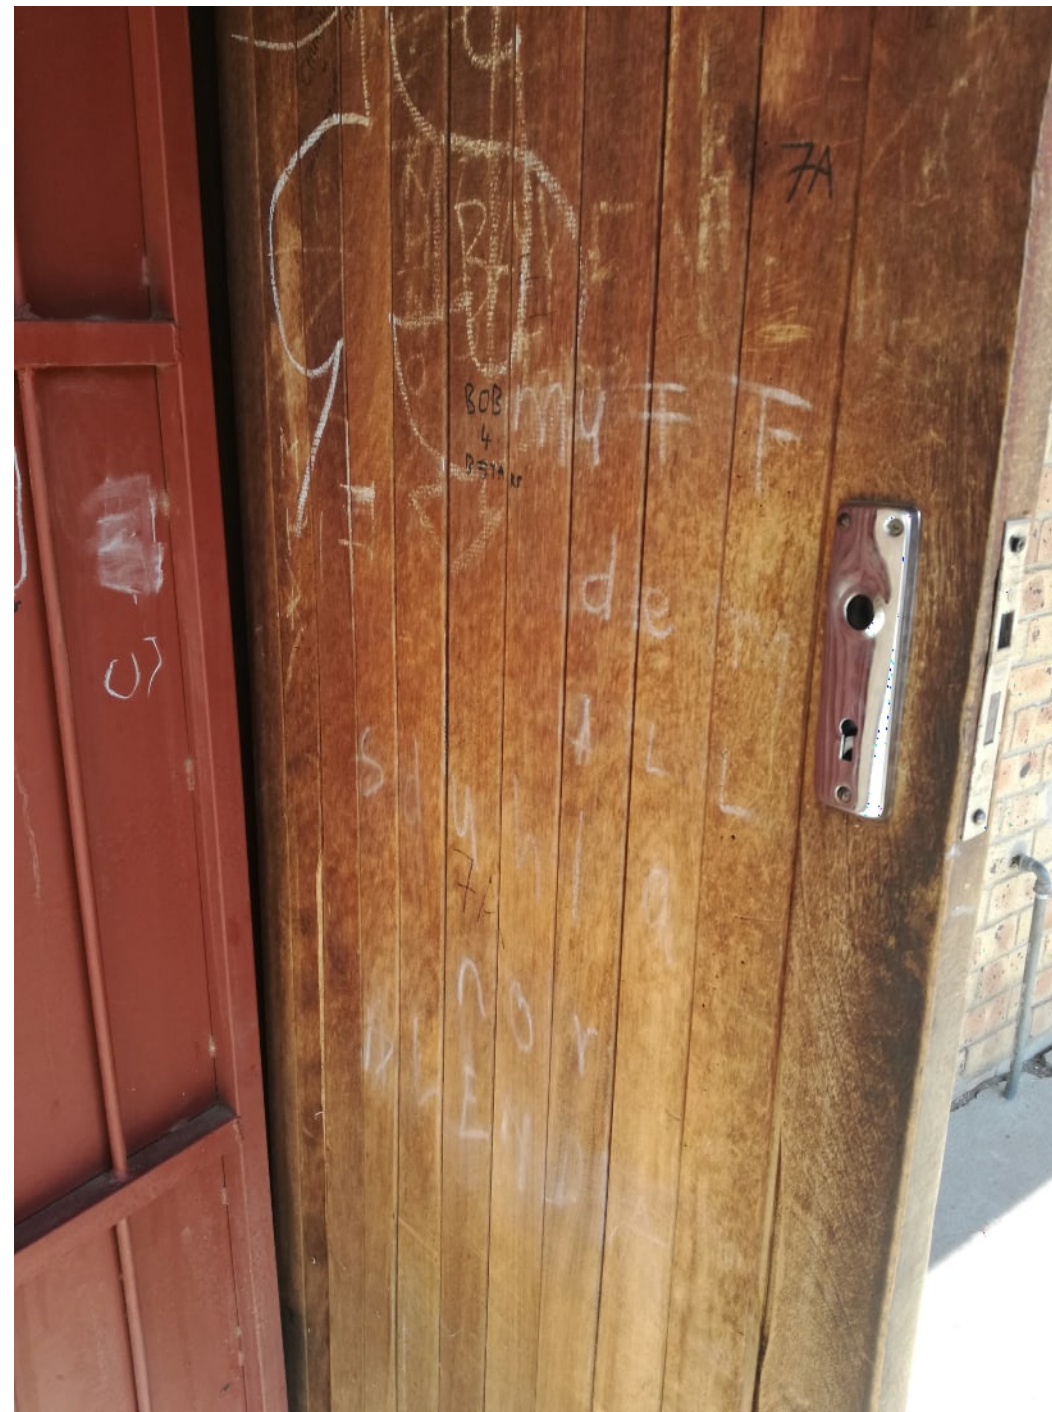
### REPLACEMENT OF IRONMONGERY:

11. Replace any missing or damaged door ironmongery.
12. Corrosion to door and window frames & security gates, sand off as much rust as possible, apply rust inhibiting primer to restore the steel, prime and paint. Where it cannot be restored, to be replaced with new to match existing. REFER TO TYPICAL DETAIL.

Replace all existing door handles with new to match existing.
