P.17080 DPW OSHOEK SITE CLEARANCE

ELECTRICAL STATUS QUO REPORT

FINAL REPORT
REVISION 00

DECEMBER 2017

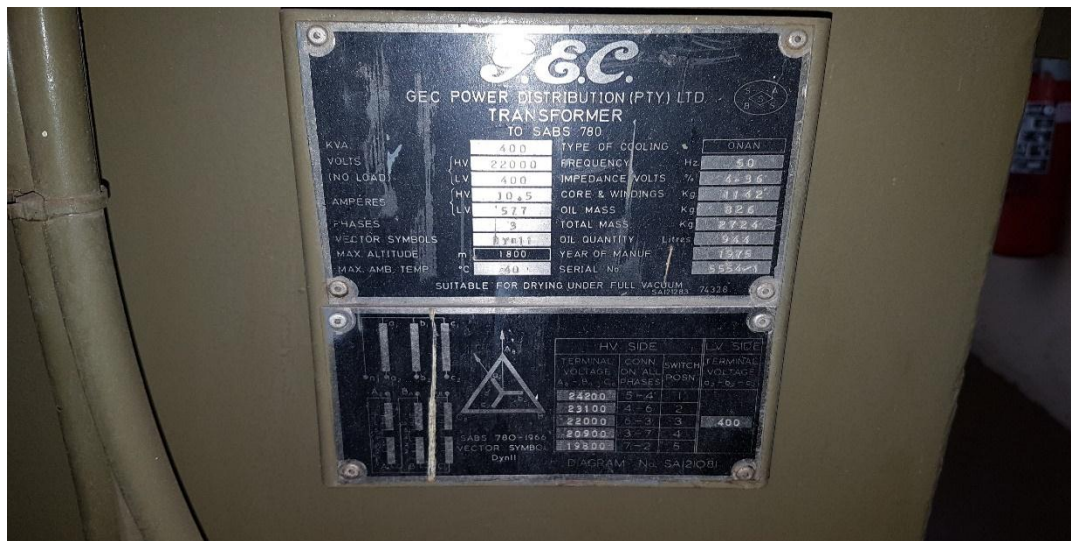
Figure 4-1: Nameplate of the main transformer located to the right of the main entrance

The capacity of the supply is currently unknown. However, a 400 kVA, 22 kV / 400 V main transformer is installed in a substation building to the right of the main entrance, next to the generator room. The transformer nameplate is shown below. The transformer was found in good working condition. No leaks were found and the cable terminations appeared to be in good condition.

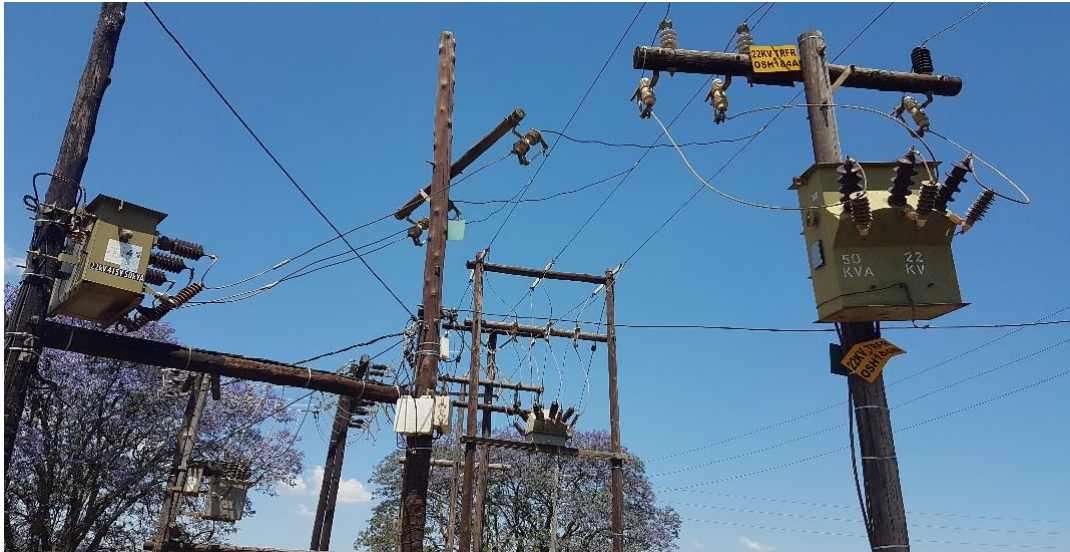
Figure 4-2: Two pole mounted transformers located directly to the right of the main entrance

Two of these transformers are clustered together and are located directly to the right of the main entrance. Both transformers are rated 50 kVA.

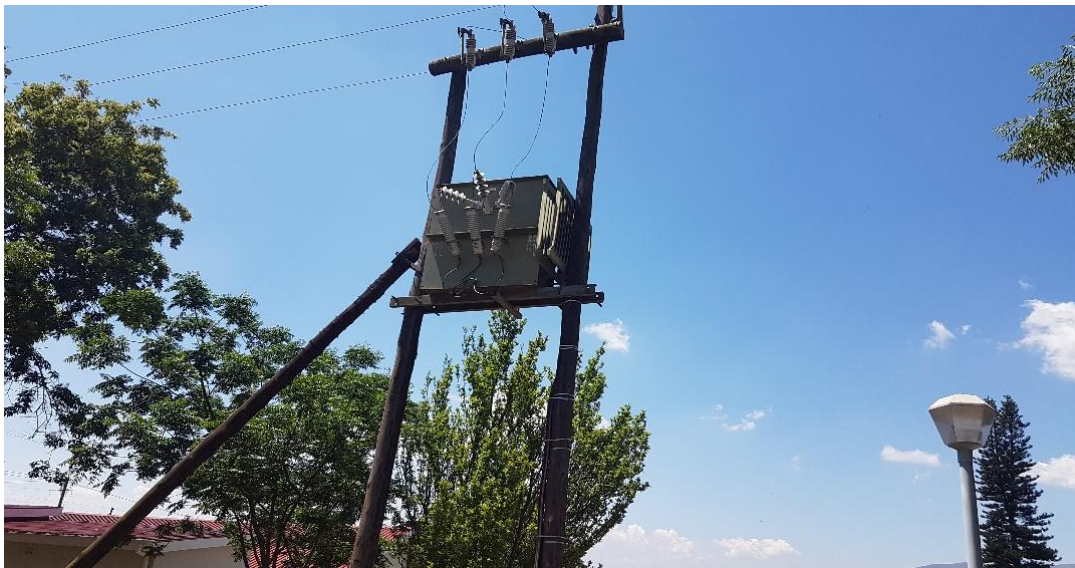
Figure 4-3: Pole mounted transformers located south of the main entrance

A third pole mounted transformer is located to the right of the main entrance, just after the two pole mounted transformers mentioned above. This transformer is rated 200 kVA.

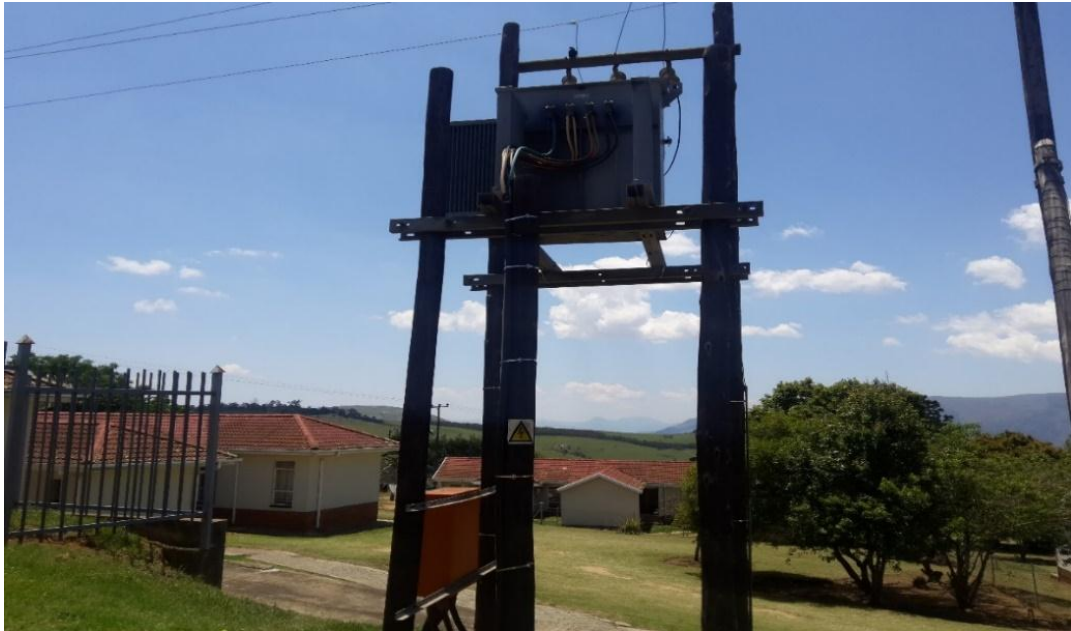
Figure 4-4: Pole mounted transformer located to the far right of the main entrance

A fourth pole mounted transformer is located towards the far right of the main entrance along the road towards the water reservoir. The transformer is rated 500 kVA. The transformer seems to supply several distribution kiosks along the road.

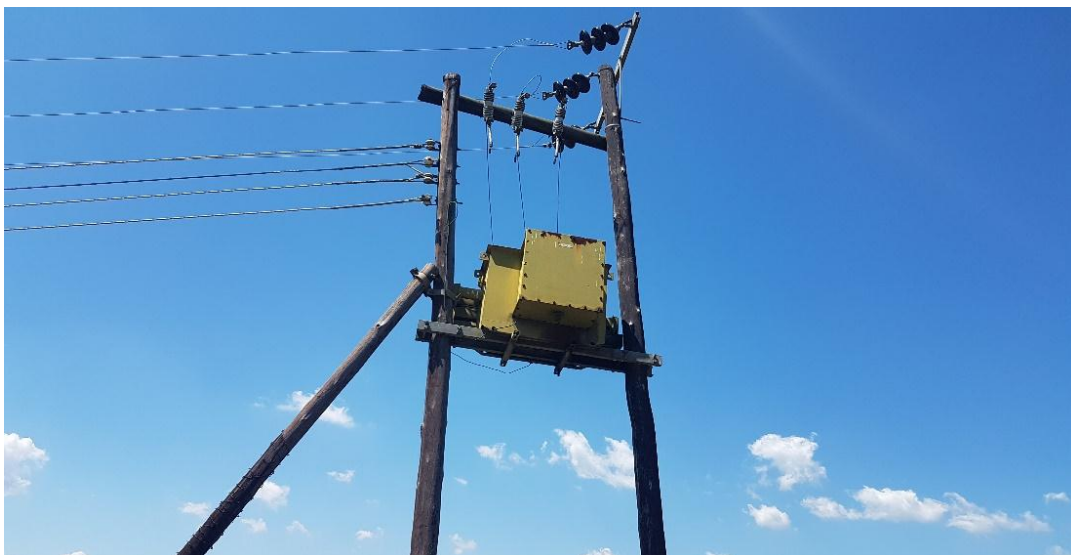
Figure 4-5: Disconnected pole mounted transformer located close to the water reservoir

The fifth transformer is located two houses below the water reservoir, towards the right. The transformer is unlabelled and seems to have been disconnected from the supply. From visual inspections, it seems to have been replaced by the pole mounted transformer down the street from its location (that transformer is described above).

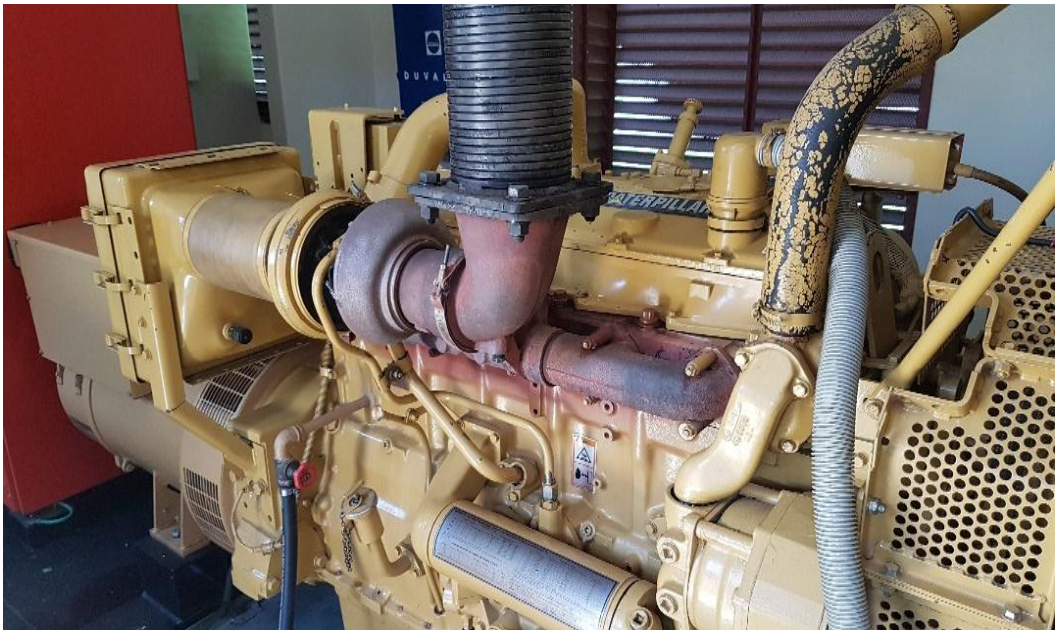
Figure 4-6: Diesel generator

The generator room is to the south of the public parking area, behind the light vehicle inspection area (inbound) and contains a Barlow world (CAT) 280 kVA generator. It is currently unknown which loads are fed from this generator.

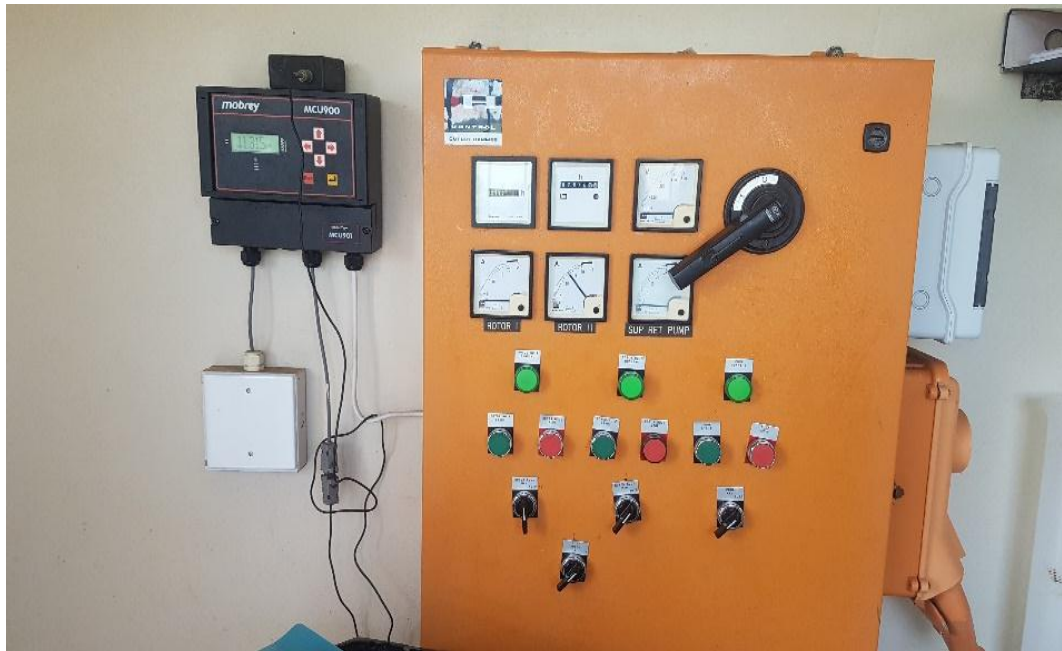
Figure 4-8: Rotor pump control panel for the waste water treatment plant

There is a 320 V rotor pump control panel for the Water Treatment Plant to the north of the border post, behind the vehicle impound.

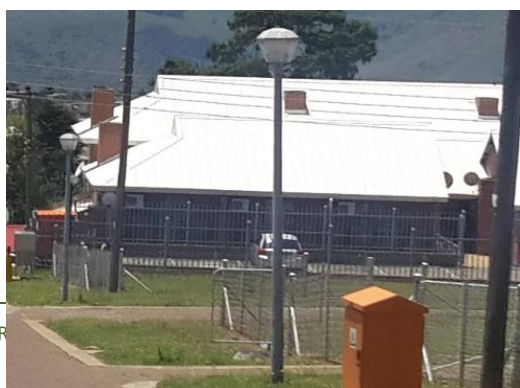
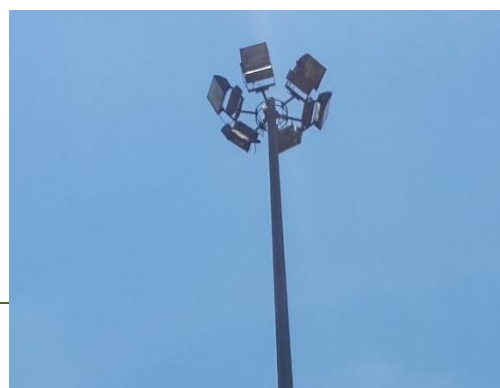
Figure 4-9: Post-top lights and high-mast lights

The lighting on site is achieved by pole mounted street lights and high-mast area lights for the border post, and Post top light fittings for the residential area.
