# OSHOEK SITE CLEARANCE

## CIVIL ENGINEERING STATUS QUO REPORT

DRAFT REPORT  
REVISION 00  
NOVEMBER 2017

**Prepared by:**  
Delta Built Environment Consultants (Pty) Ltd

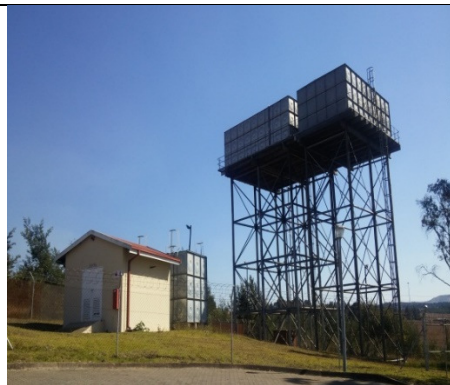
The existing water storage capacity is not sufficient for the fire risk category.

**Figure 3-1: Two elevated potable water tanks, firewater tank and fire pump station**

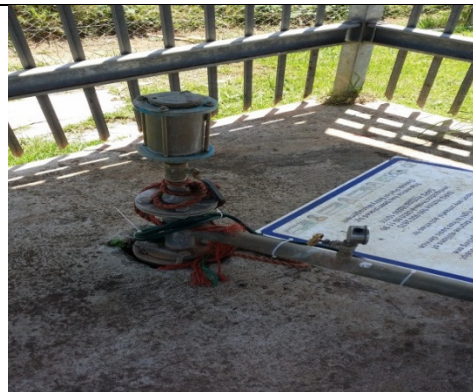
- Borehole 1 (Site Office) can deliver 1.5 litres/sec at 12 hours with a total of 64800 liters/day
- Borehole 2 (next to fence) can deliver 0.5 litres/sec at 24 hours with a total of 43200 litres/day.

**Figure 3-2: A borehole**

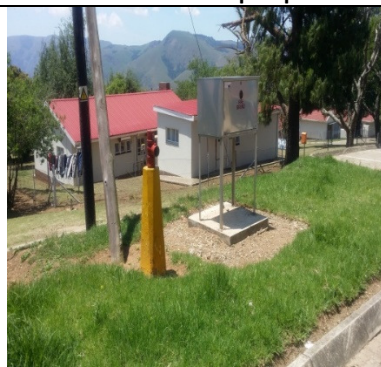
**Figure 3-3: Fire water hydrant and hose reel**

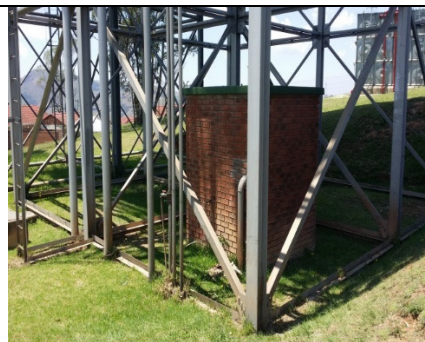
**Figure 3-4: Disinfectant Dosing room**

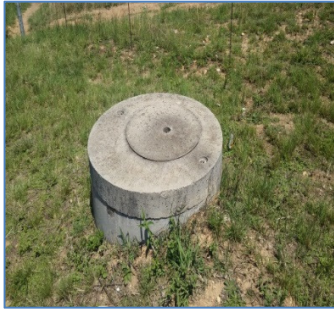
The sewer reticulation network is in a good working condition, with no overflowing manholes, and all are seemingly in order. The image below depicts one of the non-overflowing manholes:

Figure 3-5: Non-overflowing manhole

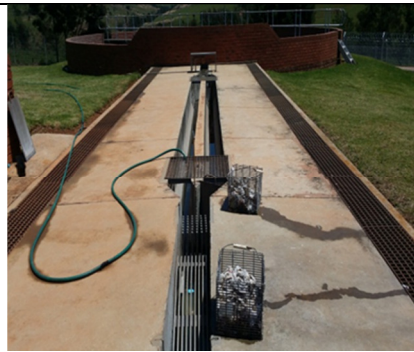
Figure 3-7: WWTW Inlet headworks

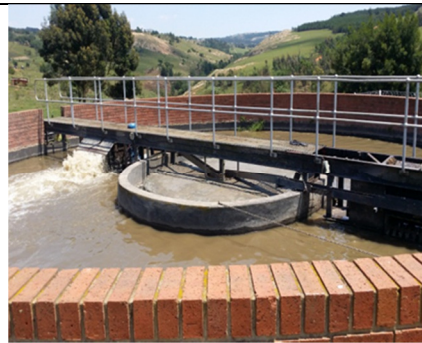
Figure 3-8: WWTW Settling tank

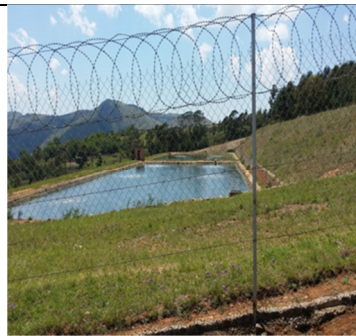
The perimeter fence around the maturation ponds and reed bed has reached its design life span and animals around the area have access to the ponds.

Figure 3-9: WWTW maturation ponds

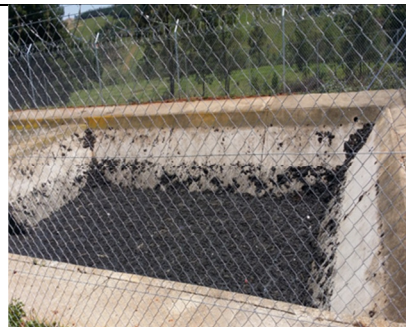
- The aeration basin is being used as the sludge lagoon
- Animals have access to the reeds bed for grazing, that reduces the functionality of the unit.

Figure 3-10: WWTW aerobic tank used as a drying bed

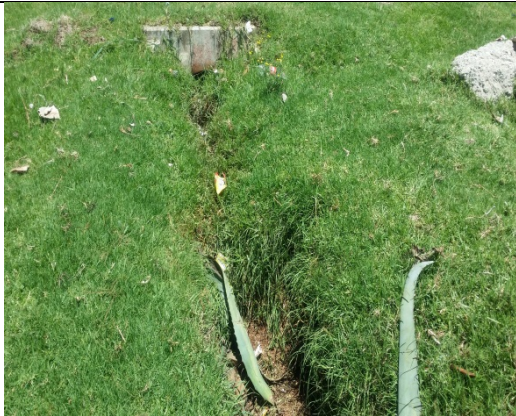
Silt build up on an open earth channel suggests that the channel is not self-cleansing and therefore the channel will need to be redesigned to the adequate slope. Earth channels need to be cleaned regularly.

**Figure 3-11: Earth channel overgrown with grass**

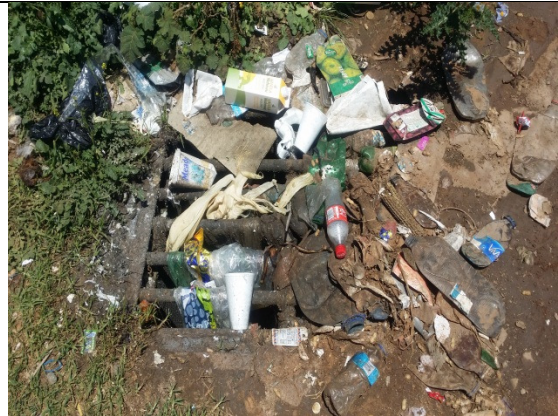
Oshoek border post has a number of stormwater side channels and pipe networks around the site that direct excess stormwater during heavy rain. Sections of the stormwater network are no longer functional and require urgent maintenance. These sections are completely filled with silt. In other sections the grid inlet is completely blocked, thus reducing the capacity of the system.

**Figure 3-12: Blocked grid inlet**

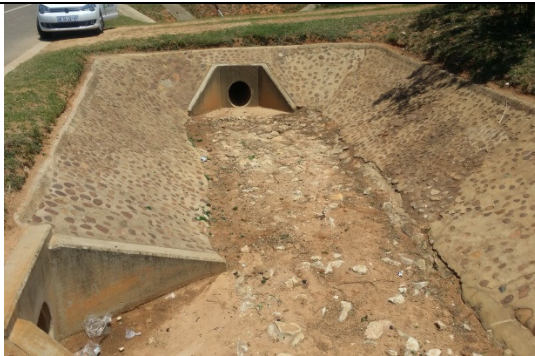
**Figure 3-13: Grouted stone pitching with silt deposition**

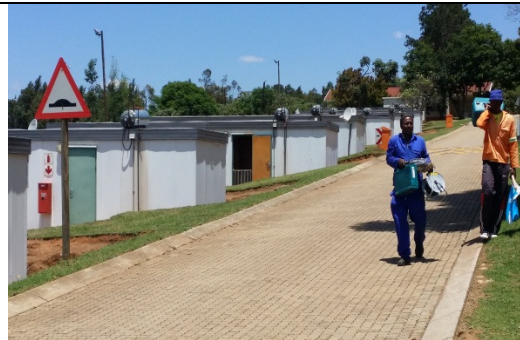
**Figure 3-14: Kerbs forming a channel along the segmented block paving**

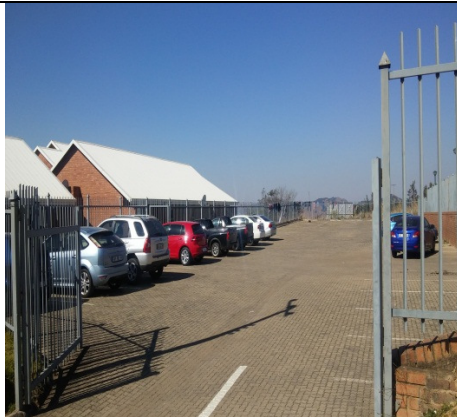
Figure 3-15: Parking bays

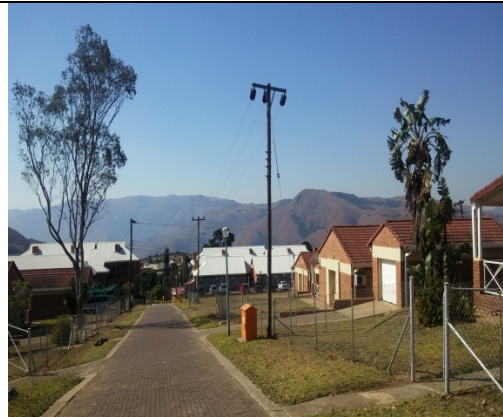
Figure 3-16: Internal roads still in a good condition

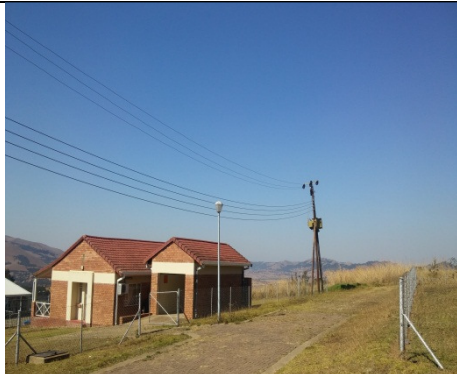
The road network is in a fair condition with just minor concerns. Certain sections of the road network are not maintained with grass growing over the paving blocks.

Figure 3-17: Segmented paving block that is overgrown with grass

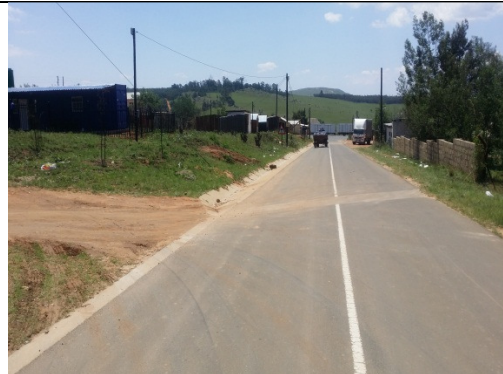
Figure 3-18: Asphalt internal road still in a good condition
