Project: **CONDITION ASSESSMENT
DR. BOHMER SECONDARY SCHOOL**

Drawing description: **EXISTING BLOCKS:
REFURBISHMENT SCOPE OF WORKS :
S.T.U & V**

Drawing Number: 082-DRBS-104

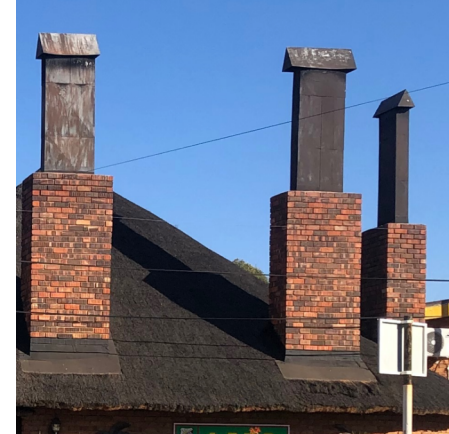
CORROSION TO CHIMNEYS

1. In good condition
2. Corrosion to Chimney Flute (REFER TO DETAIL BELOW)

Chip out / remove all of the rust and ensure that the surface is free from loose dirt, rust, paint, oil & grease. Fill holes with a suitable putty and allow to cure for 48 hours. Remove all remaining rust and strip paint down to the bare metal. Once cleaned and degreased, apply a coat of primer and when dry, apply two coats of Plascon metal paint to match existing colour, as per manufacturer's recommendations.

IF IT CANNOT BE RESTORED, REPLACE WITH NEW TO MATCH EXISTING.

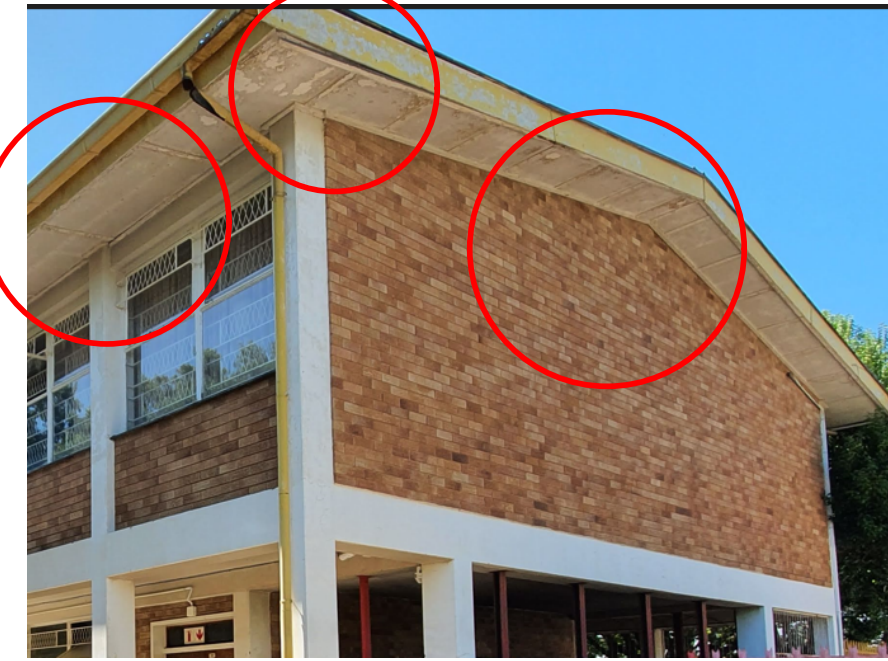
DETERIORATION TO ROOF OVERHANG SOFFITS

5. Structural Damage noted, refer to Structural Engineer's report.
6. External ceiling to u/s of roof overhang on facades in a poor condition - recommend removing and replacing with new to match (REFER TO DETAIL BELOW)

Carefully remove existing damaged ceilings boards and cornices. Install new gypsum ceiling boards, 6.4mm thick, with PVC cover strips and coved cornices, to be skimmed until smooth and even. Paint with fully washable matt white PVA.

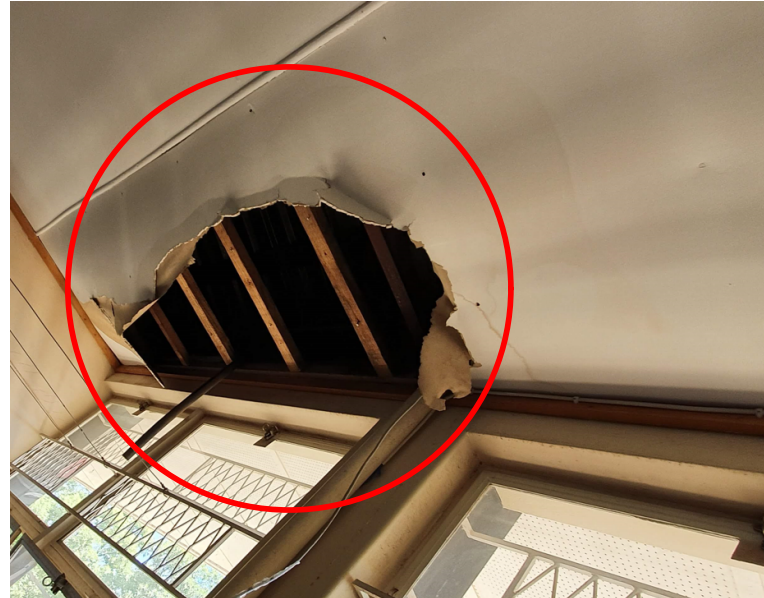
DAMAGED CEILING PANELS OR DAMAGED CORNICES

10. Ablutions have no floor finishes - install new floor finishes and skirtings. (REFER TO TYPICAL TILE FLOORING DETAILS)
11. Some of the classrooms ceilings are damaged - recommend removing and replacing damaged ceilings, including for skimming, painting and new cornices.(REFER TO DETAIL BELOW)

Carefully remove existing damaged ceilings boards and cornices. Install new gypsum ceiling boards, 6.4mm thick, with PVC cover strips and coved cornices, to be skimmed until smooth and even. Paint with fully washable matt white PVA.

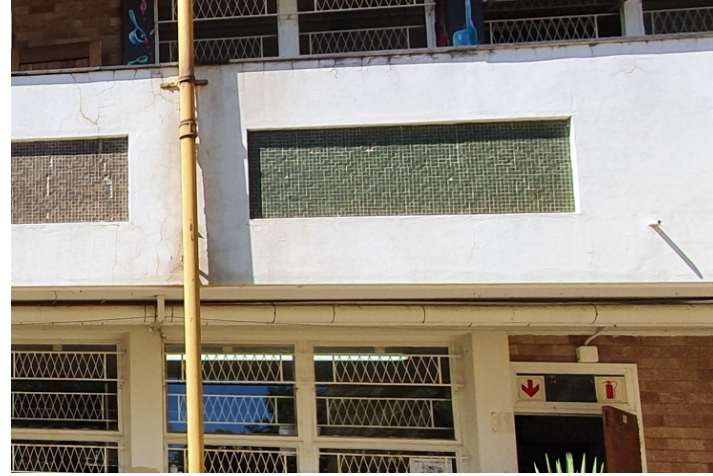
DETERIORATION TO BRICK BALUSTRADE

7. First floor brickwork balustrade walls are in a poor condition - recommend rubbing down, make good and repainting. Missing sill on top of balustrade to be replaced with new to match. (REFER TO DETAIL BELOW)

Replace 1x missing sill/coping to first floor brick balustrade. Rub down, prime and repaint deteriorating paintwork (to match) across entire balustrade.

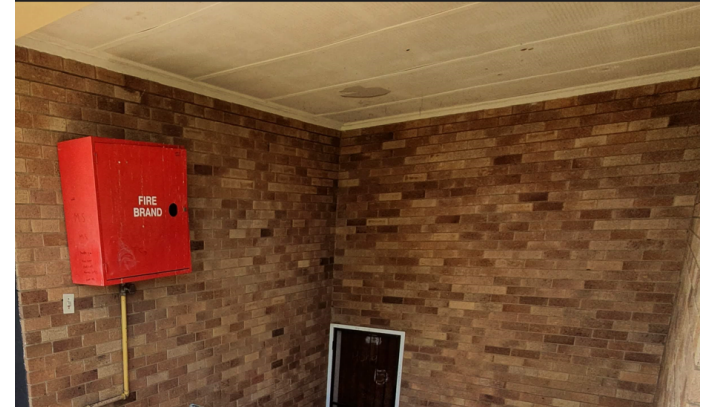
DAMAGED CEILING PANELS IN STAIR VOID

8. Ceiling in staircase void is in a poor condition - recommend removing and replacing with new to match.(REFER TO DETAIL BELOW)
9. Some of the classrooms floors are damaged - recommend removing and replacing damaged floor finishes, including new skirtings.(REFER TO TYPICAL VINYL FLOORING DETAILS)

Carefully remove existing damaged ceilings boards and cornices. Install new gypsum ceiling boards, 6.4mm thick, with PVC cover strips and coved cornices, to be skimmed until smooth and even. Paint with fully washable matt white PVA.
