Project: **CONDITION ASSESSMENT DR. BOHMER SECONDARY SCHOOL**

Drawing description: **SITE DEVELOPMENT PLAN (EXISTING BUILDINGS)**

Drawing Number: 082-DRBS-100

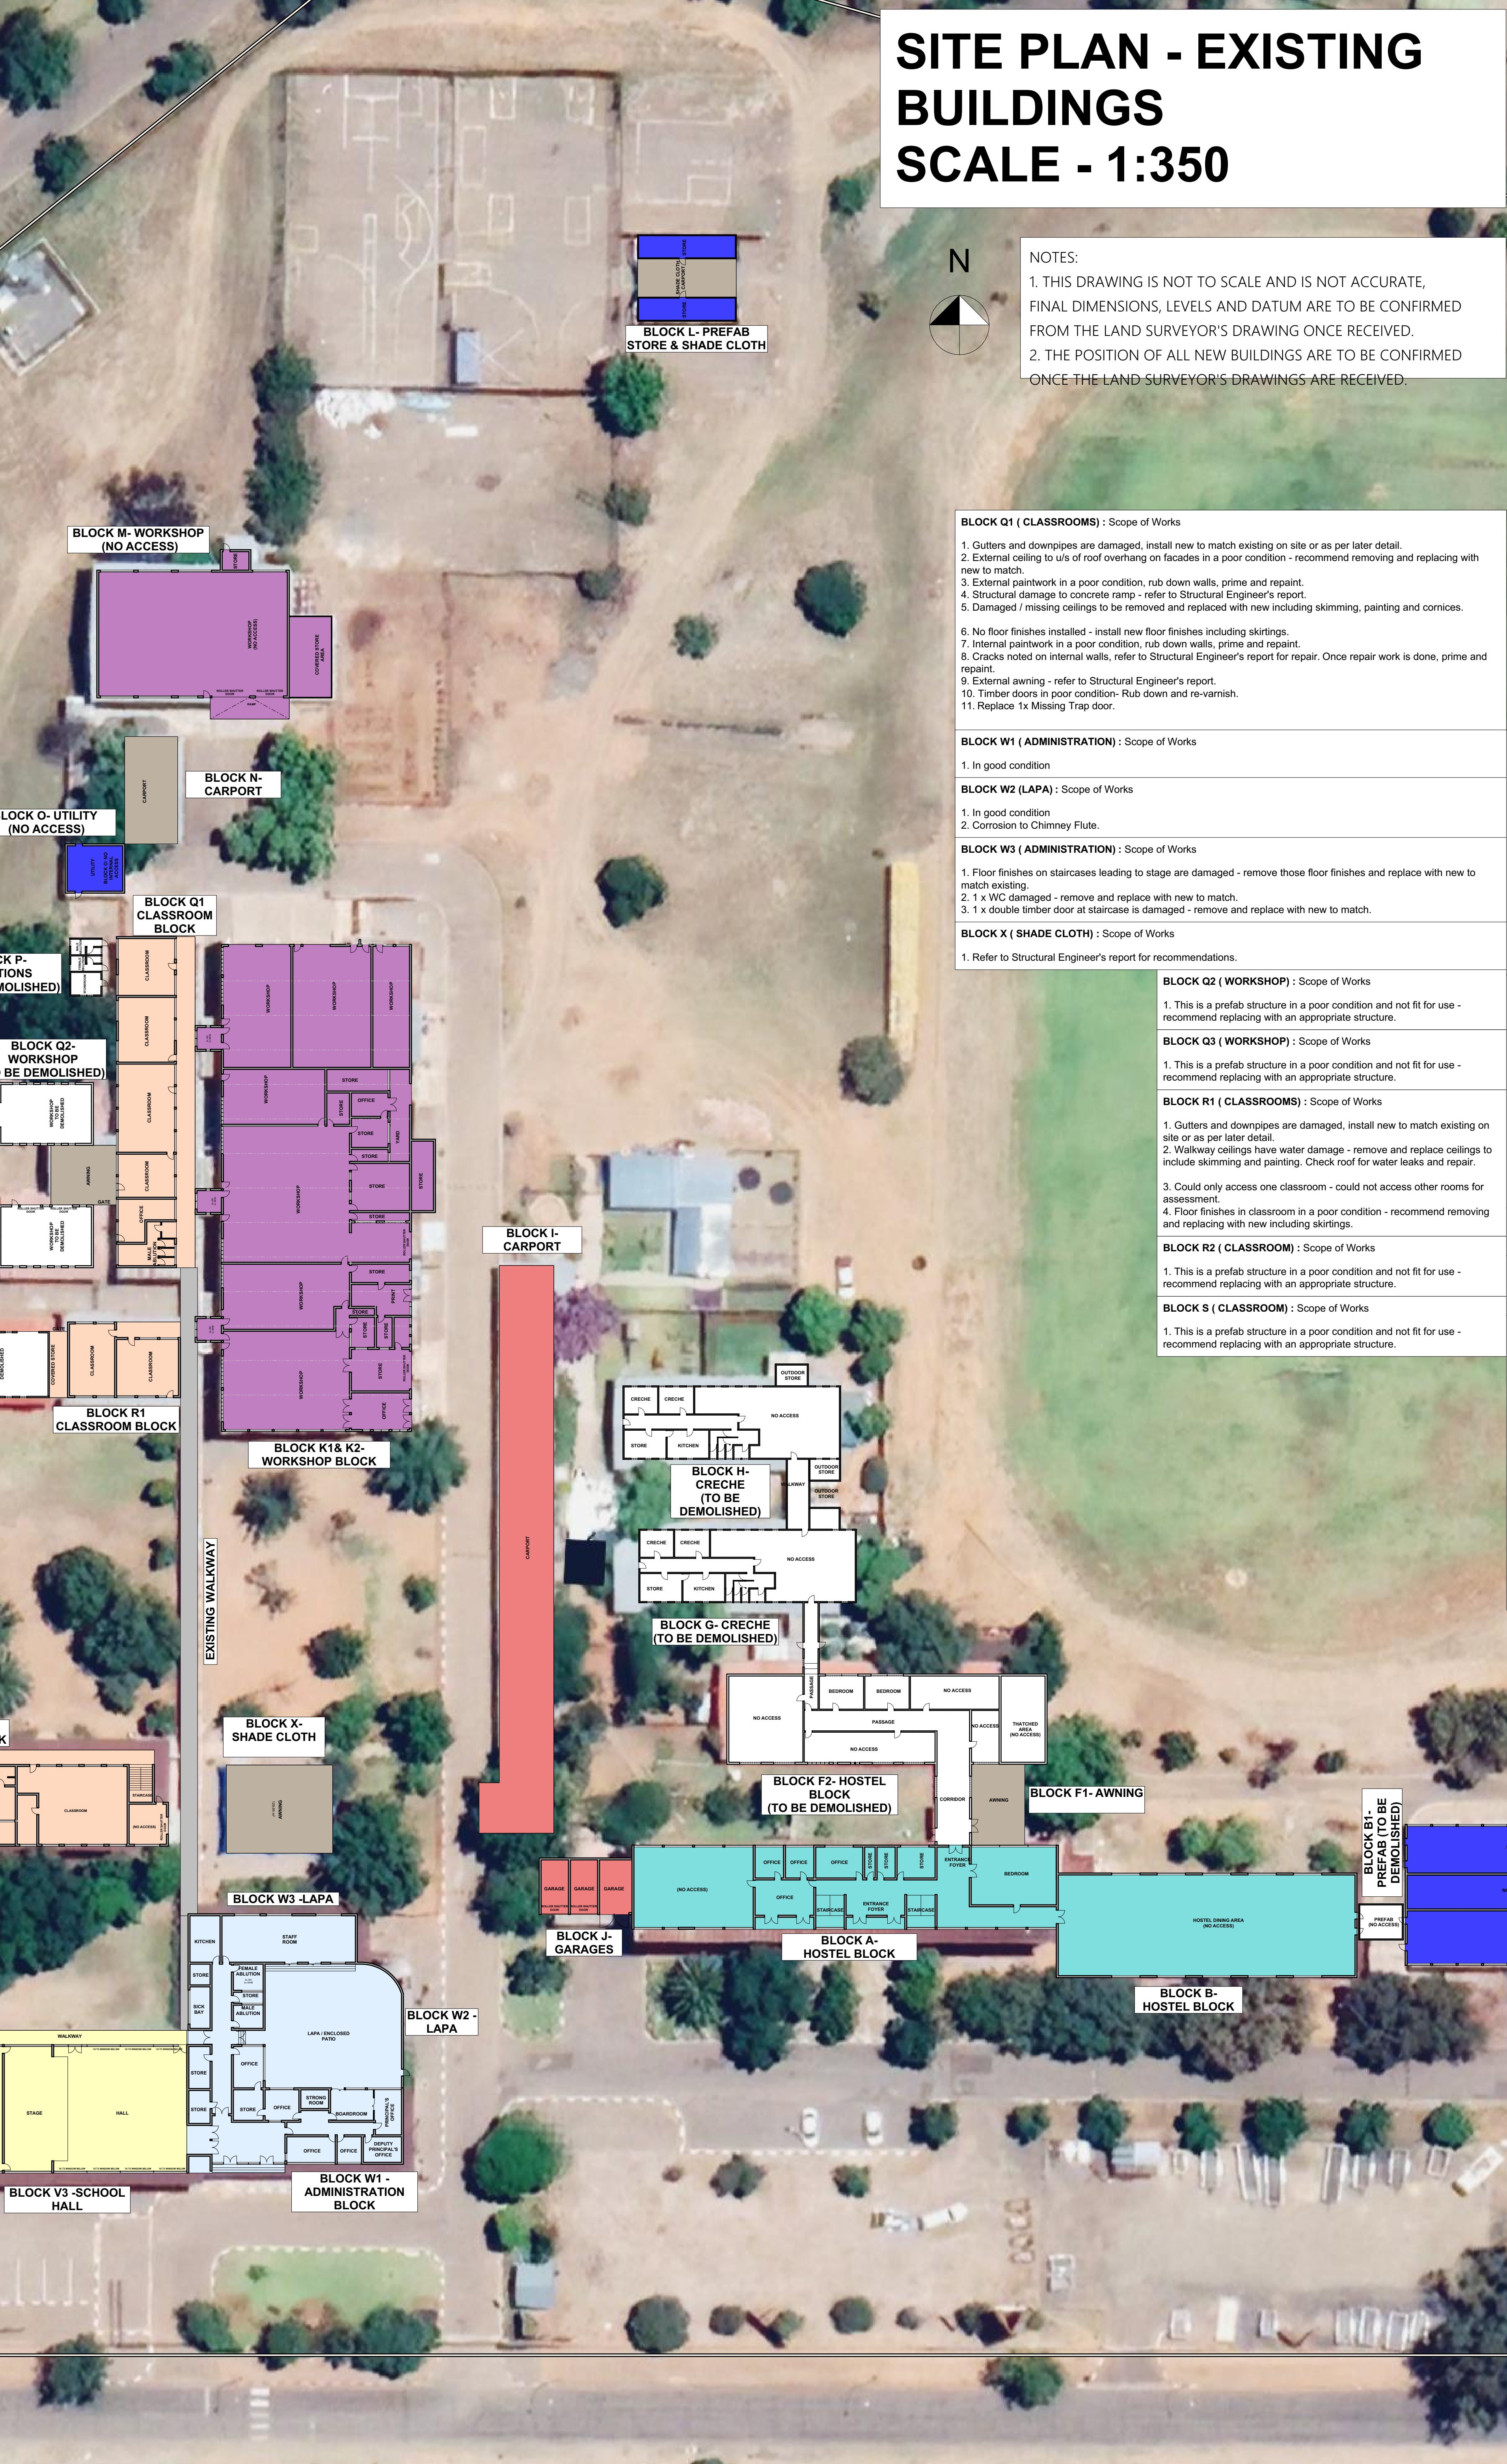
SITE PLAN - EXISTING BUILDINGS

- BLOCK A (HOSTEL):** Scope of Works
- Gutters and downpipes are damaged, install new to match existing on site or as per later detail.
 - External steel staircases, balustrades & landing are corroded - remove and replace with new SANS 10400 compliant fire escape staircases with overhead coverings. Refer to Structural Engineer's report.

- Chimney at spiral staircase is corroded - remove and replace with new.
 - Wall at spiral staircase is severely stained with rust marks - recommend rubbing down, priming and repainting.

5. Internal floor finishes in a poor condition, remove and replace with new, including skirtings.
6. Internal steps at emergency exit are non-compliant. Recommend installing new balustrade to steps.

7. Internal floor tiles in all ablutions / bathrooms to be removed and replaced with new.
8. Damaged wall tiles in ablutions / bathrooms to be removed and replaced with new to match.

9. Replace all floor tiles to all showers.
10. Peeling & flaking paint to internal walls in ablutions - rub down, prime & repaint.
11. Water damage to ceilings, remove all affected panels and cornices and replace with new to match, including skimming and painting. Roof sheeting and trusses to be inspected for leakage / damage and to be repaired or replaced.

12. Some of the internal walls in a poor condition - rub down, prime & repaint.
13. Structural Damage noted, refer to Structural Engineer's report.
14. Emergency exit timber door on first floor is damaged, to be removed and replaced with new.

15. Water damage to u/s of sills in ablutions - locate leaks and repair, waterproof and repaint.
16. External paintwork in a poor condition, rub down walls, prime and repaint.

17. Creeping plant on airbricks to be removed as it is damaging the external facade.
18. Corrosion to window frames, sand off as much rust as possible, apply rust inhibiting primer to restore the steel, prime and paint. Where it cannot be restored, to be replaced with new to match existing.

19. External ceiling to u/s of roof overhang on facades in a poor condition - recommend removing and replacing with new to match.
20. Roof sheeting is corroding / damaged; replace roof sheeting with new.

21. Fascia and barge boards damaged, remove, make good and install new to match existing on site or as per later detail.
22. Could not gain access into many areas for assessment & inspection.

- BLOCK B (HOSTEL):** Scope of Works
- Roof sheeting is corroding / damaged; replace roof sheeting with new.
 - Gutters and downpipes are damaged, install new to match existing on site or as per later detail.
 - External paintwork in a poor condition, rub down walls, prime and repaint.
 - External ceiling to u/s of roof overhang on facades in a poor condition - recommend removing and replacing with new to match.
 - Water damage & damp to external walls at duct door. Locate source of leak / damp and repair / replace. Waterproof and repaint walls.
 - Corrosion and deterioration to external duct doors. Remove and replace with new.
 - No access into Block B for assessment.
 - From looking through window: ceiling tiles in dining hall in a poor condition - appears to be water damaged - recommend removing and replacing with new to match.

- BLOCK C (NO ACCESS):** Scope of Works
- No access for assessment.
 - External paintwork in a poor condition, rub down walls, prime and repaint.
 - Gutters and downpipes are damaged, install new to match existing on site or as per later detail.
 - Roof sheeting is corroding / damaged; replace roof sheeting with new.

- BLOCK D (NO ACCESS):** Scope of Works
- No access for assessment.

- BLOCK E (NO ACCESS):** Scope of Works
- No access for assessment.
 - External paintwork in a poor condition, rub down walls, prime and repaint.
 - Gutters and downpipes are damaged, install new to match existing on site or as per later detail.

- BLOCK F1 (WALKWAY/AWNING):** Scope of Works
- No access for assessment.
 - Gutters and downpipes are missing, install new to match existing on site or as per later detail.

- BLOCK F2 (HOSTEL):** Scope of Works
- This is a prefab structure with asbestos wall panels - recommend replacing with an appropriate structure as it is being used for dormitory rooms.
 - No access into some of the areas for assessment.

- BLOCK G (CRECHE):** Scope of Works
- This is a prefab structure with asbestos wall panels - recommend replacing with an appropriate structure as it is being used for dormitory rooms.

- BLOCK K (WORKSHOP):** Scope of Works
- Roof sheeting, gutters and downpipes all in a poor condition. Recommend removing and replacing with new to detailed design.

- Structural damage noted to some of the protruding white box gutters.
 - Damage / missing ceilings to be removed and replaced with new including skimming, painting and cornices.

- Cracks noted on internal walls, refer to Structural Engineer's report for repair. Once repair work is done, prime and repaint.
 - Replace 2 x damaged double timber door.

- Replace 1 x damaged steel sink & splashback tiles.
 - External ceiling to u/s of roof overhang on facades in a poor condition - recommend removing and replacing with new to match.

- Damaged brickwork step edges - replace missing brickwork to match existing and make good.
 - Corrosion to door frames, sand off as much rust as possible, apply rust inhibiting primer to restore the steel, prime and paint. Where it cannot be restored, to be replaced with new to match existing.

- Bathrooms / ablutions in a poor condition. Water damage & damp on walls. Recommend rubbing down walls, prime and repaint. Locate any leaks, repair / replace and make good. Install new floor finishes.

- Water ingress from high level windows - investigate reasons for water ingress and waterproof / seal windows.
 - Replace 2x missing trap doors.

- BLOCK L (CARPORT - PREFAB):** Scope of Works
- Refer to Structural Engineer's report for recommendations.

- BLOCK M (WORKSHOP):** Scope of Works
- No access into the internal area for assessment.
 - Gutters and downpipes are damaged, install new to match existing on site or as per later detail.
 - Barge boards - rub down, prime and repaint.
 - Timber doors - rub down and re-varnish.

- BLOCK N (CARPORT):** Scope of Works
- Refer to Structural Engineer's report for recommendations.

- BLOCK O (UTILITY):** Scope of Works
- No access into the internal area for assessment.
 - Clean off vandalism from external surfaces.

- BLOCK P (ABLUTIONS):** Scope of Works
- This is a prefab structure in a poor condition and not fit for use - recommend replacing with an appropriate structure.

- BLOCK H (CRECHE):** Scope of Works
- This is a prefab structure with asbestos wall panels - recommend replacing with an appropriate structure as it is being used for dormitory rooms.

- BLOCK I (CARPORT):** Scope of Works
- Refer to Structural Engineer's report for recommendations.

- BLOCK J (GARAGE):** Scope of Works
- No gutters or downpipes installed. Install new to match existing on site or as per later detail.
 - Roof sheeting is corroding / damaged; replace roof sheeting with new.

- BLOCK Q1 (CLASSROOMS):** Scope of Works
- Gutters and downpipes are damaged, install new to match existing on site or as per later detail.
 - External ceiling to u/s of roof overhang on facades in a poor condition - recommend removing and replacing with new to match.

- External paintwork in a poor condition, rub down walls, prime and repaint.
 - Structural damage to concrete ramp - refer to Structural Engineer's report.

- Damaged / missing ceilings to be removed and replaced with new including skimming, painting and cornices.
 - No floor finishes installed - install new floor finishes including skirtings.

- Internal paintwork in a poor condition, rub down walls, prime and repaint.
 - Cracks noted on internal walls, refer to Structural Engineer's report for repair. Once repair work is done, prime and repaint.

- External awning - refer to Structural Engineer's report.
 - Timber doors in poor condition - Rub down and re-varnish.
 - Replace 1x Missing Trap door.

- BLOCK W1 (ADMINISTRATION):** Scope of Works
- In good condition

- BLOCK W2 (LAPA):** Scope of Works
- In good condition
 - Corrosion to Chimney Flue.

- BLOCK W3 (ADMINISTRATION):** Scope of Works
- Floor finishes on staircases leading to stage are damaged - remove those floor finishes and replace with new to match existing.
 - 1 x WC damaged - remove and replace with new to match.
 - 1 x double timber door at staircase is damaged - remove and replace with new to match.

- BLOCK X (SHADE CLOTH):** Scope of Works
- Refer to Structural Engineer's report for recommendations.

- BLOCK Q2 (WORKSHOP):** Scope of Works
- This is a prefab structure in a poor condition and not fit for use - recommend replacing with an appropriate structure.

- BLOCK Q3 (WORKSHOP):** Scope of Works
- This is a prefab structure in a poor condition and not fit for use - recommend replacing with an appropriate structure.

- BLOCK R1 (CLASSROOMS):** Scope of Works

- Gutters and downpipes are damaged, install new to match existing on site or as per later detail.
- Walkway ceilings have water damage - remove and replace ceilings to include skimming and painting. Check roof for water leaks and repair.
- Could only access one classroom - could not access other rooms for assessment.
- Floor finishes in classroom in a poor condition - recommend removing and replacing with new including skirtings.

- BLOCK R2 (CLASSROOM):** Scope of Works

- This is a prefab structure in a poor condition and not fit for use - recommend replacing with an appropriate structure.

- BLOCK S (CLASSROOM):** Scope of Works
- This is a prefab structure in a poor condition and not fit for use - recommend replacing with an appropriate structure.

- BLOCK T (CLASSROOMS):** Scope of Works
- External paintwork in a poor condition, rub down walls, prime and repaint.
 - Roof sheeting is corroding / damaged; replace roof sheeting with new.

- Gutters and downpipes are damaged, install new to match existing on site or as per later detail.
 - Fascia and barge boards damaged, remove, make good and install new to match existing on site or as per later detail.

- Structural Damage noted, refer to Structural Engineer's report.
 - External ceiling to u/s of roof overhang on facades in a poor condition - recommend removing and replacing with new to match.

- First floor brickwork balustrade walls are in a poor condition - recommend rubbing down, make good and repainting. Missing sill on top of balustrade to be replaced with new to match.

- Ceiling in staircase void is in a poor condition - recommend removing and replacing with new to match.
 - Some of the classrooms floors are damaged - recommend removing and replacing damaged floor finishes, including new skirtings.

- Ablutions have no floor finishes - install new floor finishes and skirtings.
 - Some of the classrooms ceilings are damaged - recommend removing and replacing damaged ceilings, including for skimming, painting and new cornices.

- Rub down & repaint deteriorating railing and handrail in staircases.

- BLOCK U (CLASSROOM):** Scope of Works

- BLOCK V1 (COMPUTER LAB):** Scope of Works
- No access into the internal area for assessment.

- BLOCK V2 (CLASSROOM):** Scope of Works
- Gutters and downpipes are damaged, install new to match existing on site or as per later detail.
 - External paintwork in a poor condition, rub down walls, prime and repaint.

- Some of the roof sheeting is corroding - remove and replace with new.
 - External ceiling to u/s of roof overhang on facades in a poor condition - recommend removing and replacing with new to match.

- First floor brickwork balustrade walls to be made good for any loose brickwork or coping Rub down, prime and repaint exterior face of balustrade.
 - Ceiling in staircase void is in a poor condition - recommend removing and replacing with new to match.

- Some of the internal floor finishes are damaged - recommend removing replacing damaged floor finishes, including new skirtings.
 - 1 x damaged / stained urinal to be replaced with new. Stained floor to be cleaned and new floor finishes to be installed in ablutions.

- Damage to concrete steps - refer to Structural Engineer's report.
 - Replace damaged / cracked window glazing.
 - Missing damaged wall tiles in ablutions to be replaced with new.

- Missing taps to WHB's to be replaced.
 - Timber doors to be rubbed down and repainted or re-varnished.
 - Some of the internal ceilings are damaged - recommend removing and replacing damaged ceilings, including new cornices-investigate for leaks.

- Timber doors in poor condition. Rub down & re-varnish.
 - Rub down and Repaint deteriorating steel balustrades and railings along staircases.
