Project:
CONDITION ASSESSMENT HTS WELKOM SCHOOL

Drawing description:
EXISTING BUILDINGS REFURBISHMENT SCOPE OF WORKS

| Drawing Number: | 082-HTSWEL-102 | Revision: A |

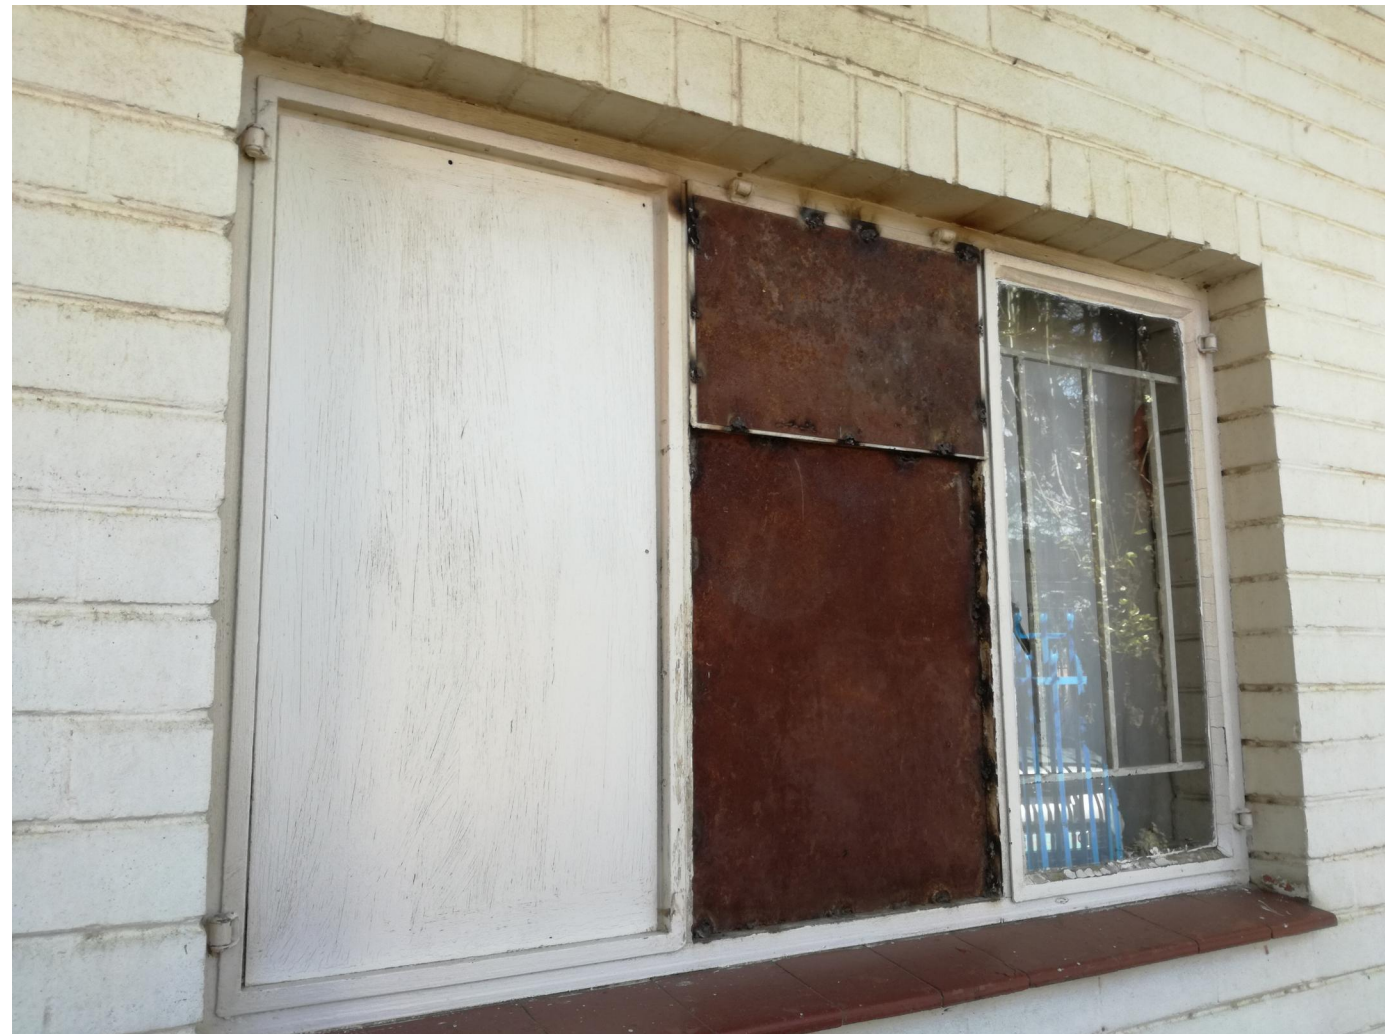
3. 1 x window T1 missing glazing panel and has been boarded up - remove and replace with new glazing to match existing. REFER TO IMAGE BELOW.
4. All external and internal doors, door frames, windows and window frames in a poor condition. Rub down, prime and repaint or re-varnish to match existing. REFER TO TYPICAL DETAILS.

EXISTING WINDOW HAS BEEN BOARDED UP. REMOVE BOARDING AND REPLACE WINDOW GLAZING WITH NEW TOUGHENED SAFETY GLAZING.

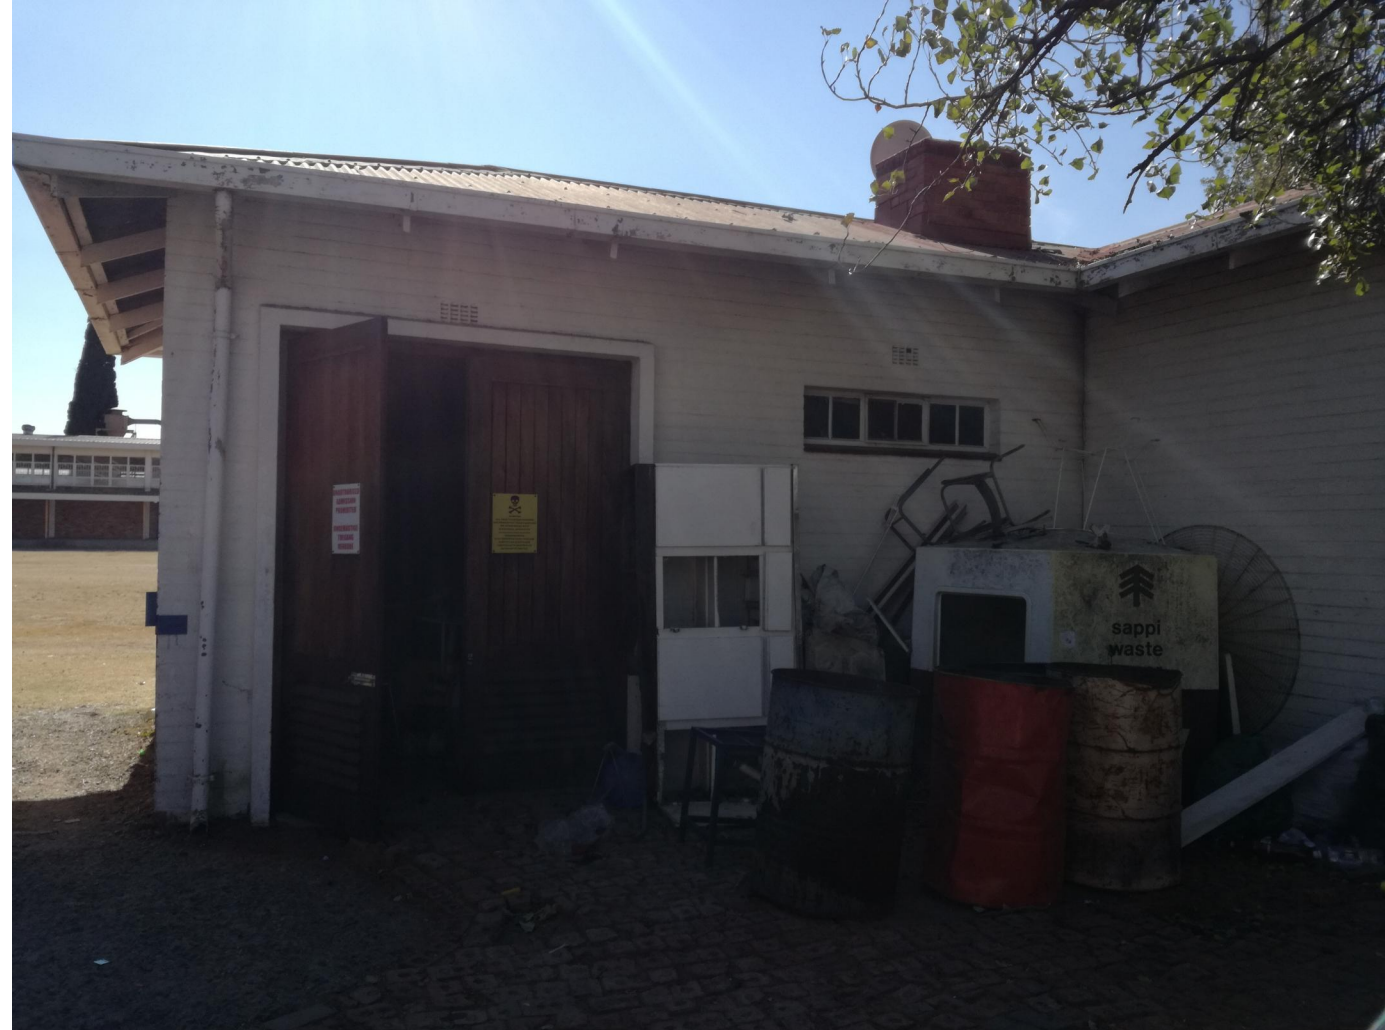
REPAINT ALL INTERNAL AND EXTERNAL WALLS.

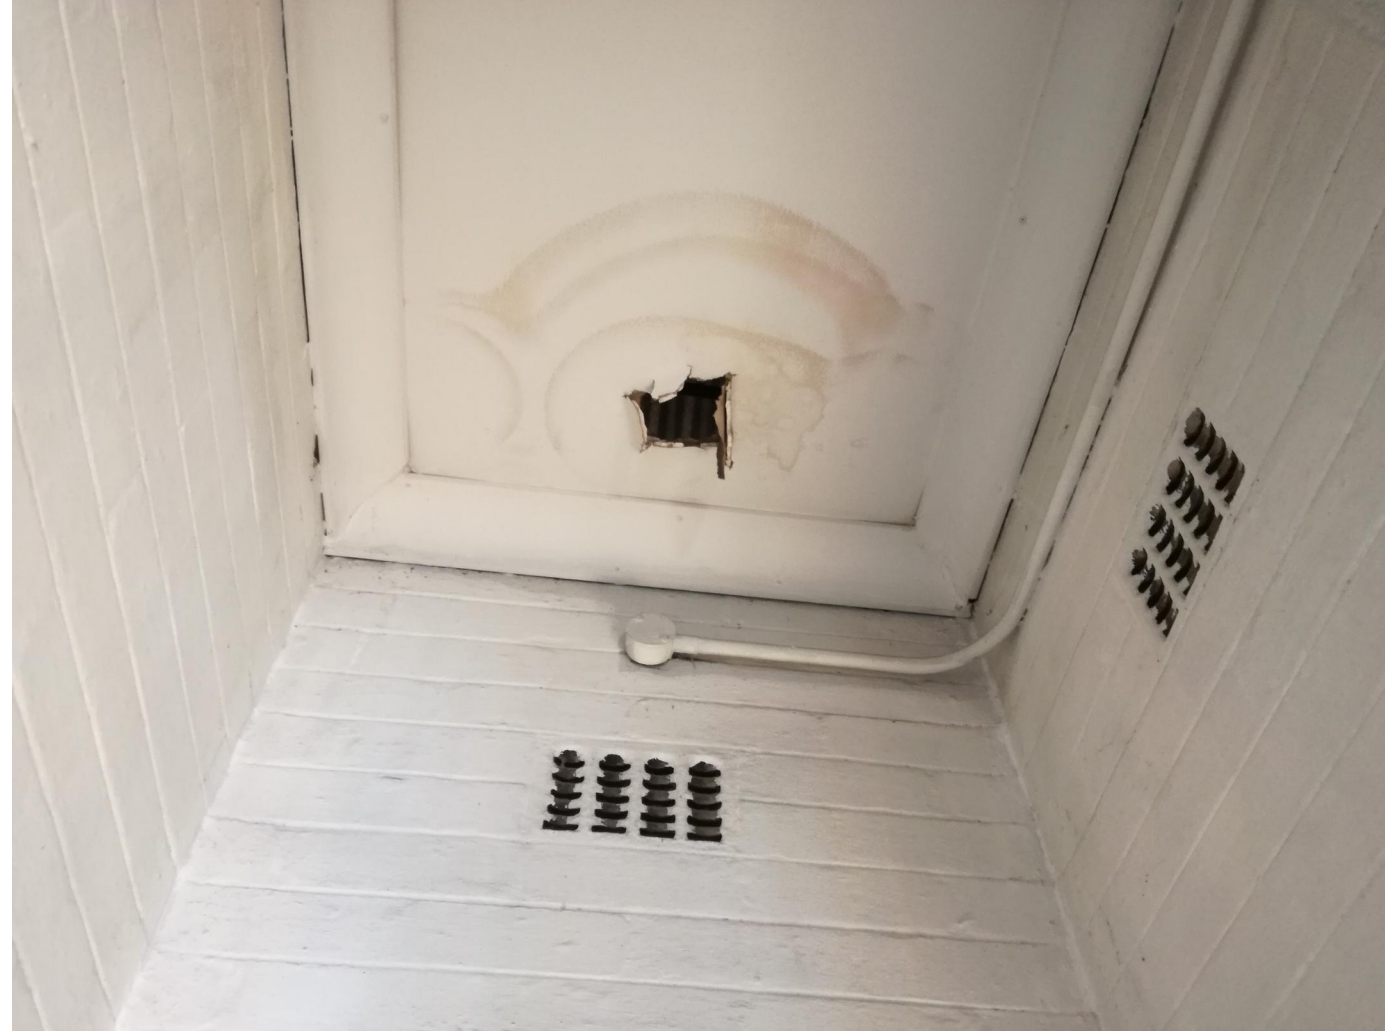
5. Water damage to ceilings, remove all affected panels and cornices and replace with new to match, including skimming and painting. Roof sheeting and trusses to be inspected for leaks / damage and to be repaired or replaced. REFER TO TYPICAL DETAILS.

REPLACE ALL INTERNAL CEILINGS WITH NEW.

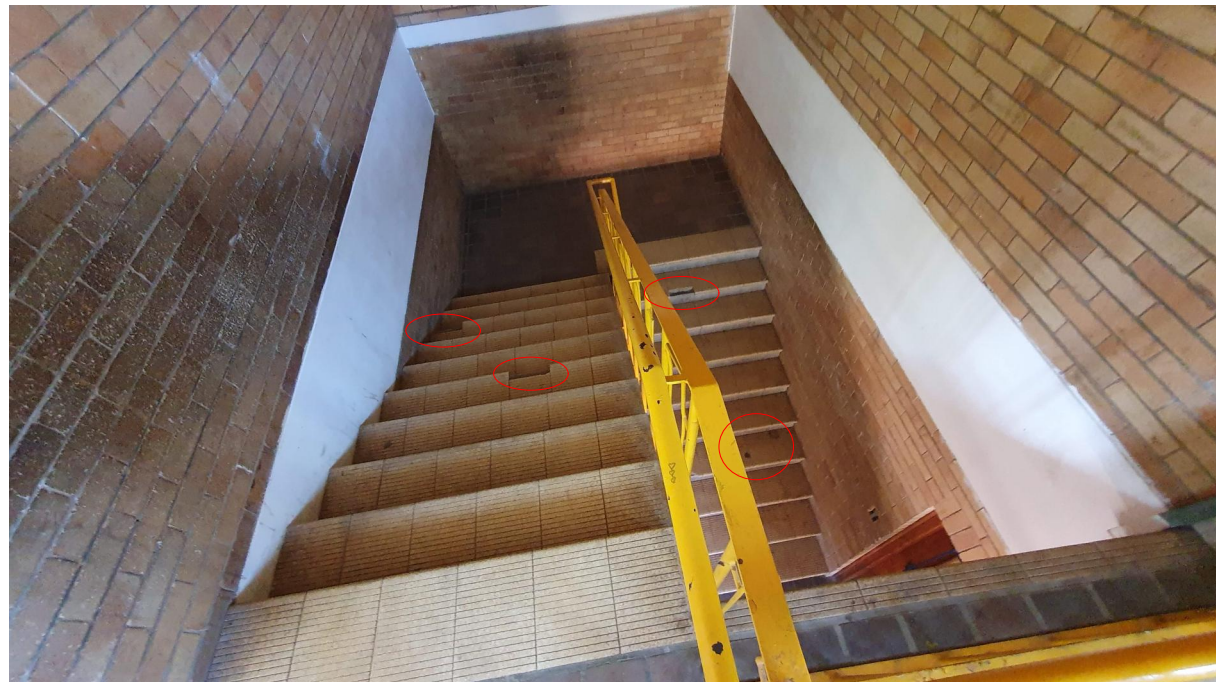
DAMAGED STAIR TILES ON TREADS TO BE REMOVED AND REPLACED WITH NEW TO MATCH EXISTING.

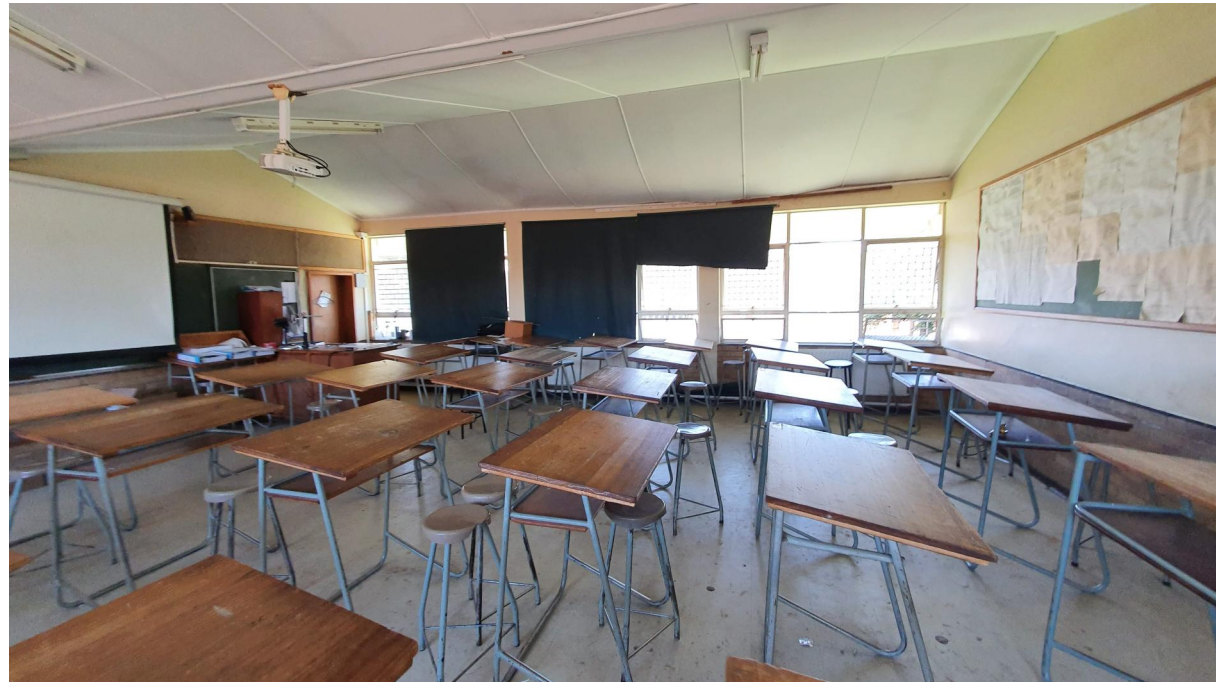
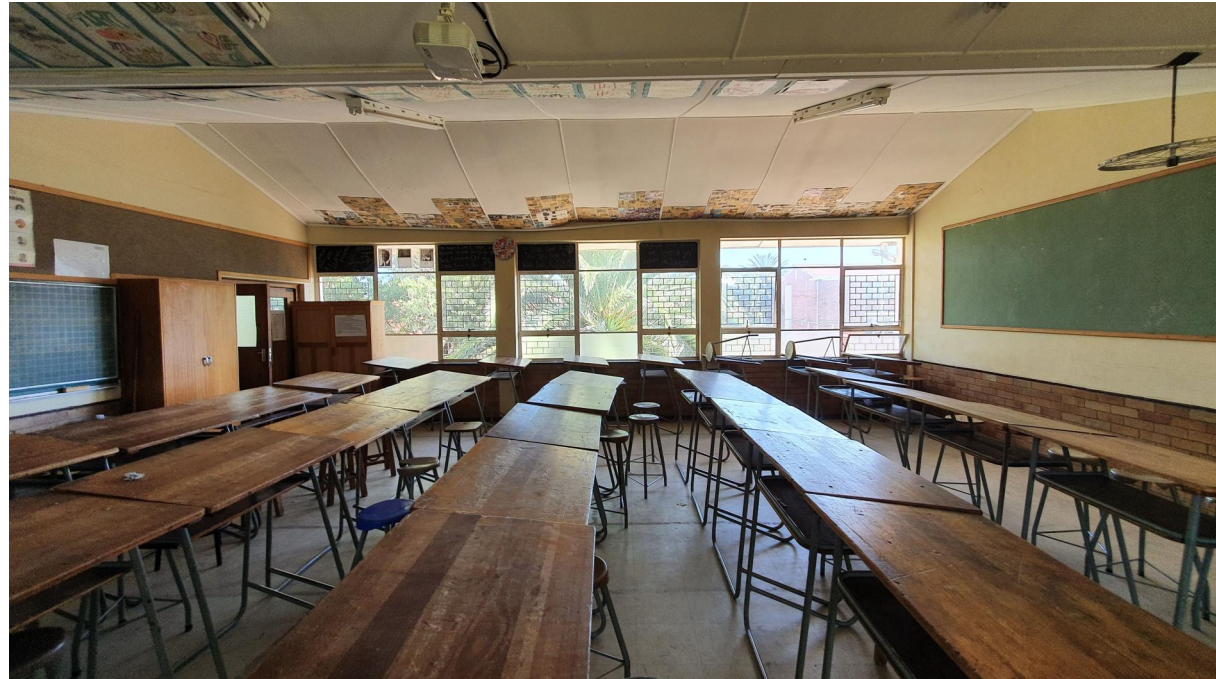
DAMAGED CEILINGS IN 2 x FIRST FLOOR CLASSROOMS TO BE REMOVED AND REPLACED WITH NEW TO MATCH EXISTING.
