Project:
**CONDITION ASSESSMENT
HTS WELKOM SCHOOL**

Drawing description:
**EXISTING BUILDINGS
REFURBISHMENT SCOPE OF WORKS**

Drawing Number:	082-HTSWEL-103	Revision:	A
-----------------	----------------	-----------	---

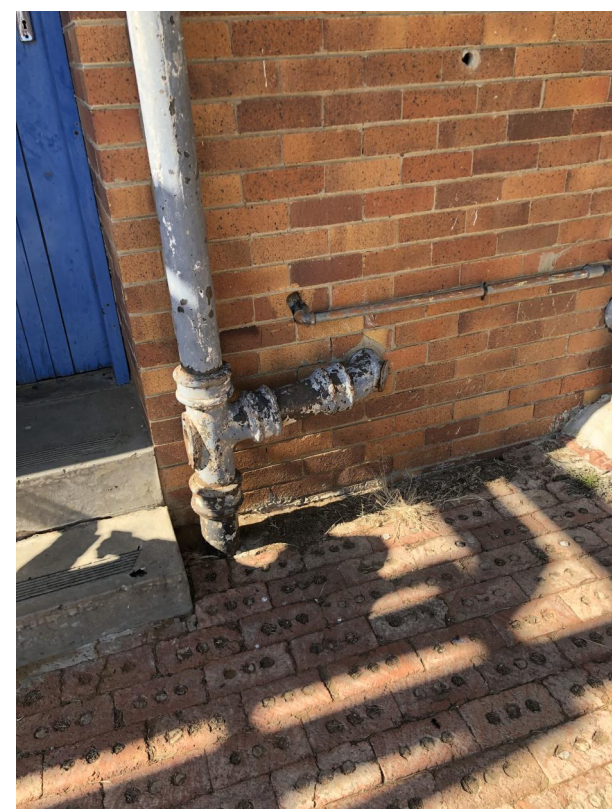
**EXTERNAL PLUMBING FITTINGS IN A POOR
CONDITION. INSPECT ALL PLUMBING AND REPAIR
/ REPLACE.**

13. Office: repaint walls. REFER TO TYPICAL DETAILS.
14. Office ablutions: rub down and repaint walls. REFER TO TYPICAL DETAILS.
15. External plumbing fittings in a poor condition - inspect all plumbing and repair/replace. REFER TO IMAGE BELOW.

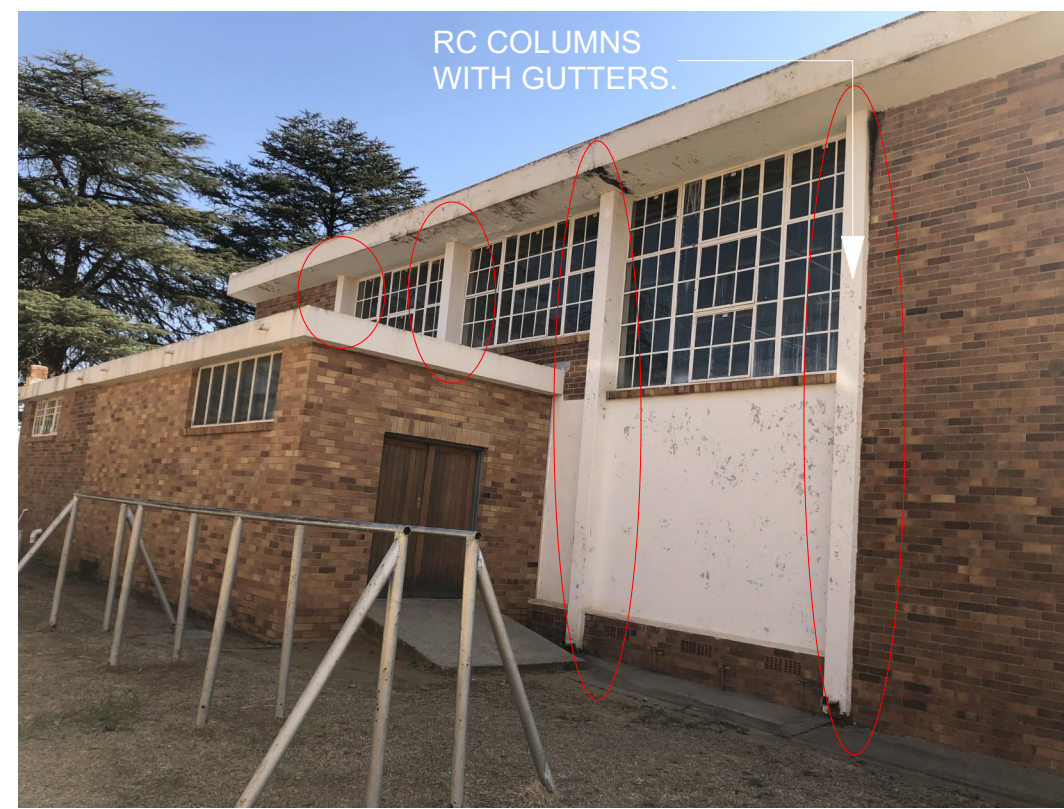
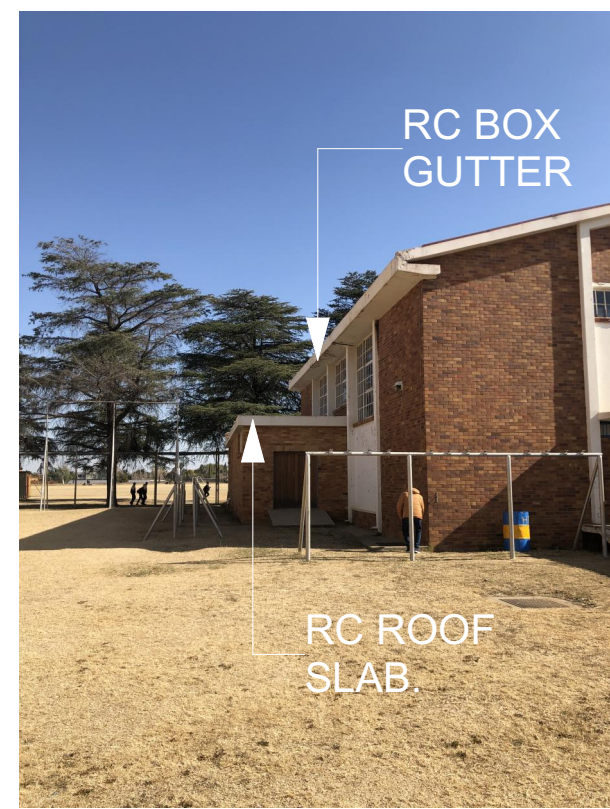
**BOX GUTTER ROOF, RC COLUMNS & RC SLAB
ROOF TO BE INVESTIGATED AND RESEALED /
WATERPROOFED.**

1. Refer to Structural Engineer's report for repairs to roof damage. Recommend resealing / waterproofing box gutter roof on high level roof and RC columns over main gymnasium (on either side of the building) and recommend resealing / waterproofing RC roof slab on lower roof over ablutions & changerooms. REFER TO IMAGES BELOW.

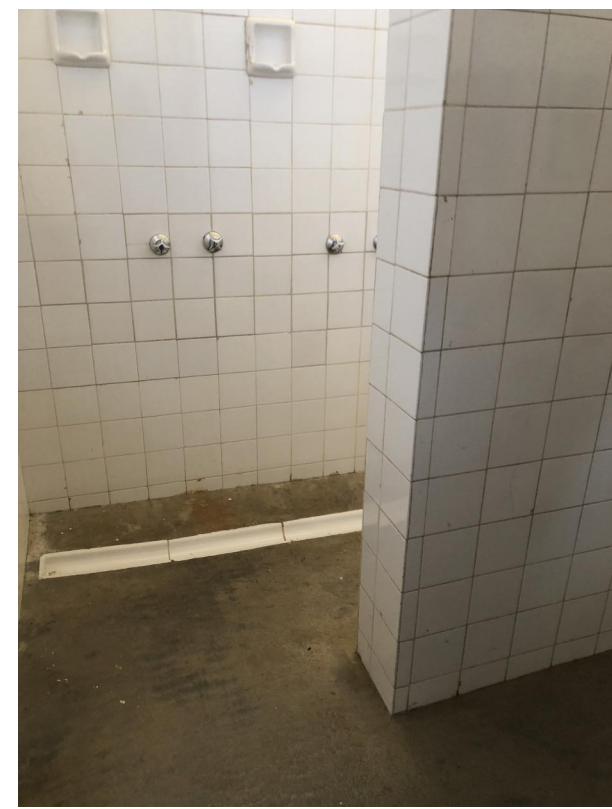
**INTERNAL WALL TILES IN A POOR CONDITION IN
ABLUTIONS. REMOVE AND REPLACE WITH NEW 400
x 400 SALT AND PEPPER TILES.**

7. Internal walls tiles in ablutions in a poor condition - recommend removing and replacing with new to match. REFER TO SPEC BELOW.
8. Steel urinal is corroded and should be replaced with new. REFER TO SPEC BELOW.

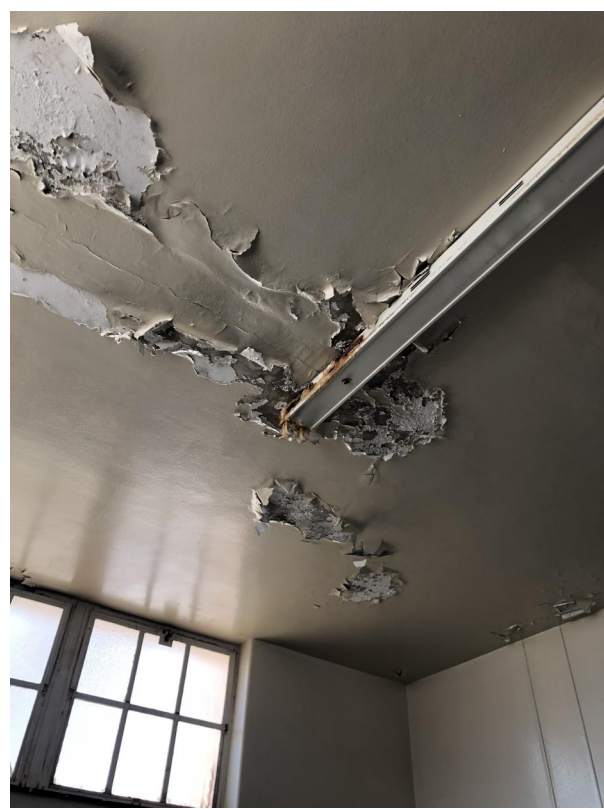
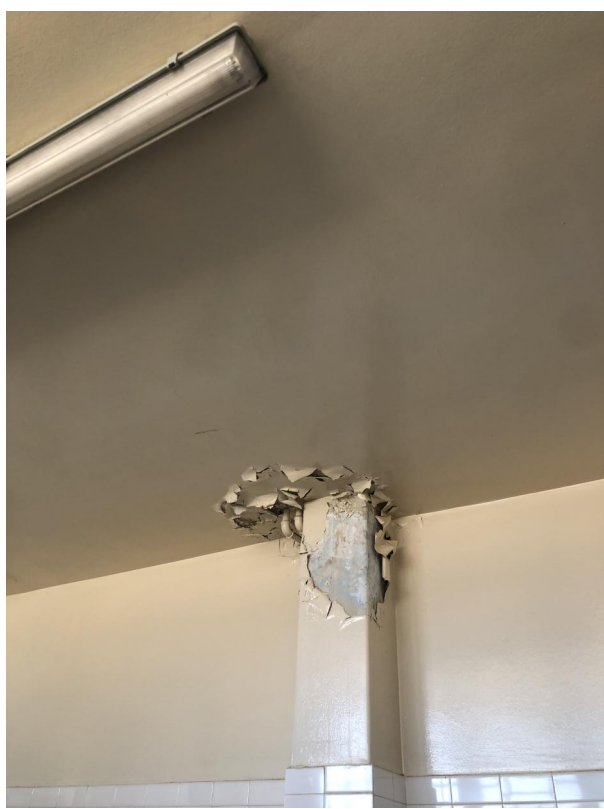
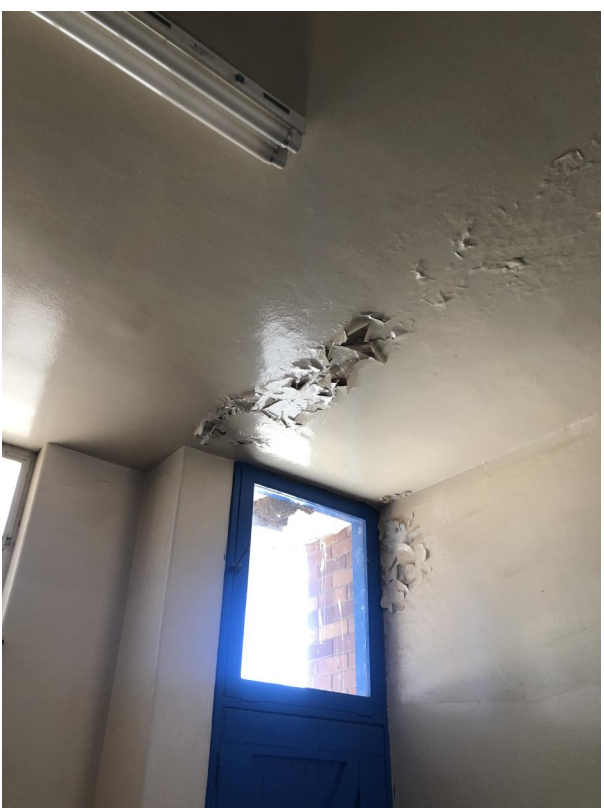
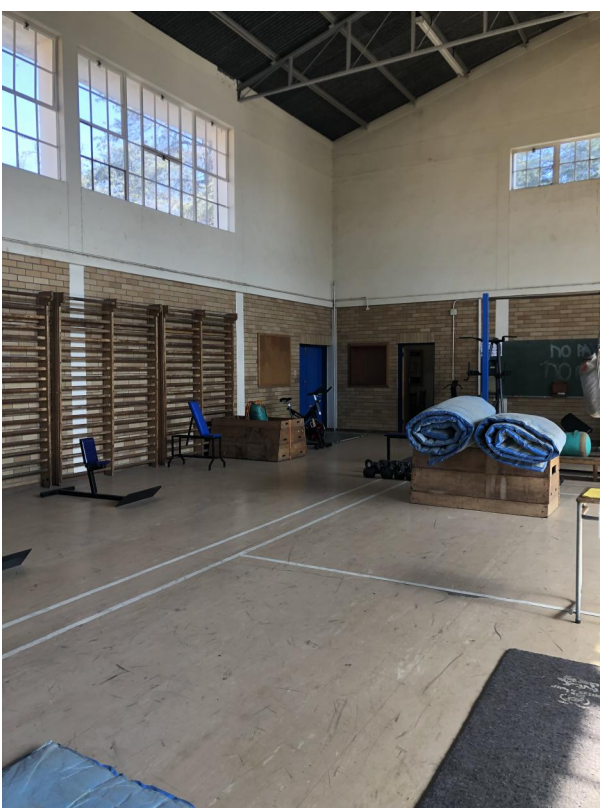
**WATER DAMAGE TO U/S SLABS IN CHANGEROOMS, ABLUTIONS AND OFFICE - REFER TO
ENGINEER'S REPORT FOR REPAIRWORKS. NEW WATERPROOFING, PRIMER AND PAINT IS
TO BE APPLIED TO U/S SLABS AND TO WALLS IN ABLUTIONS AND CHANGEROOMS.**

4. Water damage to slabs in changerooms, ablutions and office - refer to Engineer's report for repairworks. New waterproofing, primer and paint to u/s of slabs and to peeling paint on walls. REFER TO IMAGES BELOW AND TYPICAL DETAILS.

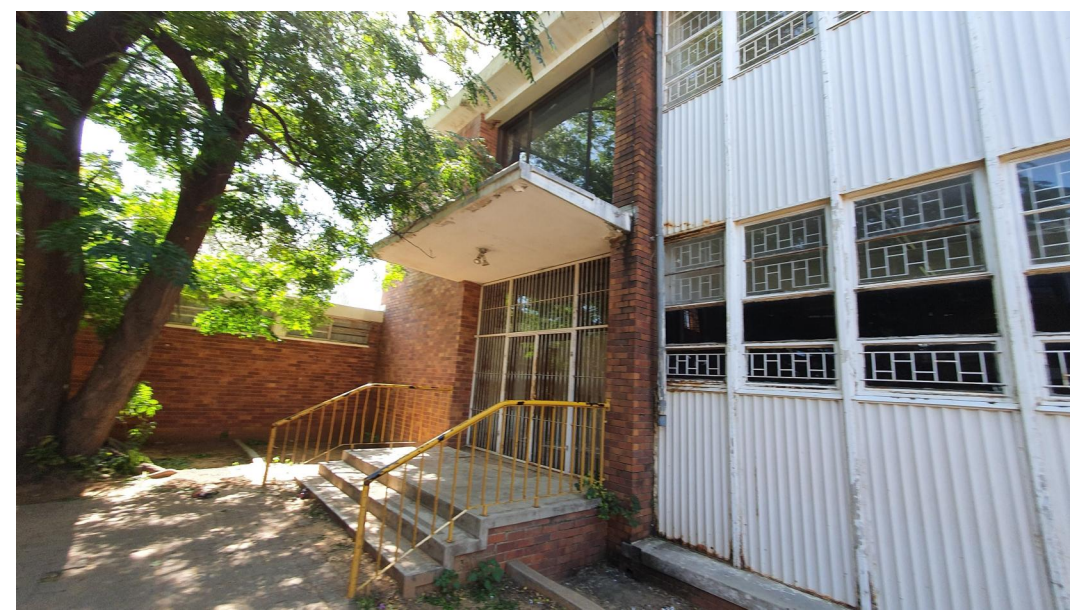
**ALL BALUSTRADES ARE TO BE RUBBED DOWN,
PRIMED AND REPAINTED.**

1. All balustrades in a poor condition. Rub down, prime and repaint. REFER TO IMAGE BELOW.
2. Entrance canopy roof - rub down u/s of canopy and repaint. Reseal / waterproof canopy. REFER TO IMAGE BELOW.

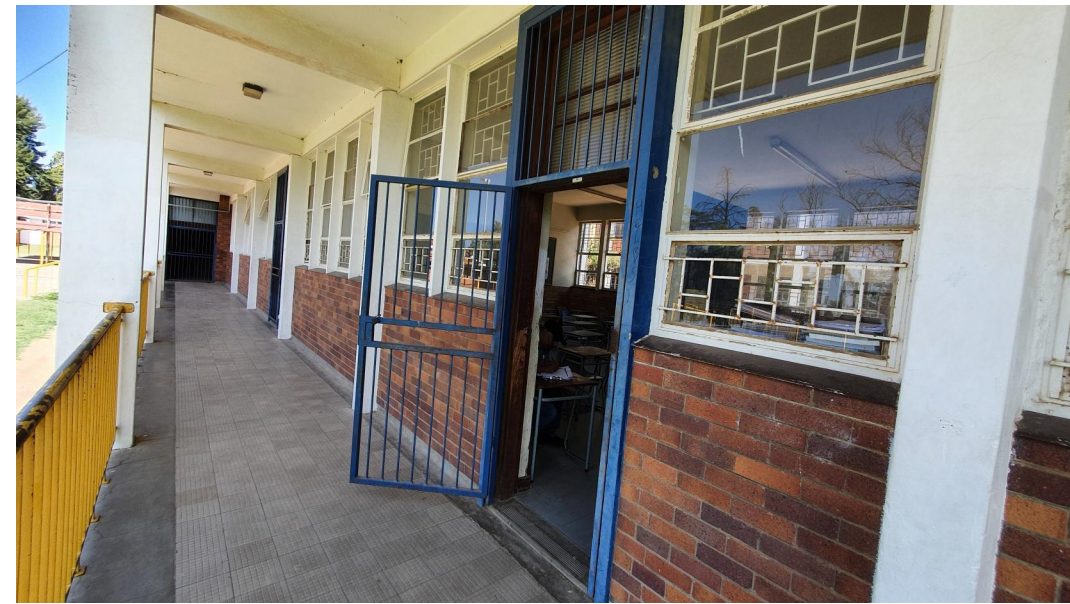
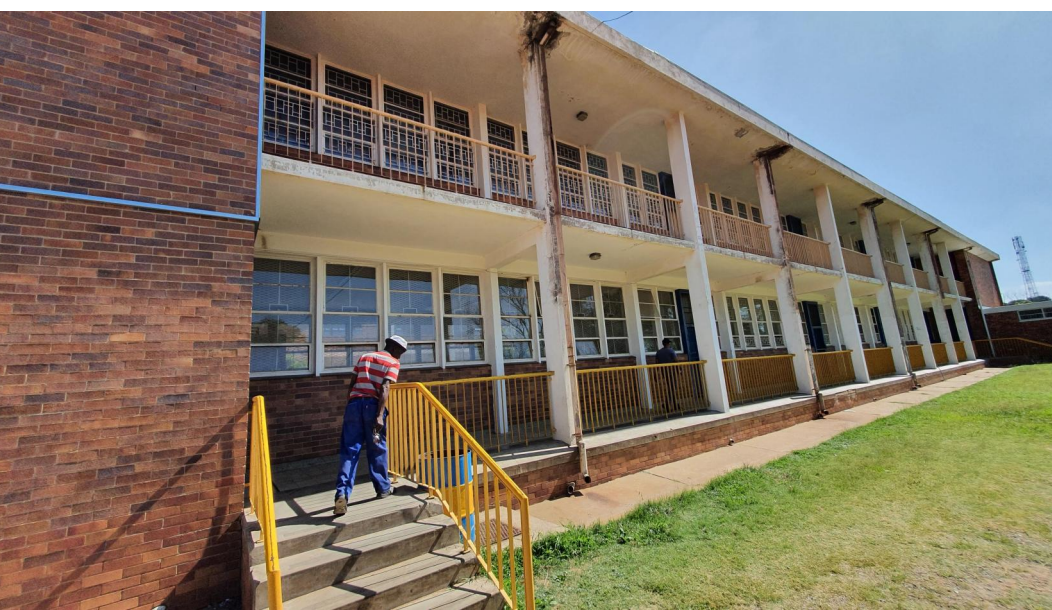
**ALL ENTRANCE GATES ARE TO BE RUBBED DOWN,
PRIMED AND REPAINTED.**

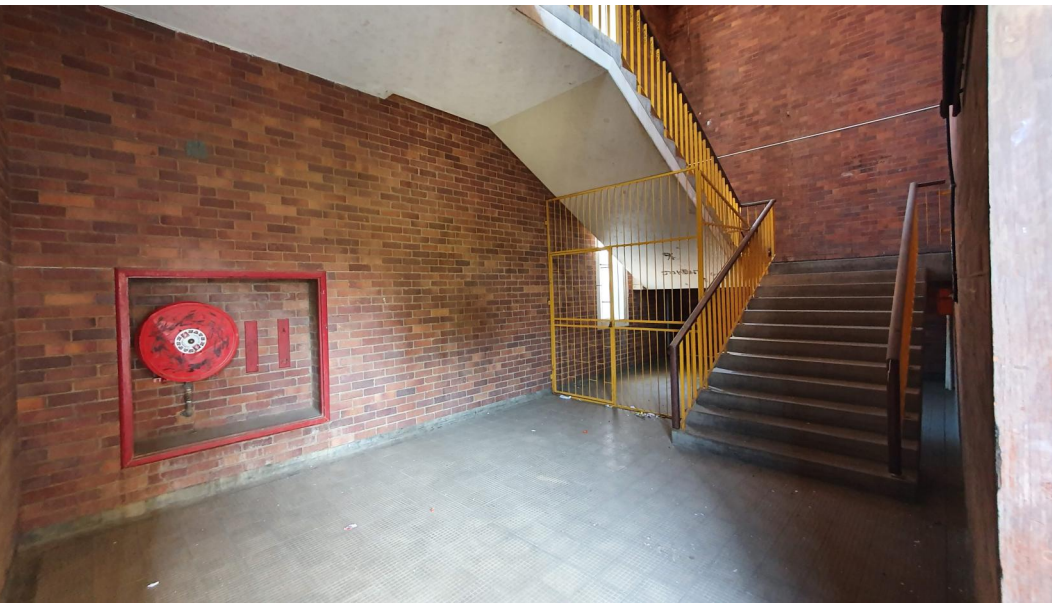
**PAINTED PORTIONS OF STAIRCASES TO BE
RUBBED DOWN, PRIMED AND REPAINTED.**

7. Paintwork on stairs in a poor condition - recommend rubbing down, prime and repaint. REFER TO TYPICAL DETAILS.
8. Internal paintwork in a poor condition, rub down walls, prime and repaint. REFER TO TYPICAL DETAILS.

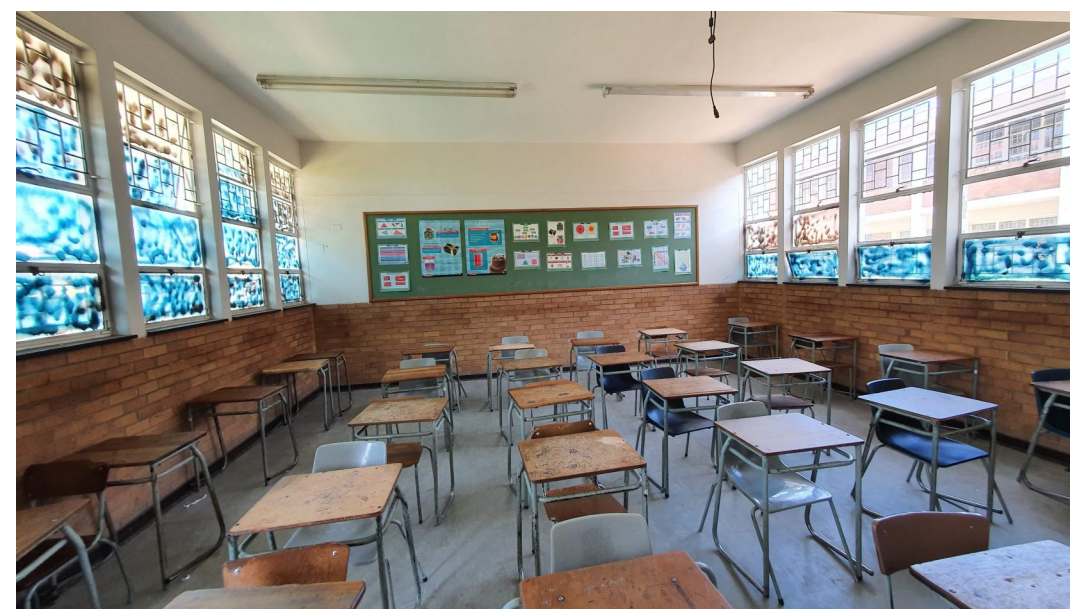
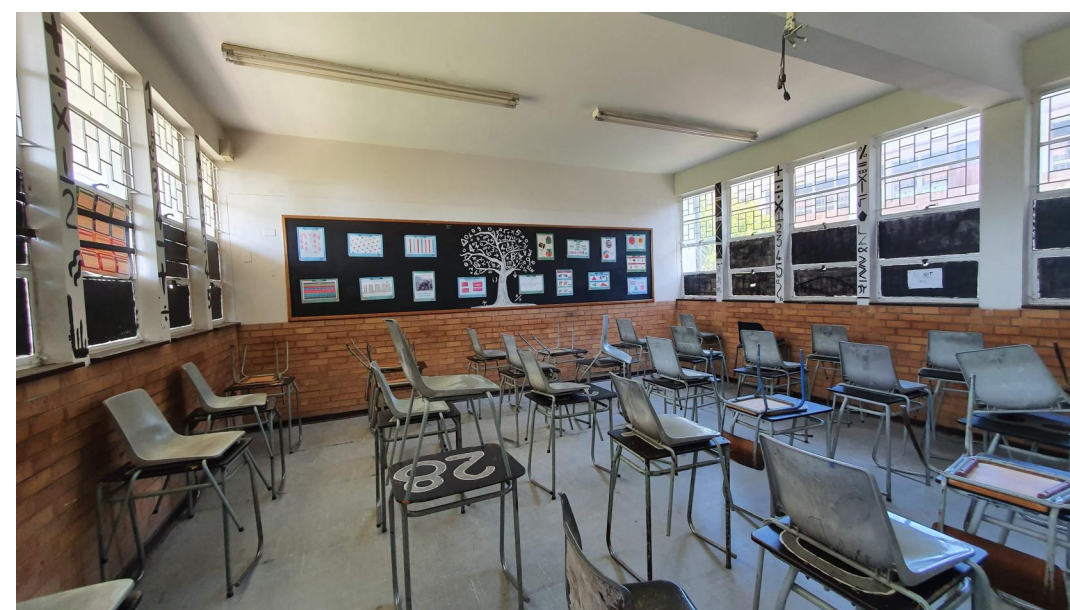
**ALL WINDOWS WHICH HAVE PAINTED GLAZING:
PAINT IS TO BE REMOVED AND NEW VINYL FILM IS
TO BE INSTALLED.**

4. Painted window panes - paint to be removed and new vinyl film to be applied. REFER TO IMAGE BELOW.
5. All gates at all door entrances - rub down, prime and repaint.

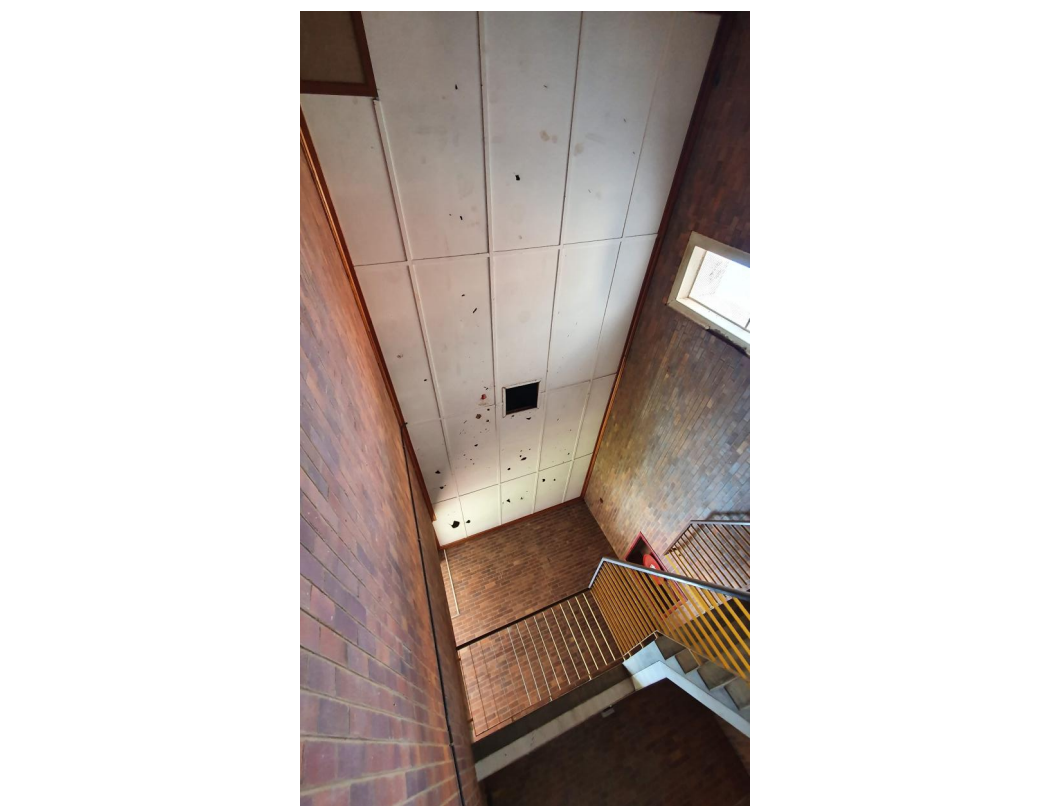
**CEILINGS OVER 2 x STAIRCASES ARE TO BE
REMOVED AND REPLACED WITH NEW TO MATCH
EXISTING.**

6. Ceiling in staircase in a poor condition - recommend removing and replacing with new, including new light fittings. REFER TO TYPICAL CEILING DETAILS AND IMAGE BELOW.
