Project:
CONDITION ASSESSMENT
HTS WELKOM SCHOOL

Drawing description:
EXISTING BUILDINGS
REFURBISHMENT SCOPE OF WORKS

Drawing Number:
082-HTSWEL-106

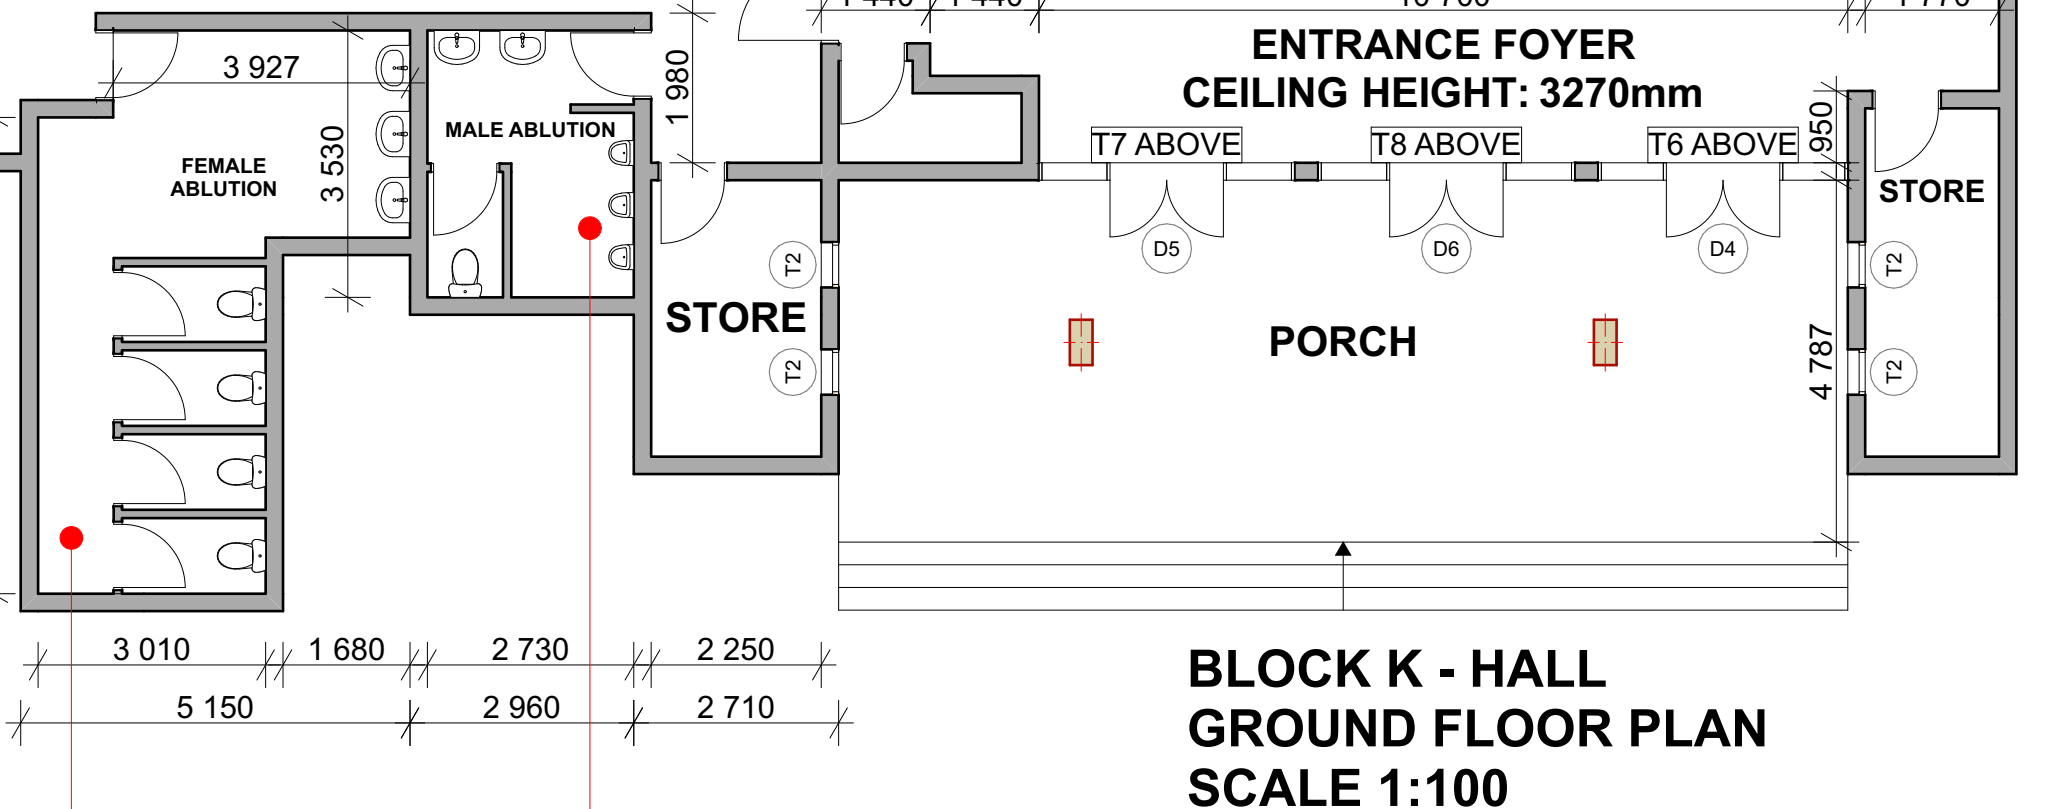
BLOCK K - HALL
GROUND FLOOR PLAN
SCALE 1:100

AS PER ENGINEER'S RECOMMENDATIONS ENTIRE FEMALE AND MALE ABLUTIONS AT HALL ENTRANCE IS TO BE DEMOLISHED AND REBUILT.

4. As per Structural Engineer's report - due to extensive damage on toilets, they are to be reconstructed - to match existing, as per detailed design. REFER TO SPECS BELOW.

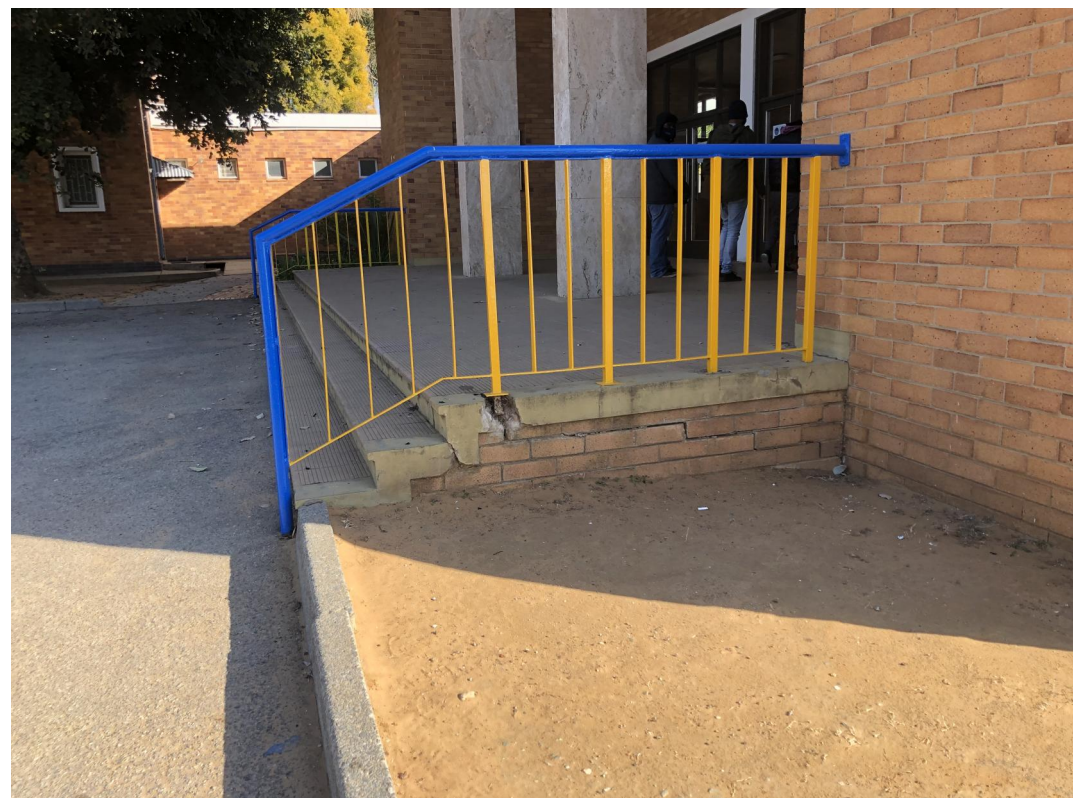
CONCRETE STEP LEADING TO HALL IS DAMAGED. REPAIR AS PER STRUCTURAL ENGINEER'S REPORT.

5. No gutters or downpipes installed. Install new to match existing on site or as per later detail.
 6. Concrete step leading to hall is damaged - refer to structural engineer's report for repairs. REFER TO IMAGE BELOW.

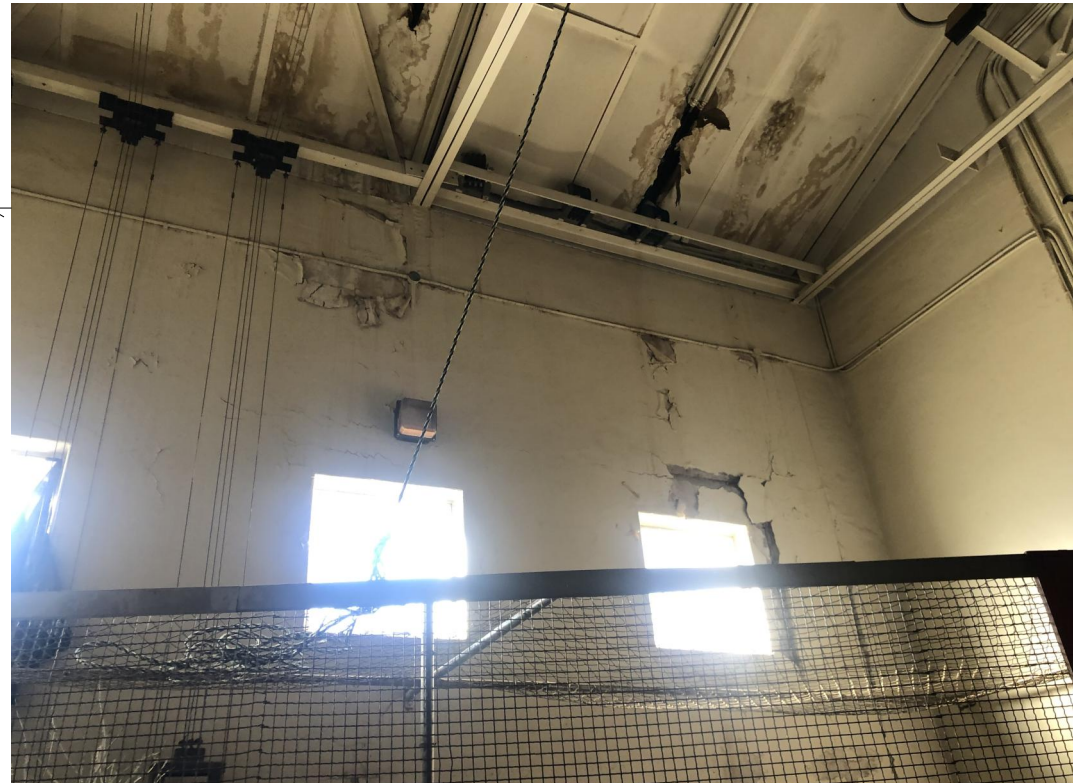
3. Walls and ceiling in stage and backstage in a poor condition (water damage). Recommend removing and replacing ceilings to match, including for skimming, painting and cornices. All light and stage fixtures to be re-used and positioned as is currently. Rub down walls, prime and repaint. Check roof sheeting for leaks and repair / replace. REFER TO IMAGES BELOW.

WALLS AND CEILINGS IN STAGE AND BACKSTAGE AREAS ARE IN A POOR CONDITION. REMOVE AND REPLACE CEILINGS TO MATCH EXISTING. INCLUDE FOR SKIMMING, PAINTING AND NEW CORNICES. ALL LIGHT AND STAGE FIXTURES AND BRACING ARE TO BE CAREFULLY REMOVED AND RE-INSTALLED ONCE CEILINGS AND WALLS ARE DONE. CHECK ROOF SHEETING FOR ANY LEAKS AND REPAIR / REPLACE IF NECESSARY.

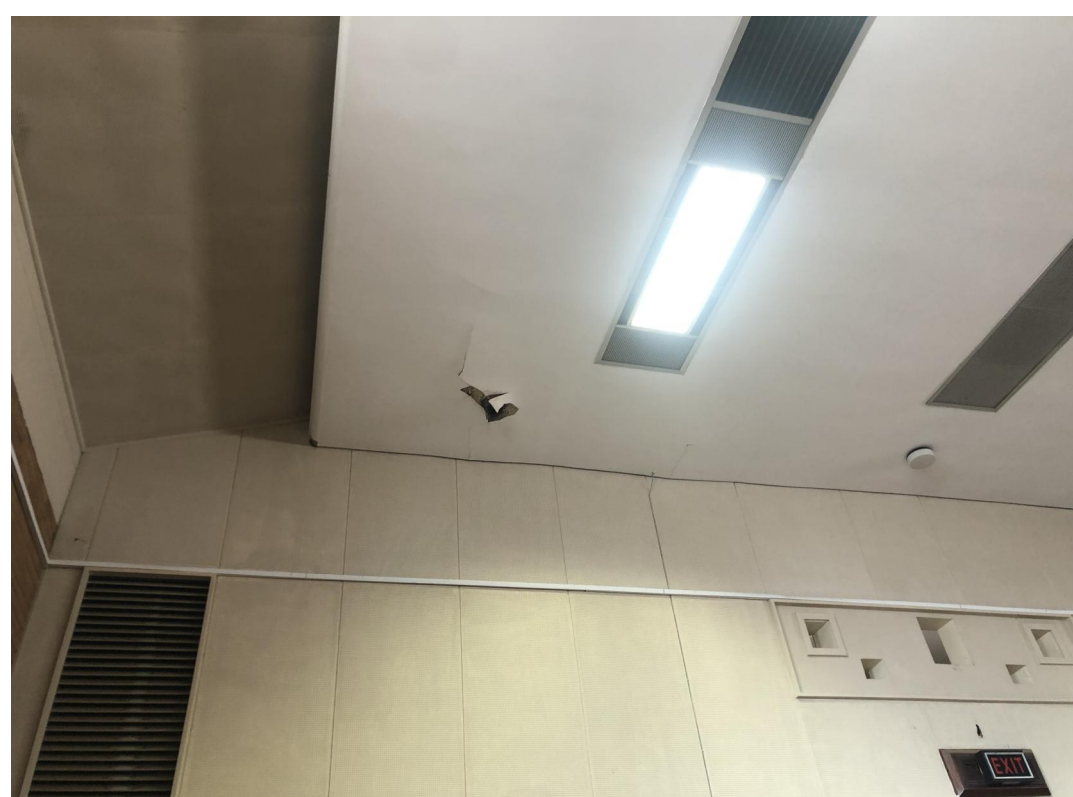
PEELING PAINT ON CEILING IN MAIN HALL. RUB DOWN, PRIME AND REPAINT.

- BLOCK K - HALL: Scope of Works**
1. Peeling paint on ceiling in main hall - rub down, prime and repaint. REFER TO IMAGE BELOW.
 2. Timber floors to be polished in main hall and stage.

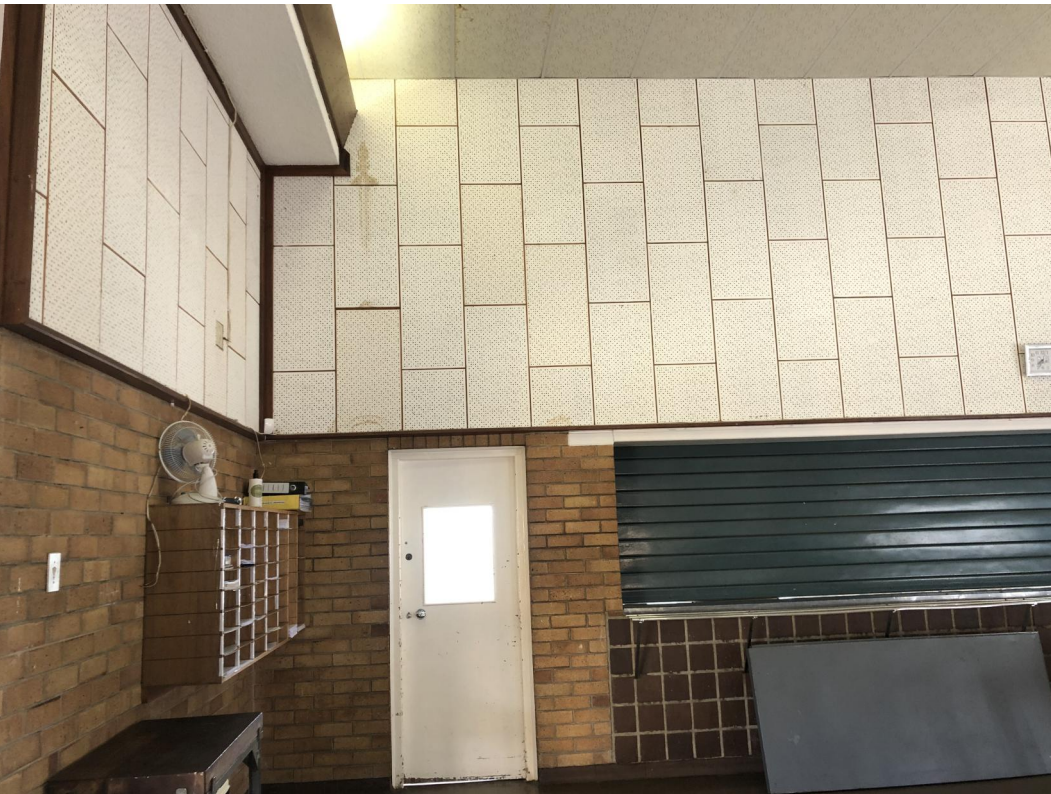
DAMAGE TO 6 OF THE CLADDING PANELS IN THE DINING HALL. REMOVE AND REPLACE WITH NEW TO MATCH EXISTING.

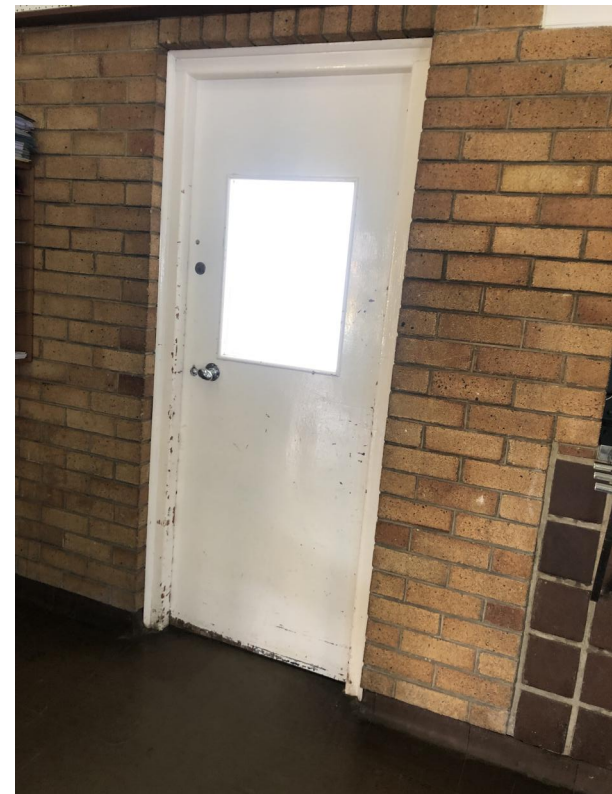
RUB DOWN AND REPAINT DOOR LEADING INTO KITCHEN.

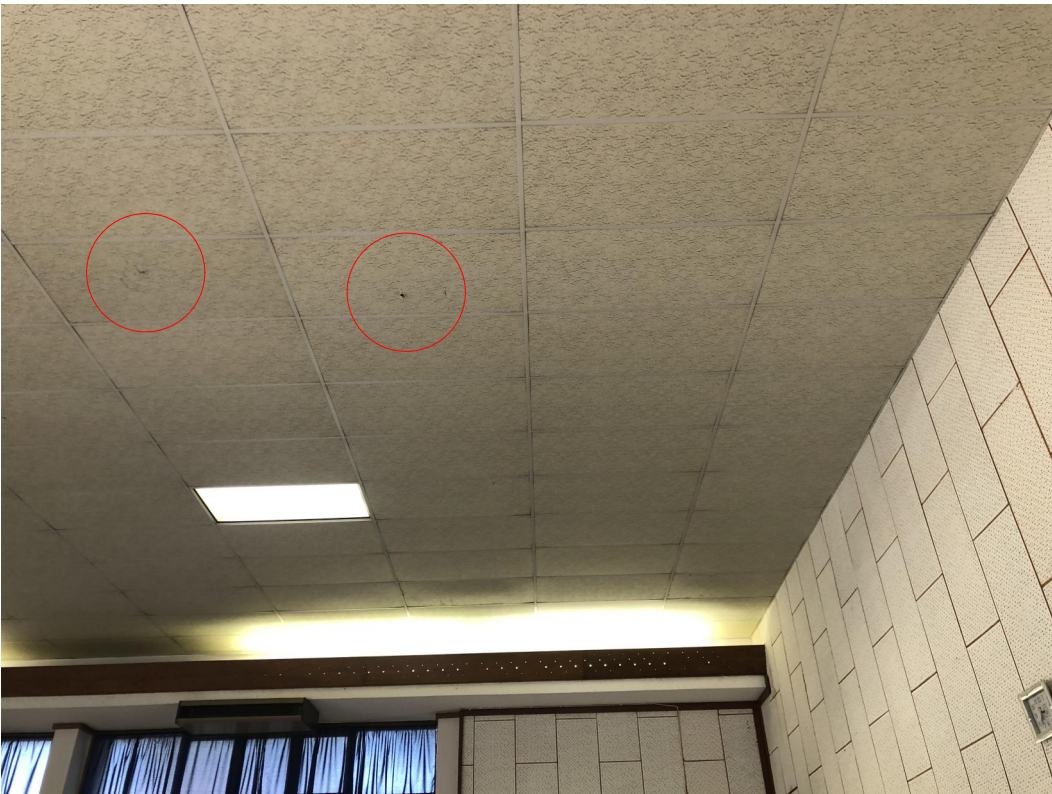
DAMAGE TO 2 OF THE CEILING PANELS IN THE DINING HALL. REMOVE AND REPLACE WITH NEW TO MATCH EXISTING.

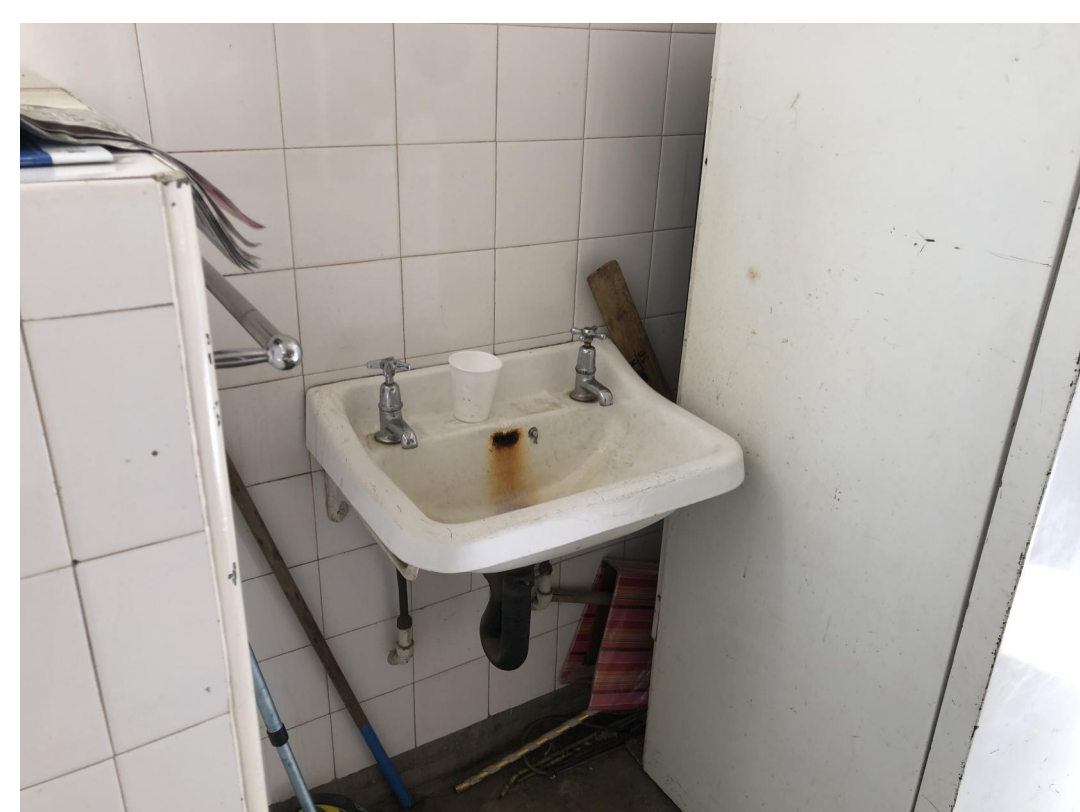
REPLACE 1 x WHB IN KITCHEN

Remove and replace 1 x WHB in kitchen with: Lecico H-Line 55cm wall-hung basin. Colour: white. Code: HLIBASWHU1550UE. Fitted with 2 x Cobra star pillar taps and all associated plumbing fixtures / brackets etc.

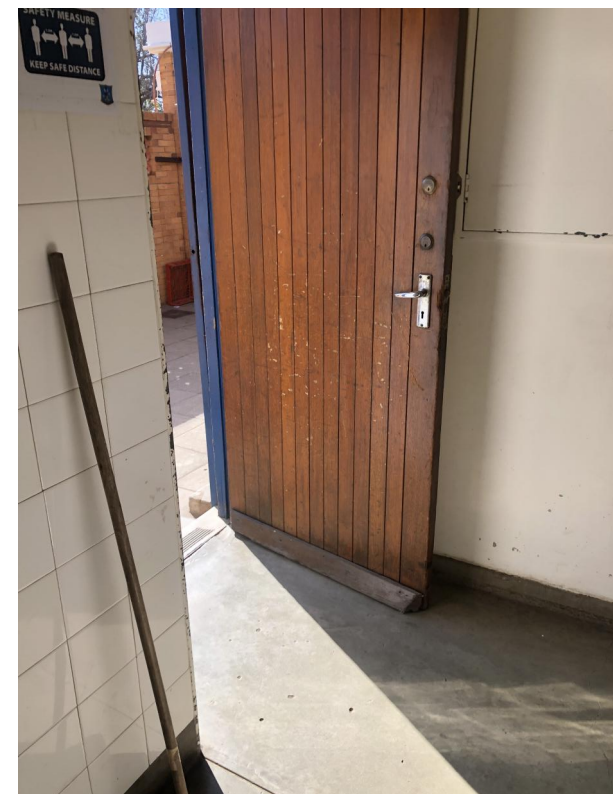
RUB DOWN AND RE-VARNISH DOOR LEADING INTO KITCHEN PASSAGE.
