**CONDITION ASSESSMENT
HTS WELKOM SCHOOL**

**EXISTING BUILDINGS
REFURBISHMENT SCOPE OF WORKS**

082-HTSWEL-109

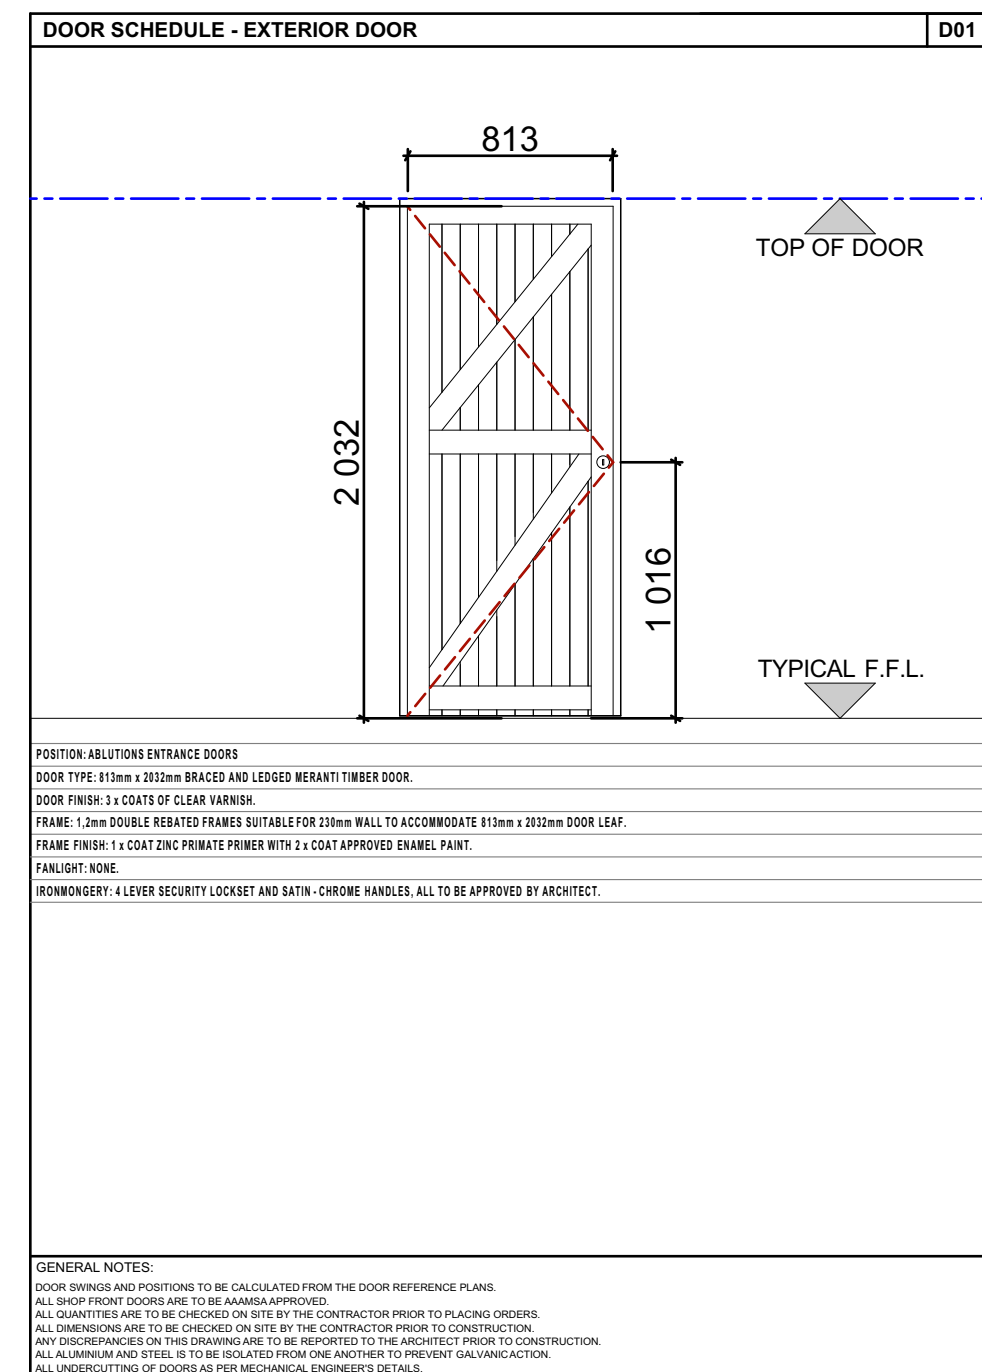
REPLACE ENTRANCE DOORS TO ABLUTIONS:

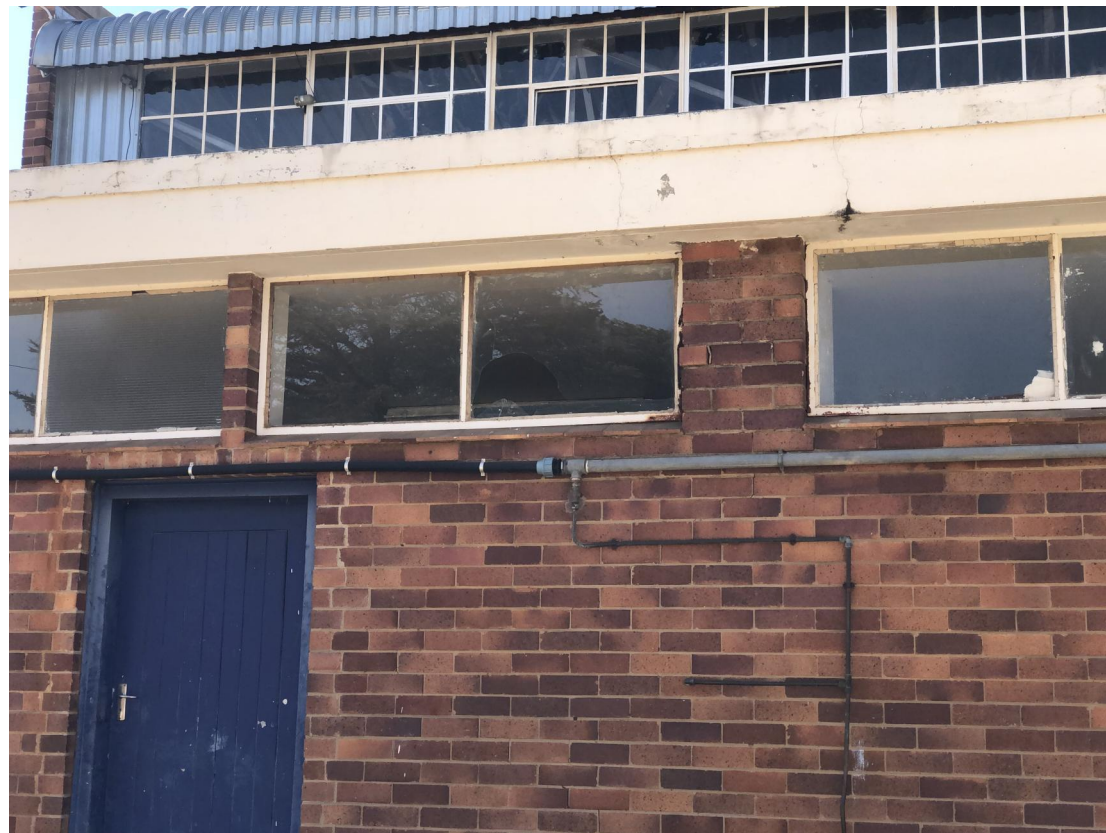
- Roof slab over passage / offices & ablutions is showing water damage - roof slab to be inspected for damage and to be resealed / re-waterproofed as per Structural Engineer's report. REFER TO IMAGES BELOW.

**ONCE WATERPROOFING AND RESEALING IS
COMPLETE, RUB DOWN EDGES OF RC ROOF SLAB,
PRIME AND REPAINT.**

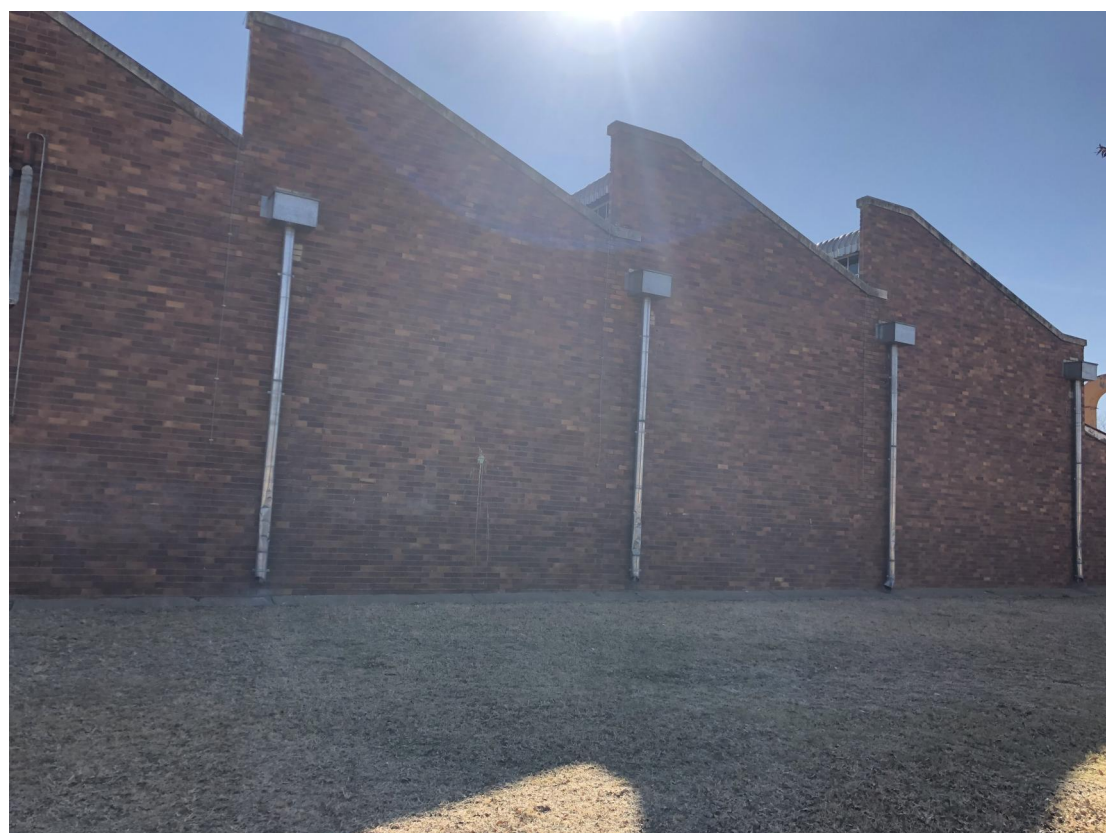
**PARAPET COPING OF SAWTOOTH ROOF IN A POOR
CONDITION. RECOMMEND CLOSER INSPECTION TO
DETERMINE ISSUE. RECOMMEND RUBBING DOWN,
PRIMING AND REPAINTING.**

- Parapet capping of sawtooth roof is in a poor condition - recommend closer inspection to determine issue and make good. REFER TO IMAGE BELOW.
- No access into some of the offices & workshop for assessment.

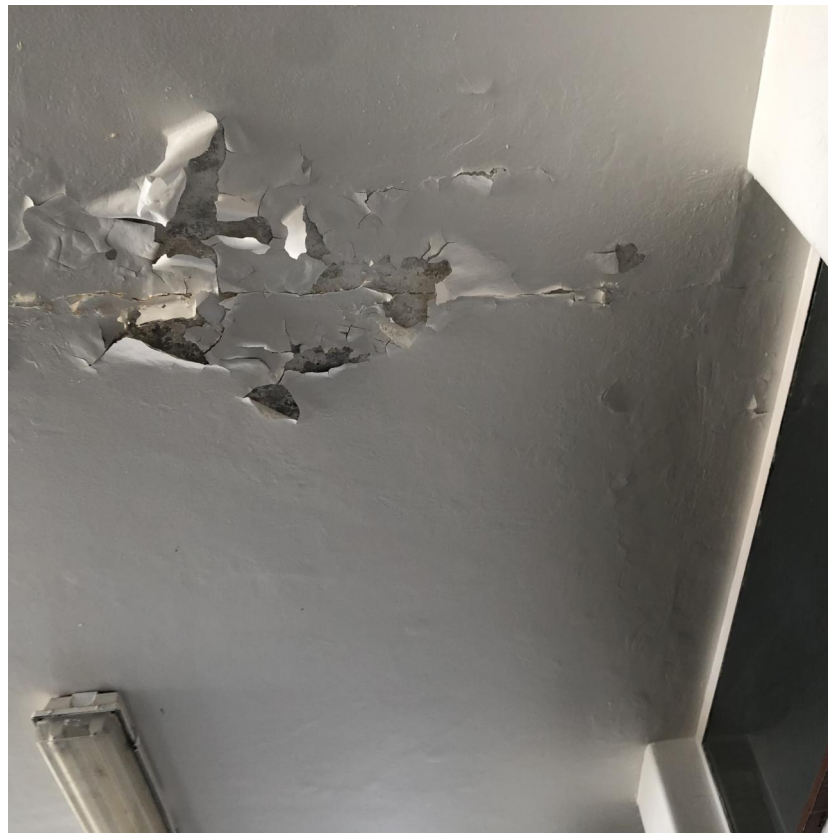
- Underside of slab (ablutions, offices and passage) to be rubbed down, primed and repainted. All light fittings are to be inspected for water damage and replaced if required. Edging along underside of slab to be removed and replaced with new. REFER TO IMAGES BELOW.

**EX. RC ROOF SLAB IS SHOWING SIGNS OF DAMP AND
LEAKING. SLAB TO BE RESEALED / RE-
WATERPROOFED. U/S OF SLAB OVER PASSAGE,
OFFICES AND ABLUTIONS TO BE RUBBED DOWN,
PRIMED AND REPAINTED.**

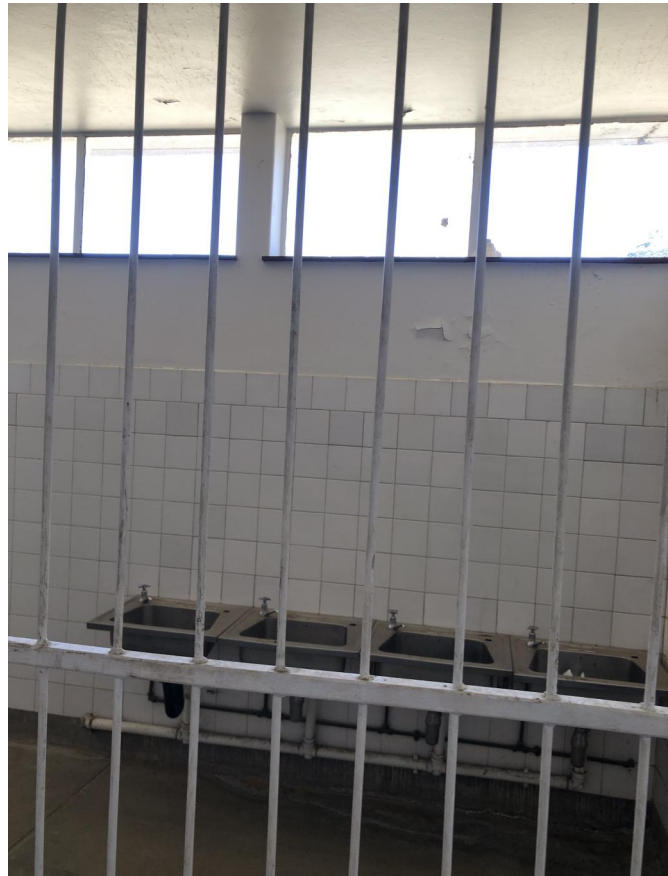
- Existing gate within ablutions to be rubbed down, primed and repainted.

**RUB DOWN EX. GATE, PRIME
AND REPAINT**

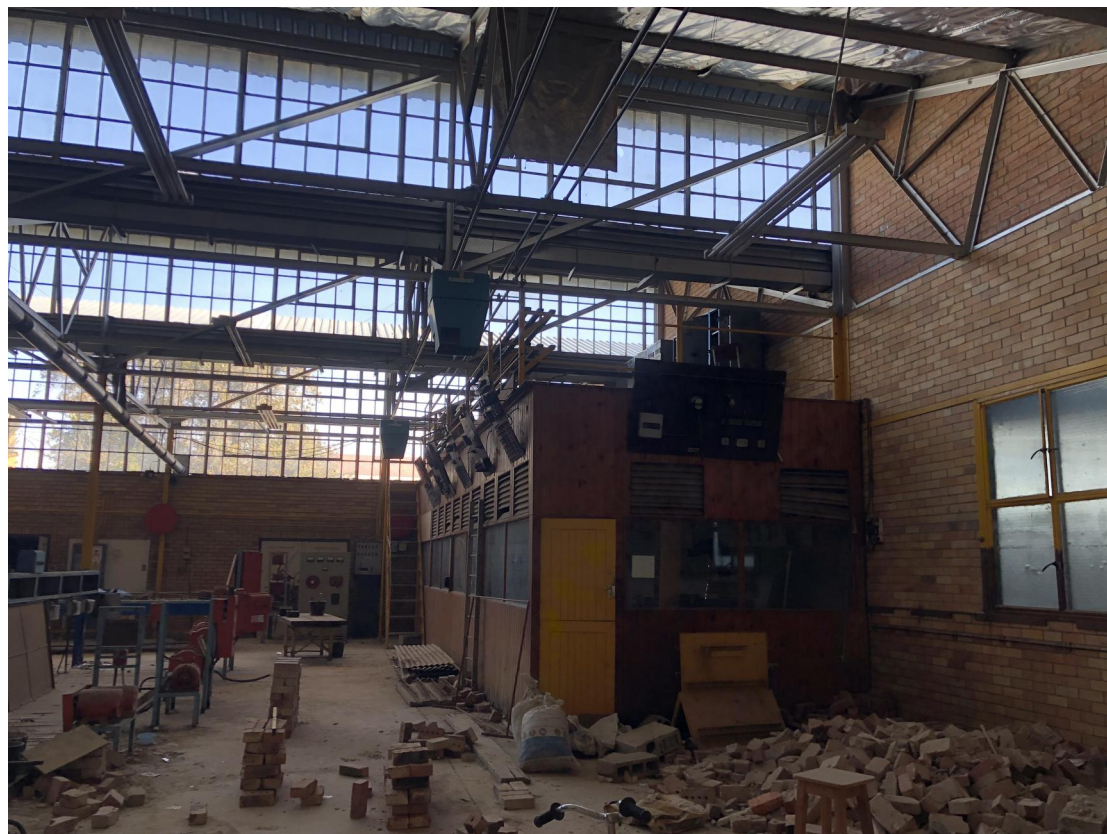
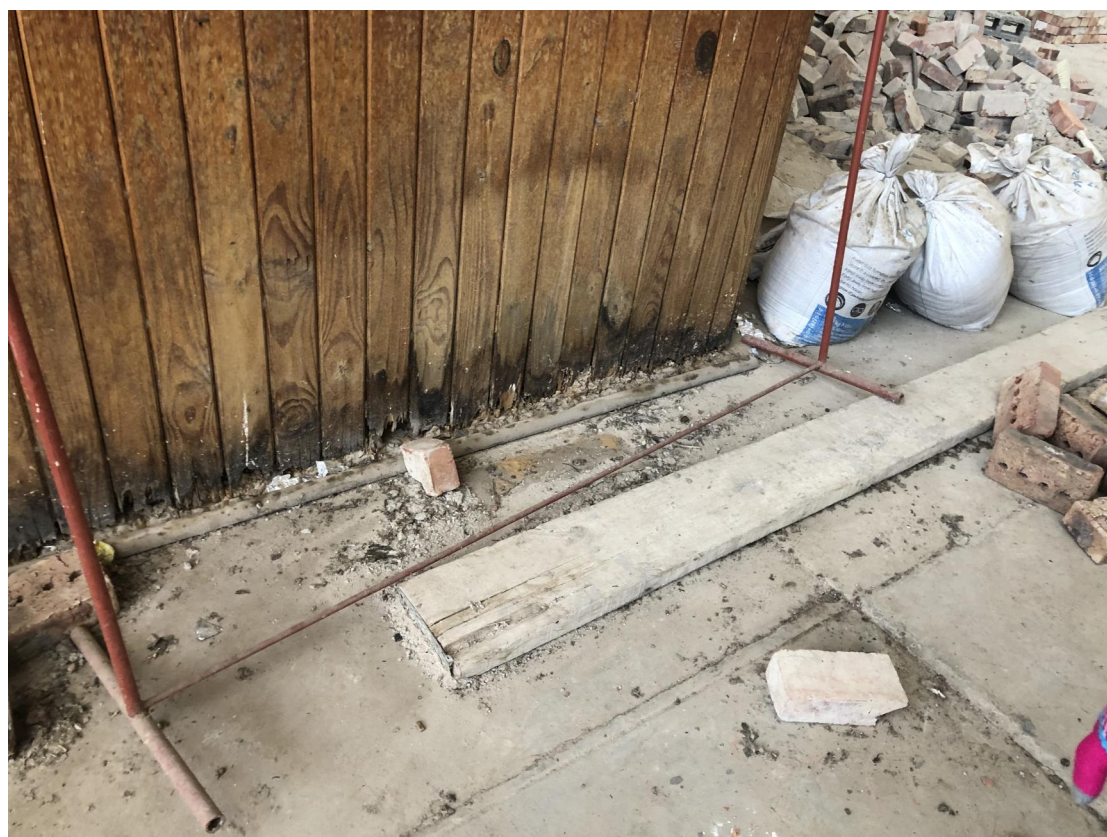
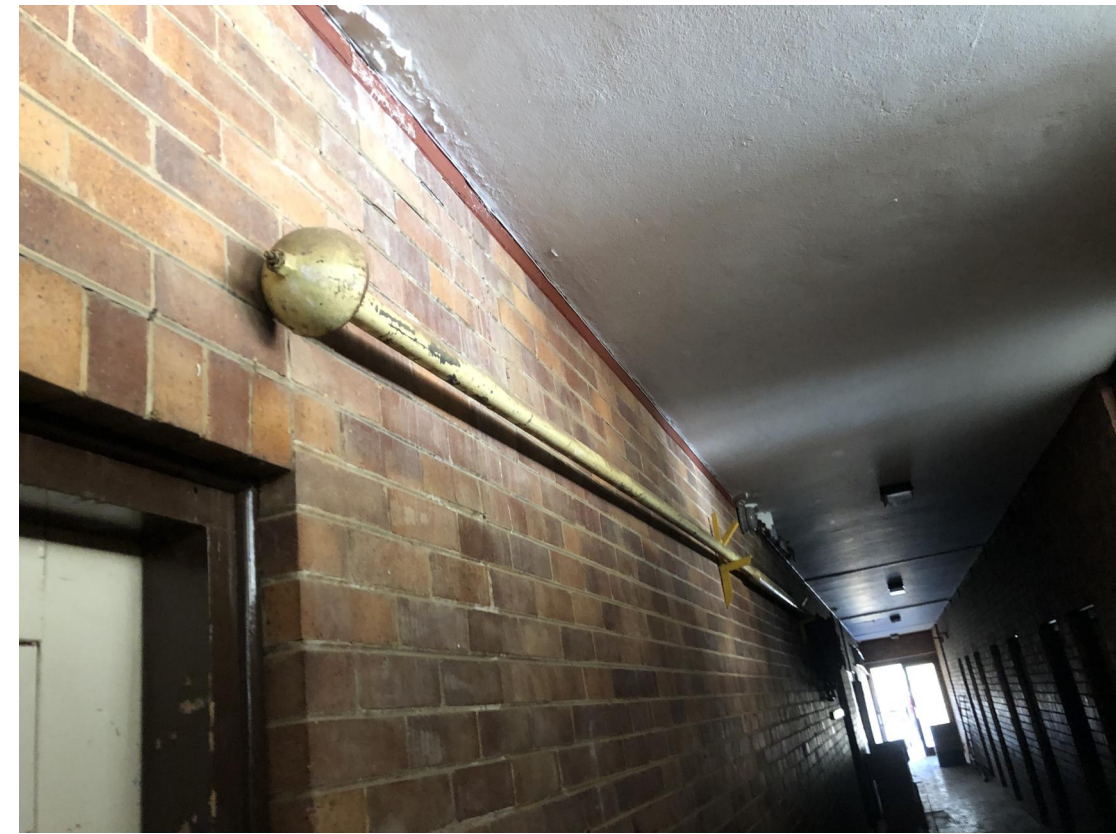
- Timber entrance doors to ablutions to be removed and replaced with new. REFER TO DETAIL BELOW.
- Timber slatted walls of office in workshop is rotting and damaged - recommend replacing timber slats with new to match.

**REMOVE AND REPLACE SLATTED
TIMBER WALLS, WINDOWS AND DOORS
OF OFFICE.**

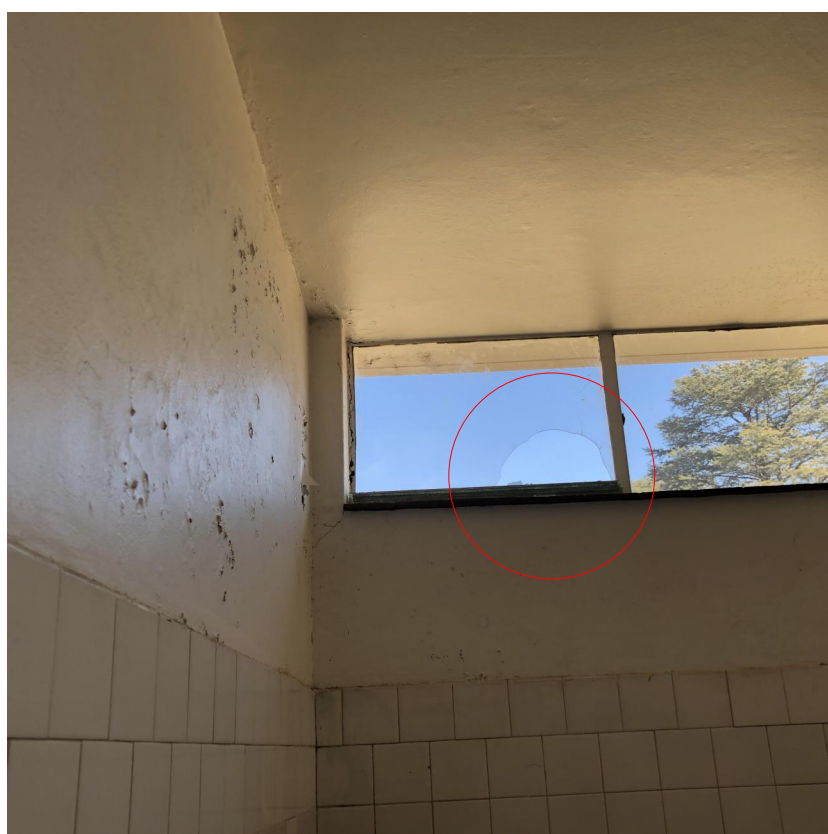
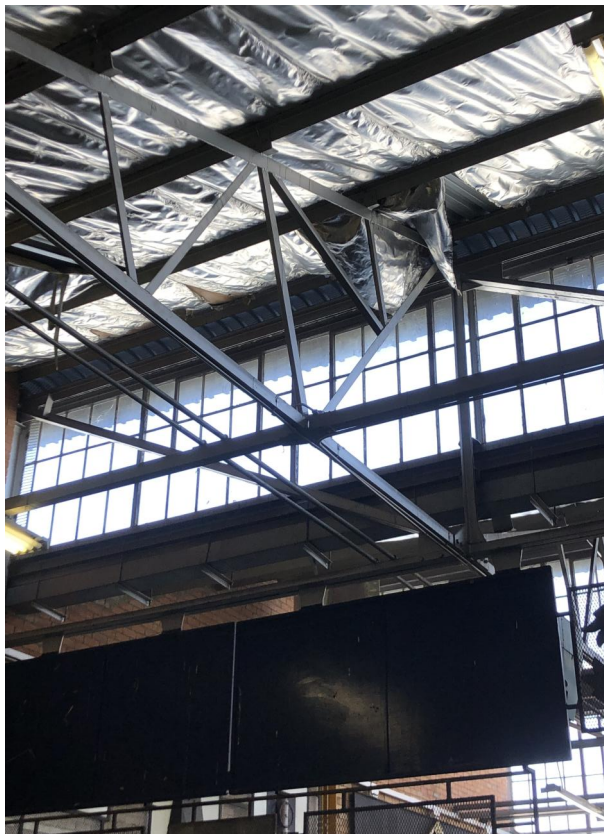
- Cracked glazing in ablutions to be removed and replaced with new to match. REFER TO IMAGE BELOW.
- Recommend installing vinyl film to ablution windows.

**REPLACE BROKEN GLAZING IN
ABLUTION WITH NEW TO MATCH
EXISTING.**

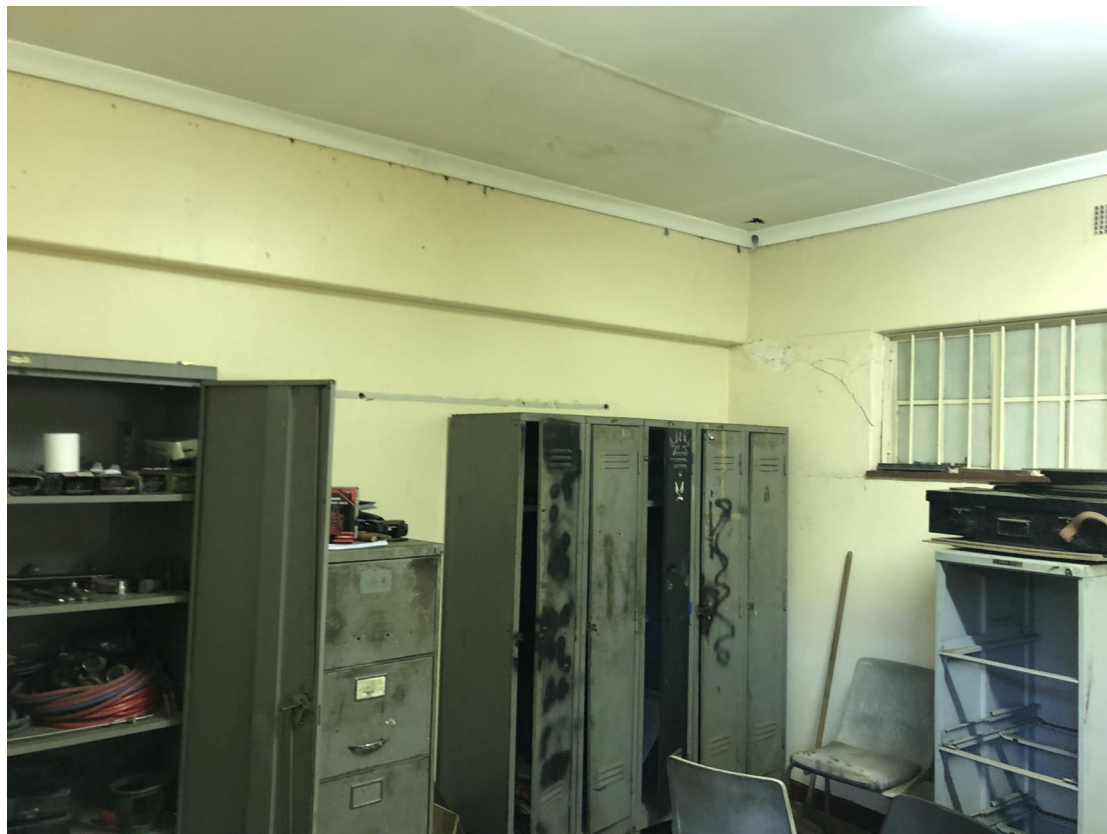
- Office in workshop paintwork in a poor condition and cracks noted. Walls to be rubbed down, primed and repainted. Water damage to walls - leaks / damp to be located and addressed. REFER TO IMAGE BELOW.

**INTERNAL WALLS OF OFFICE TO BE RUBBED
DOWN, PRIMED AND REPAINTED.**

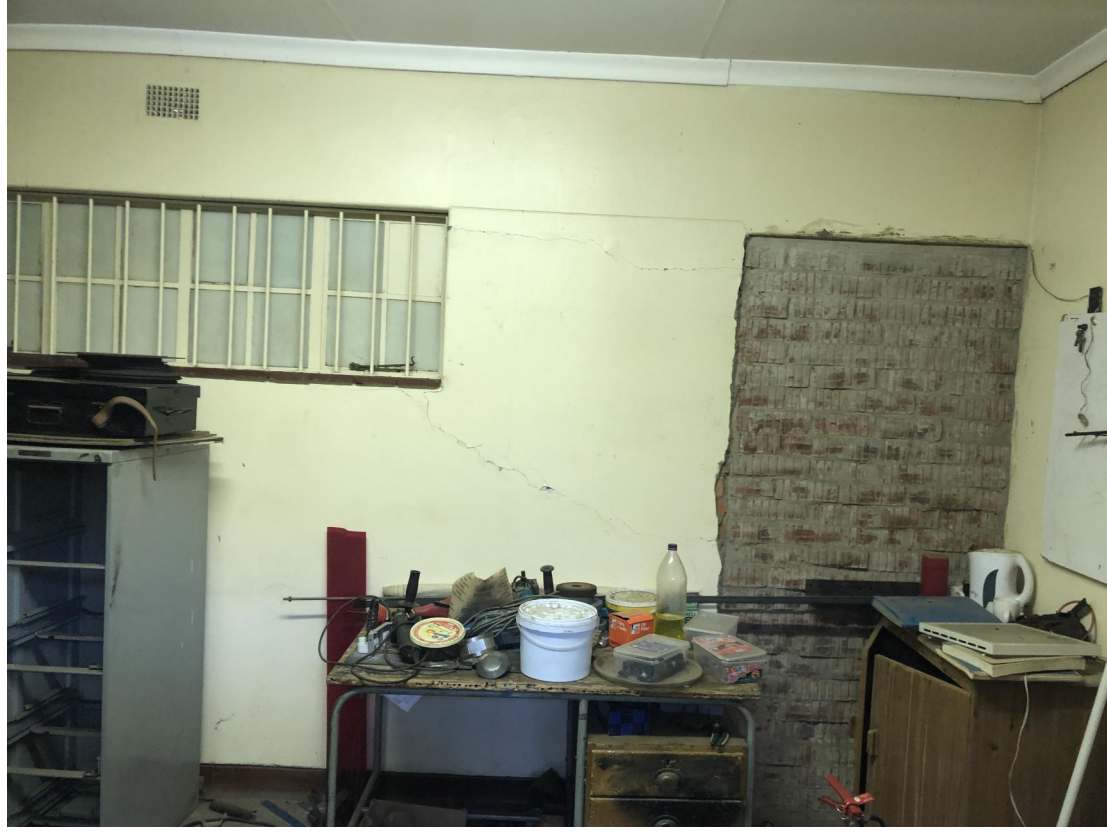
**BRICKED UP DOOR TO BE PLASTERED AND
PAINTED.**

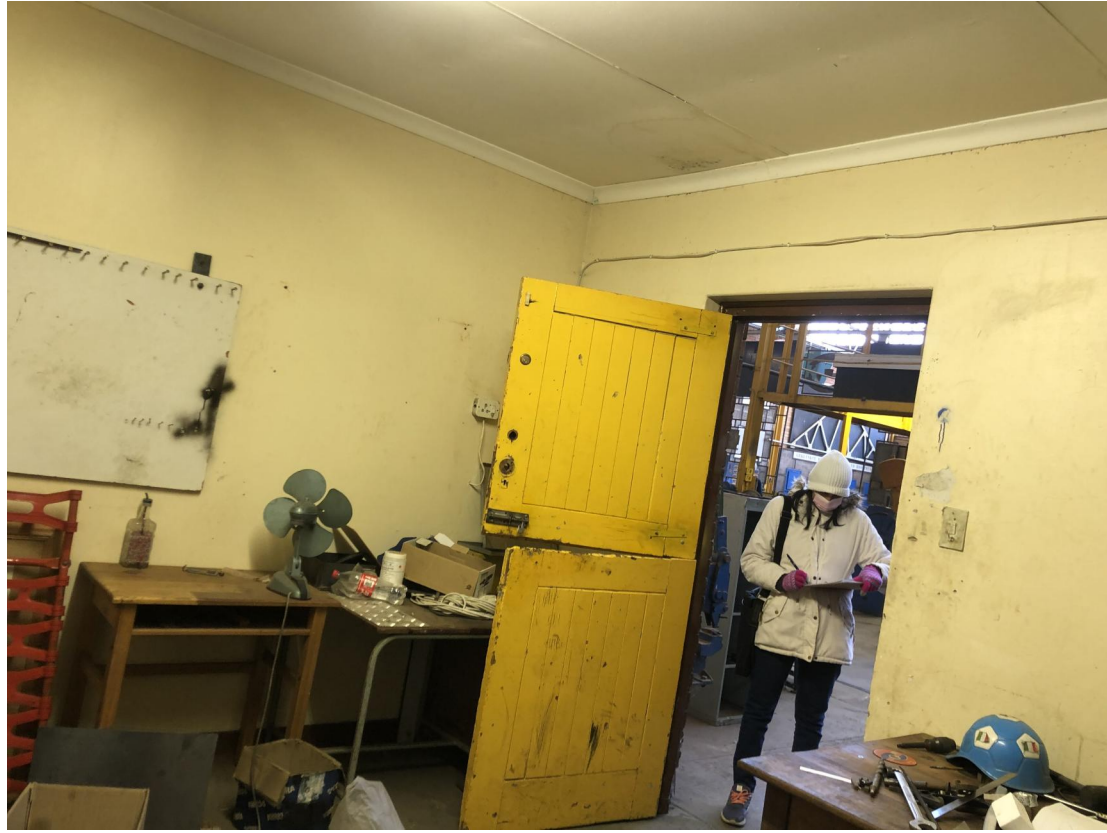
**OFFICE ENTRANCE DOOR TO BE RUBBED
DOWN, PRIMED AND REPAINTED.**

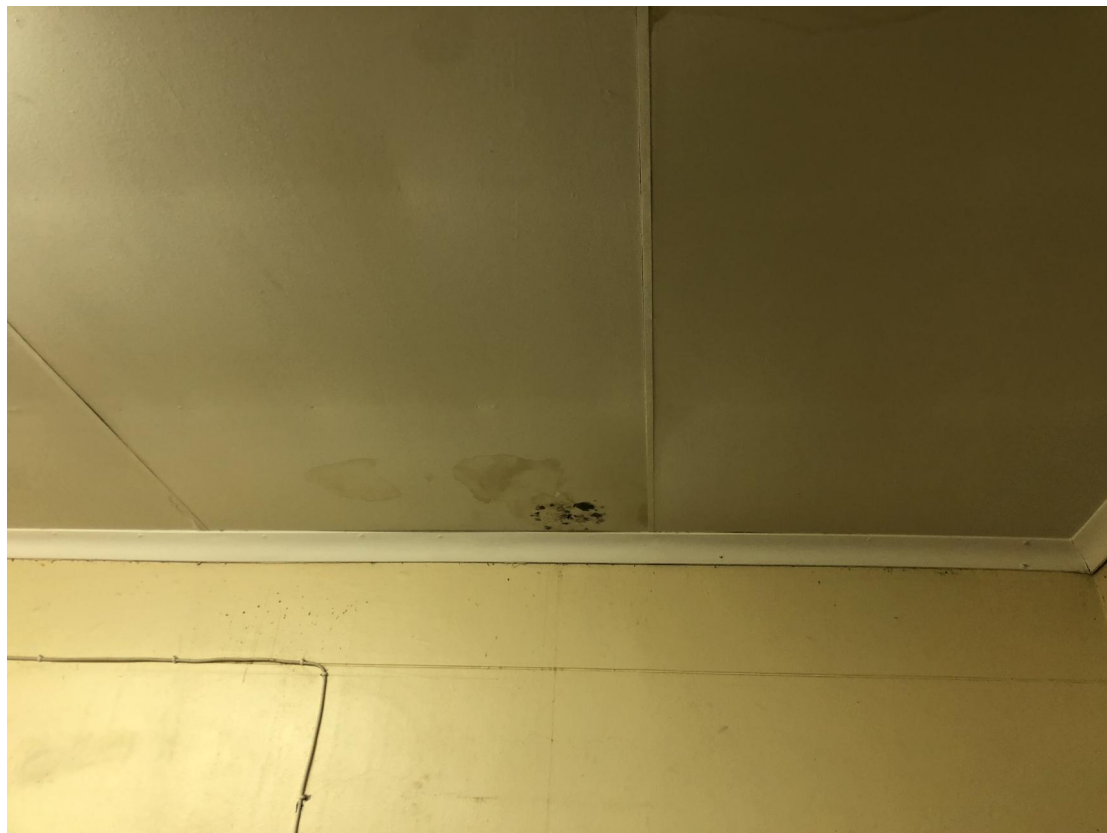
- Offices in workshop: water damage to ceilings - ceilings to be removed and replaced with new to match. REFER TO IMAGE BELOW.
- Sisalation is damaged at various points - recommend replacing with new. Roof to be checked for any leaks / damage and to be repaired. REFER TO IMAGES BELOW.

**EXISTING CEILING TO BE REMOVED AND
REPLACED WITH NEW TO MATCH EXISTING.**

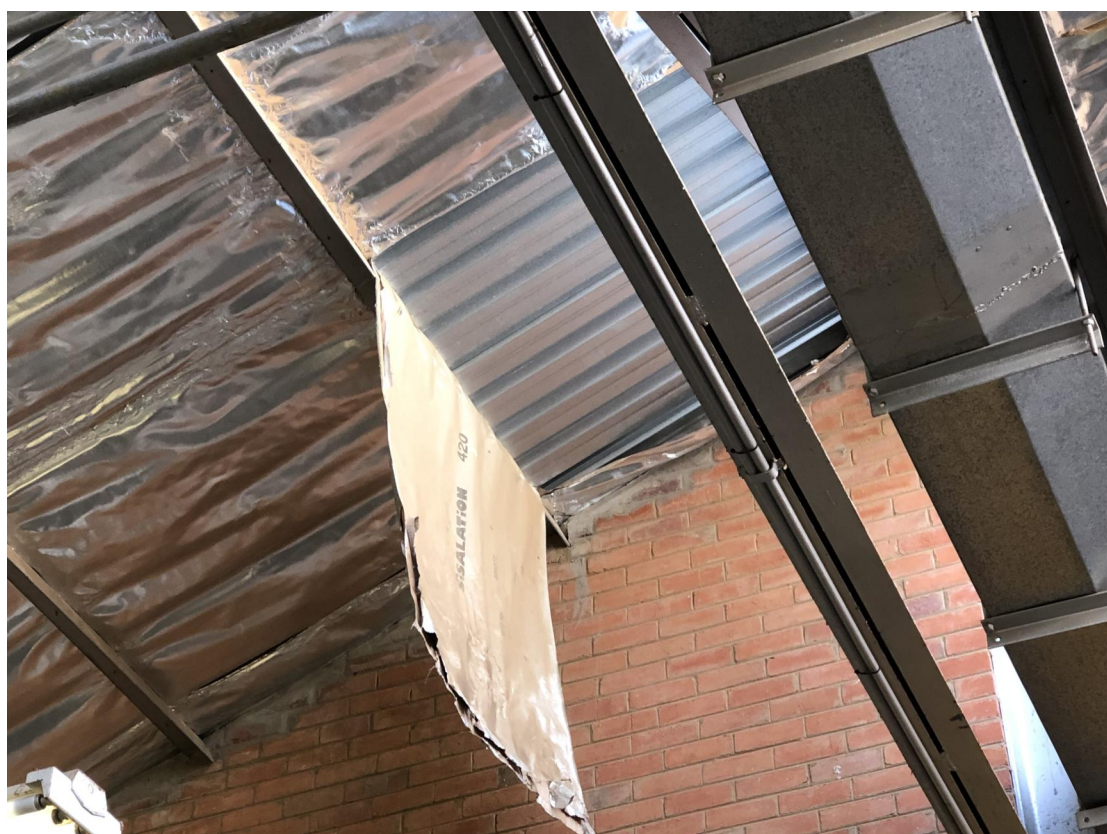
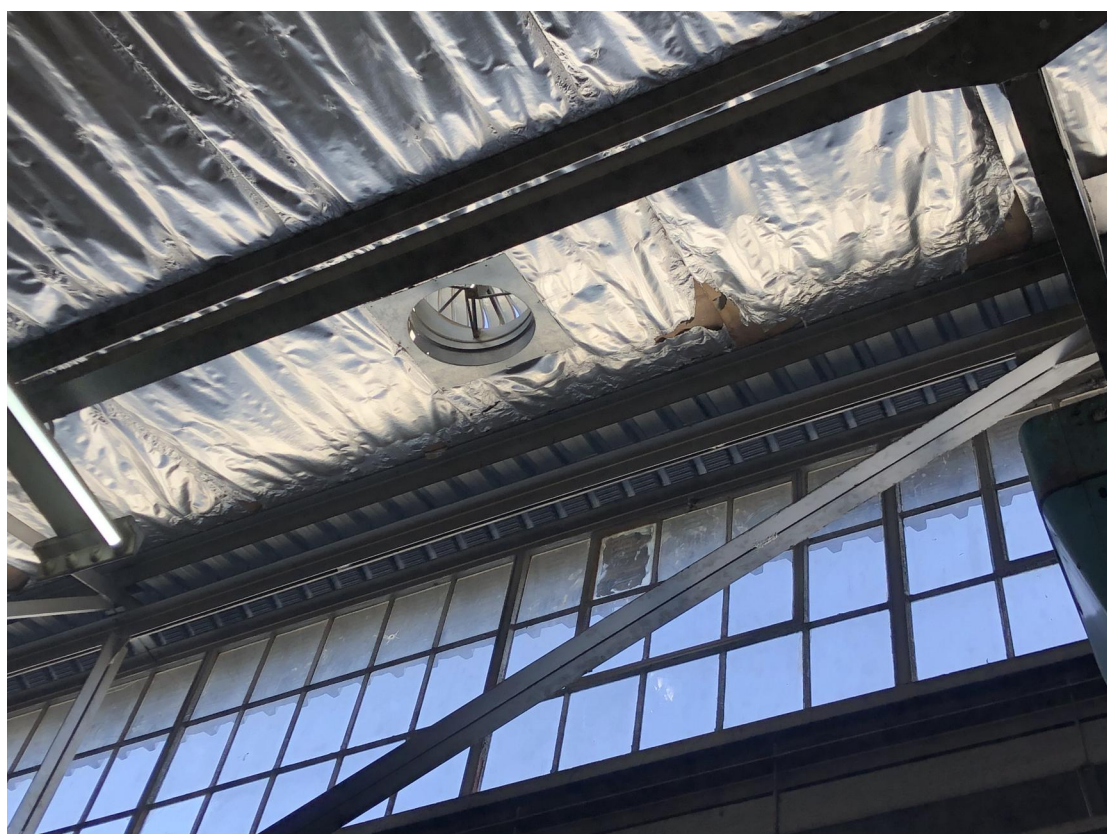
**SISALATION IS DAMAGED IN VARIOUS SPOTS.
RECOMMEND REPLACING WITH NEW TO
MATCH EXISTING.**
