CONDITION ASSESSMENT
HTS WELKOM HOSTEL

EXISTING BUILDINGS
REFURBISHMENT SCOPE OF WORKS

082-HTSWEL-112

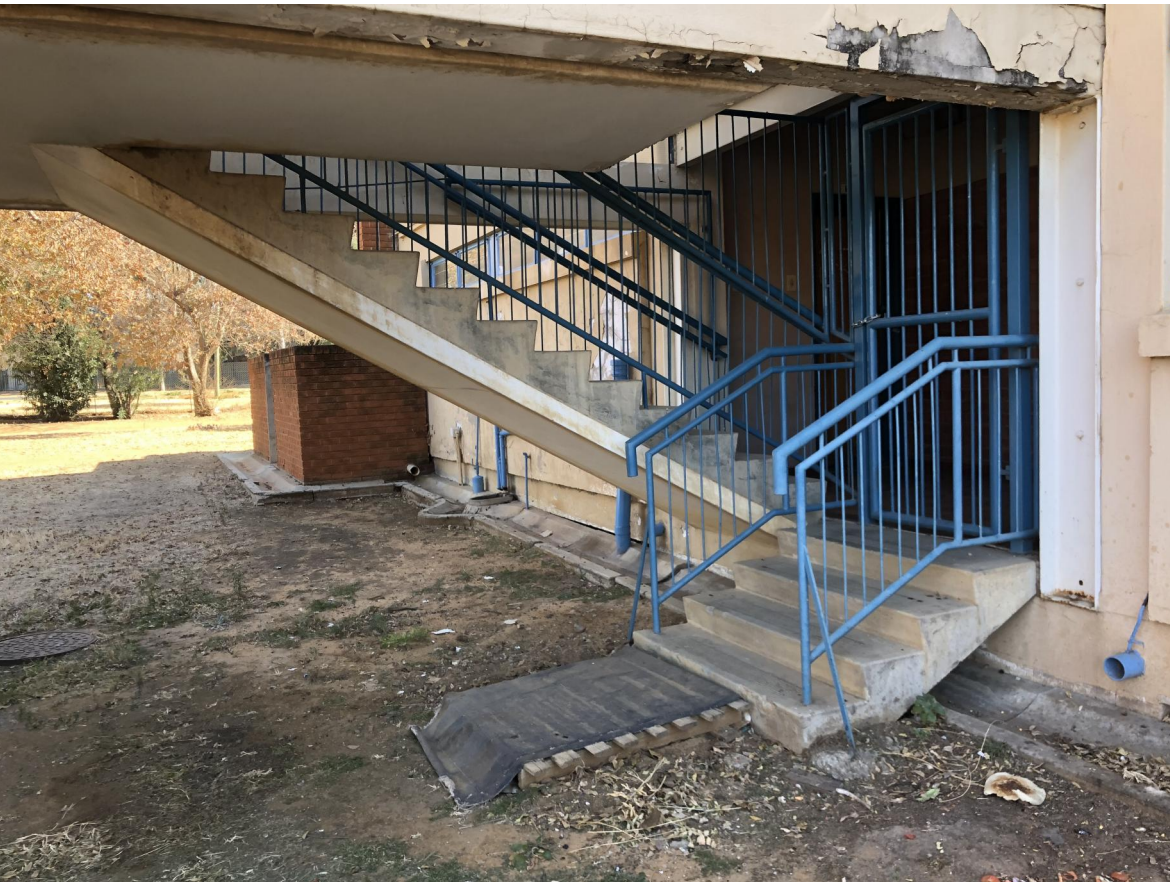
NO INTERNAL ACCESS FOR ASSESSMENT.
EXTERIOR: Refer to Engineer's report for assessment.
1. Damage to brickwork - refer to Engineer's report for replacement.
2. Missing brickwork - replace with new to match existing. REFER TO IMAGE BELOW.

EXTERNAL PAINTWORK IN A POOR CONDITION. RECOMMEND FINDING ANY LEAKS, WATERPROOFING AND REPAINTING.

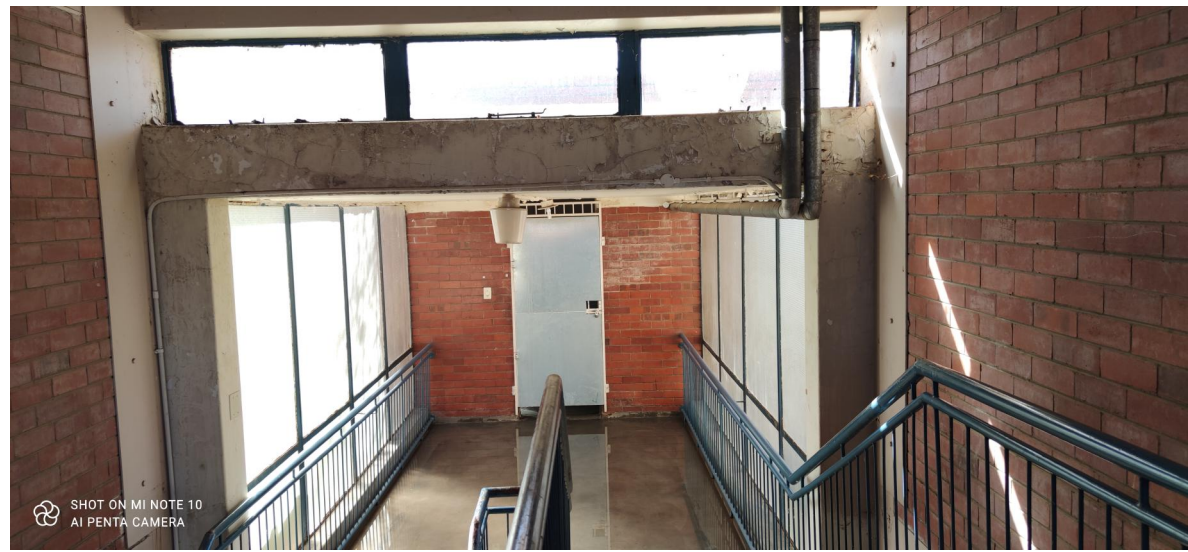
WATER PONDING OUTSIDE ABLUTIONS. LOCATE LEAK AND REPAIR.

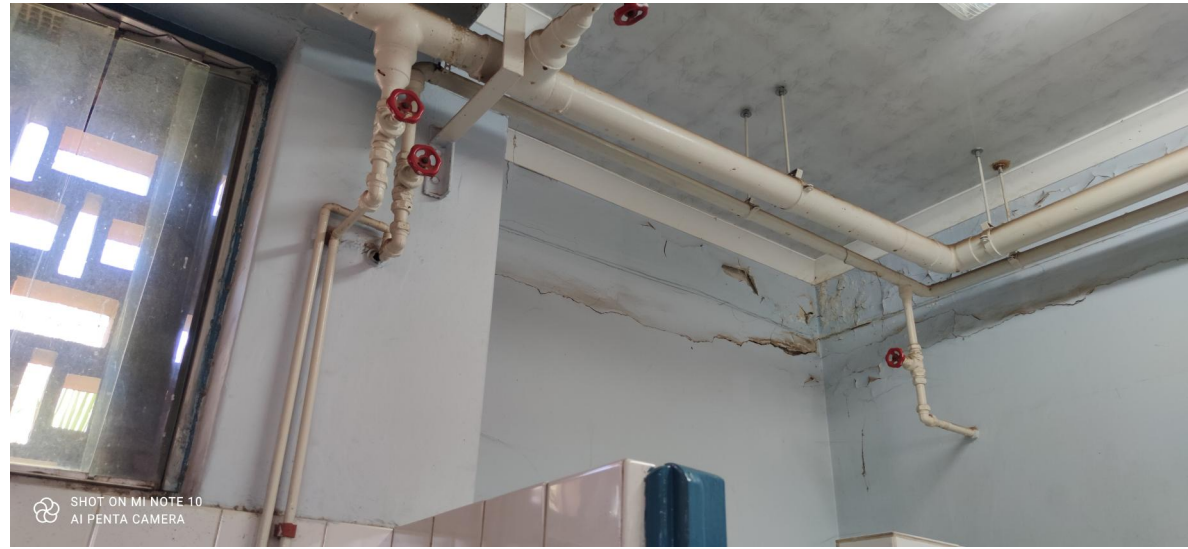
ALL INTERNAL CEILINGS ARE TO BE REMOVED AND REPLACED WITH NEW.

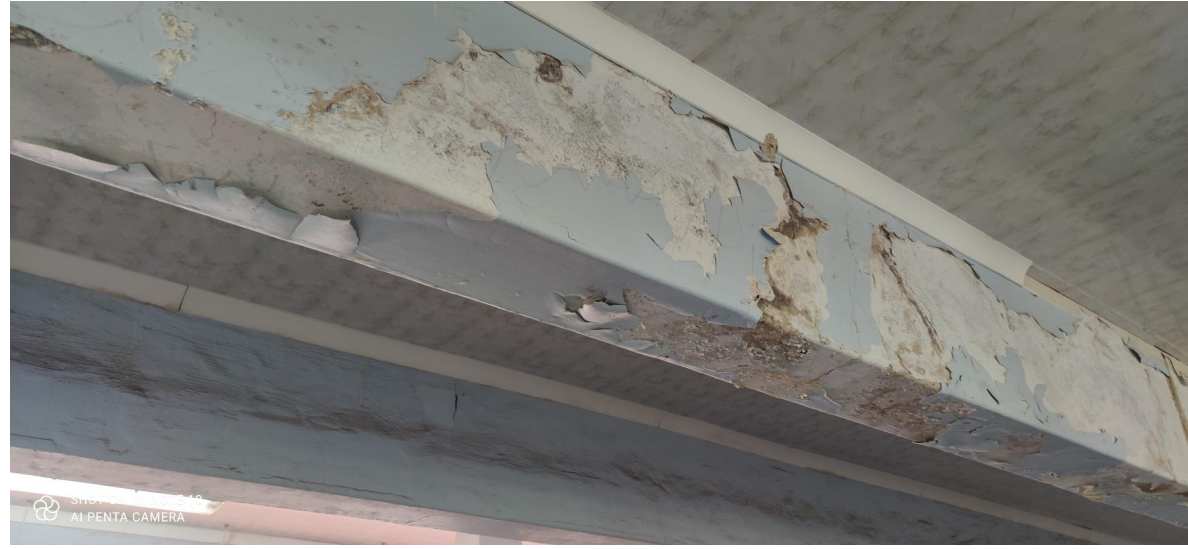
ALL INTERNAL WALLS AND BEAMS ARE TO BE RUBBED DOWN, RESEALED / RE-WATERPROOFED, PRIMED AND REPAINTED.

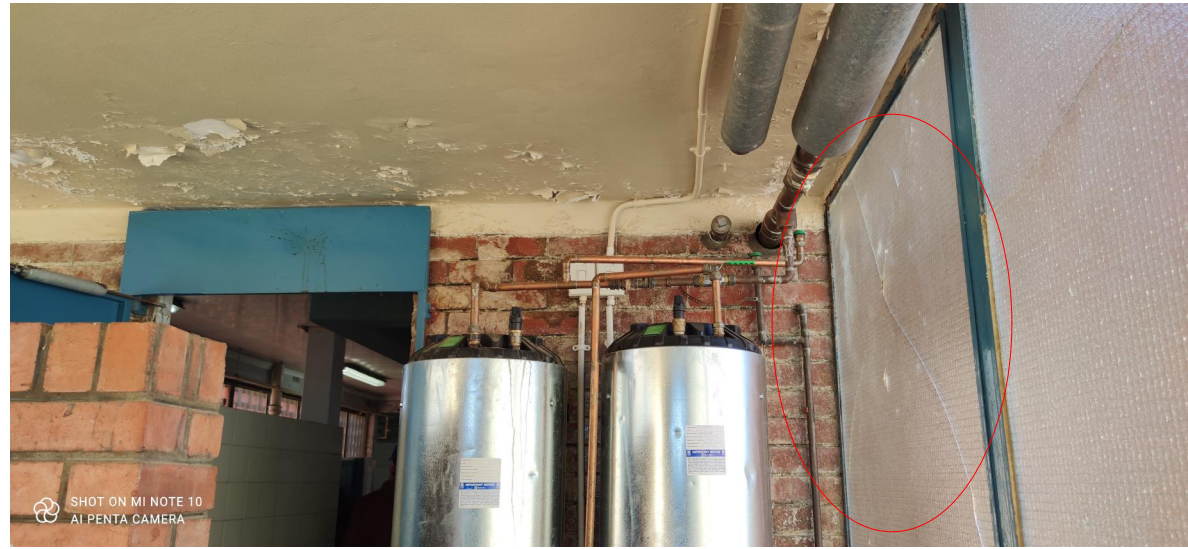
REPLACED CRACKED WINDOW GLAZING WITH NEW TO MATCH EXISTING.
