RPF 1162018 KZN PSP FRAMEWORK ORDER  
STORM DAMAGES PHASE 17

NCEKUYA PRIMARY SCHOOL  
EMIS 500342213  
KING CETSHWAYO DISTRICT  
UMLALAZI LOCAL MUNICIPALITY

BLOCK B - FLOOR PLAN

DRG No. : KLA/5330/NCE/03

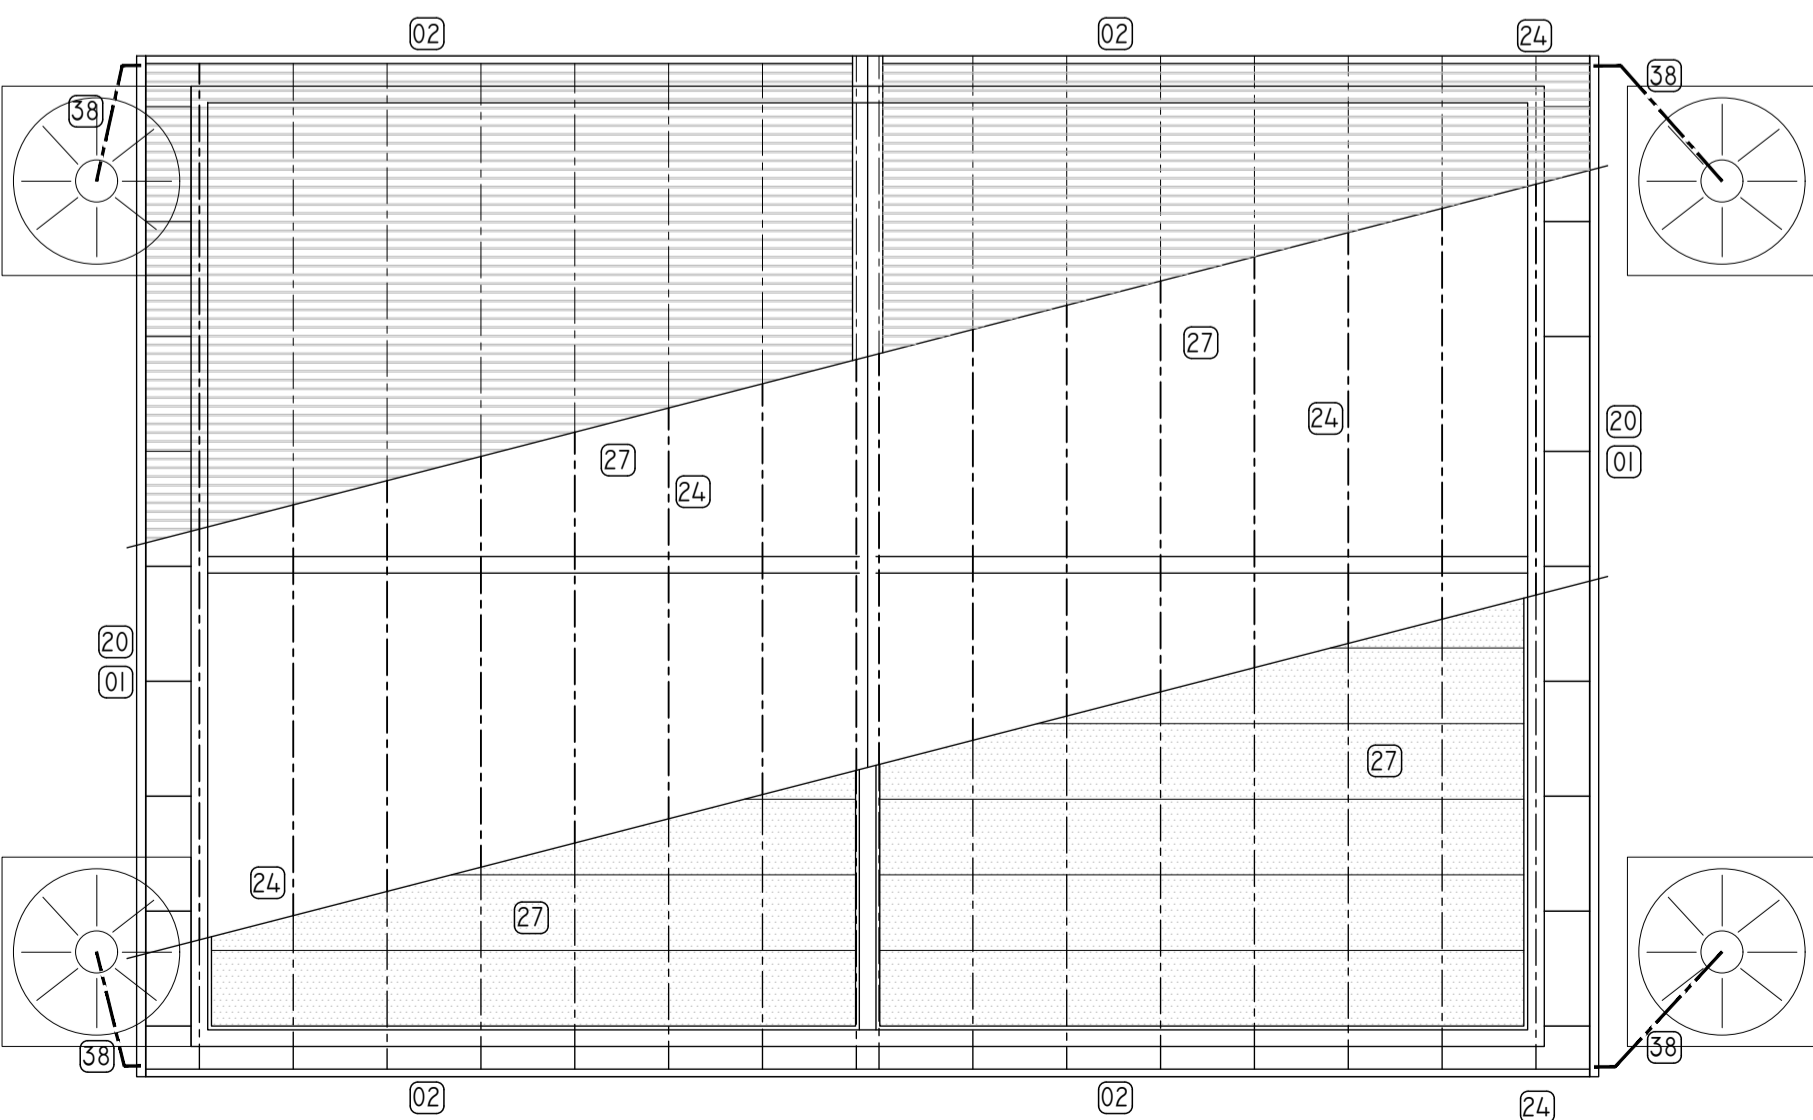
BLOCK B - ROOF PLAN 1:100

Note storm damaged roofs due to engineering procedures may require existing nailed trusses and purlins to be replaced with new gangnail trusses and purlins. Certification is problematic with old nailed trusses. Therefore, please price both options. New trusses will require new beam filling and hoop iron strapping as per the standard specification. See point 6

12 New SAP purlins and fixed as per standard drawing

13 Repaired/strengthen existing nailed SAP rafters. Check for fixings to hoop iron if still solid firm and tight or correct

14 Tilting purlins to be replaced and correctly fixed as per details and specification

37 Refix or Replace wind damaged/removed IBR/Corrugated sheeting to match existing. Include repair to roof structure elements if necessary.
