COJ BIOMETHANE PLANT GEOTECHNICAL REPORT

MAY 2019
REVISION 2

SYNOPSIS Report presenting the results of a geotechnical investigation undertaken for the new biomethane plant to be constructed at Robinson Deep Landfill site, Johannesburg, Gauteng Province

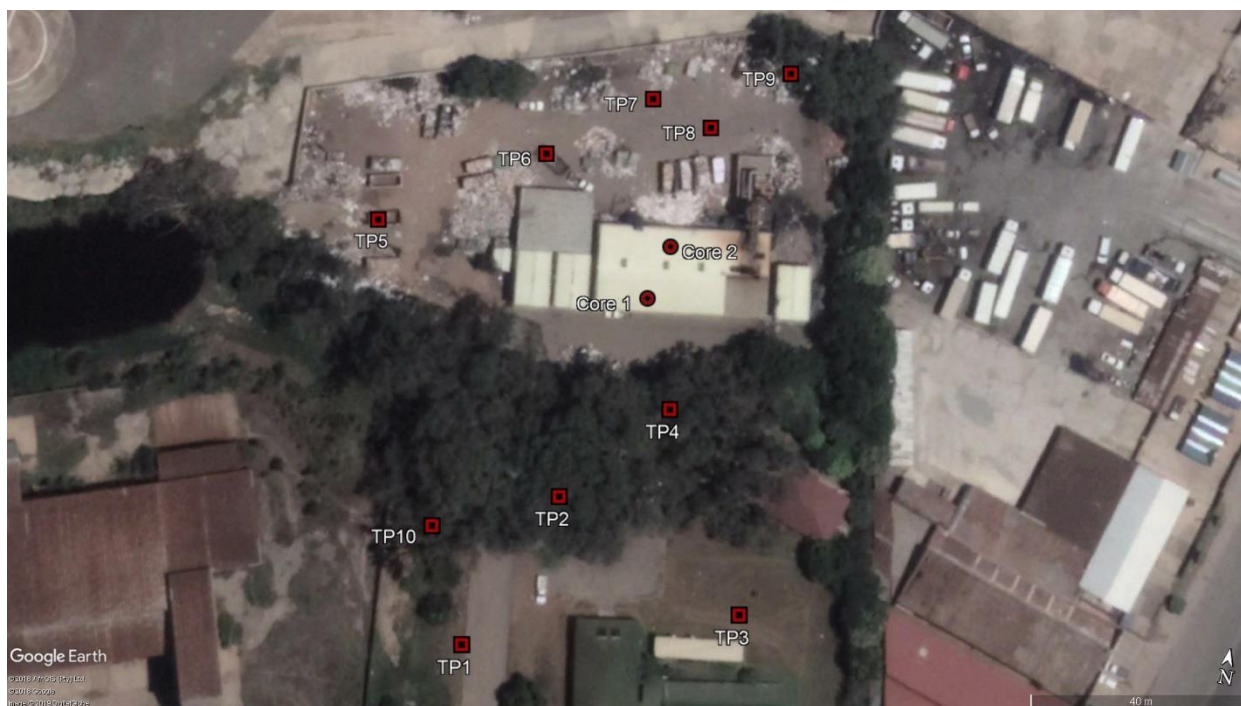
Figure 2: Test Pit Location Plan

Ten test pits, designated TP1 to TP10, were excavated by Tractor Loaded Backhoe (TLB) to depths of up to 3.10 m, below existing ground level (egl). The locations of the test pits are depicted in Figures 2 and 3, Test Pit Location Plan and Test pits with site plan overlay. The test pits were photographed and profiled immediately after excavation. The test pit logs can be found in Annexure A.
