REPORT DVH-20-78A

FINAL GEOTECHNICAL INVESTIGATION REPORT

NEW ACADEMIC HOSPITAL, POLOKWANE

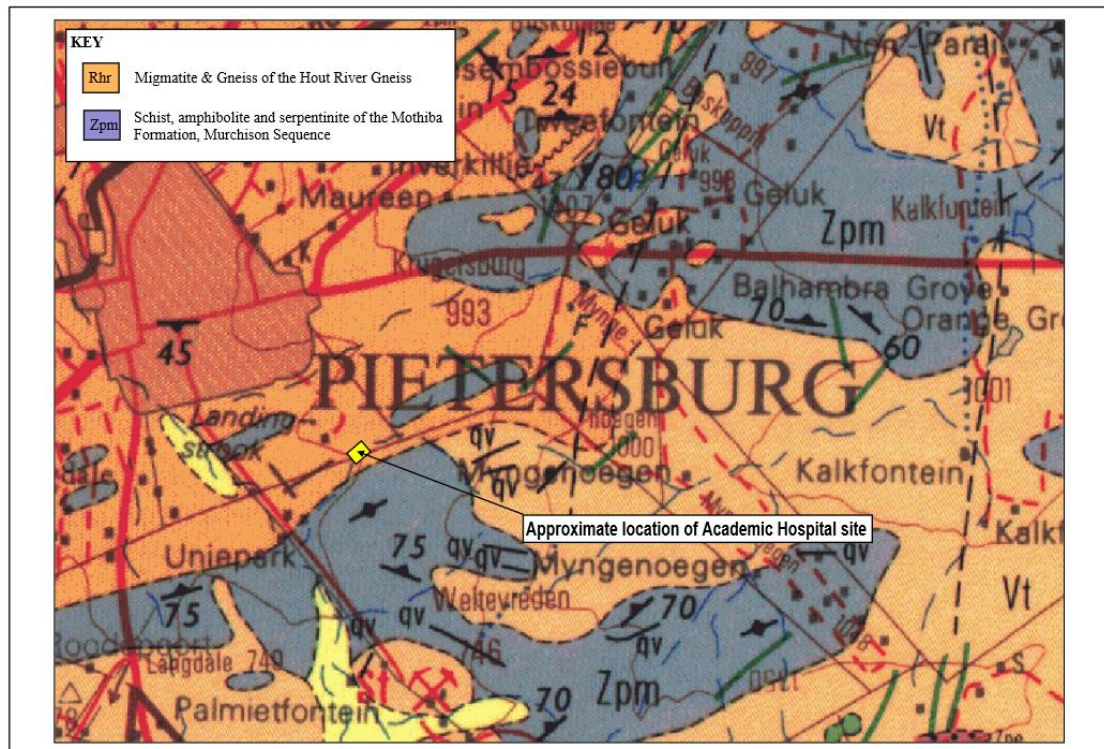
Figure 2: Regional Geology Plan, New Academic Hospital, Polokwane

Figure 2 above indicates that the site is underlain by migmatite and **gneiss** of the Hout River Gneiss. This was confirmed during the current investigation. Residual soils have developed from the weathering of the gneiss bedrock and include overlying transported soil horizons. The general soil profile is as follows.

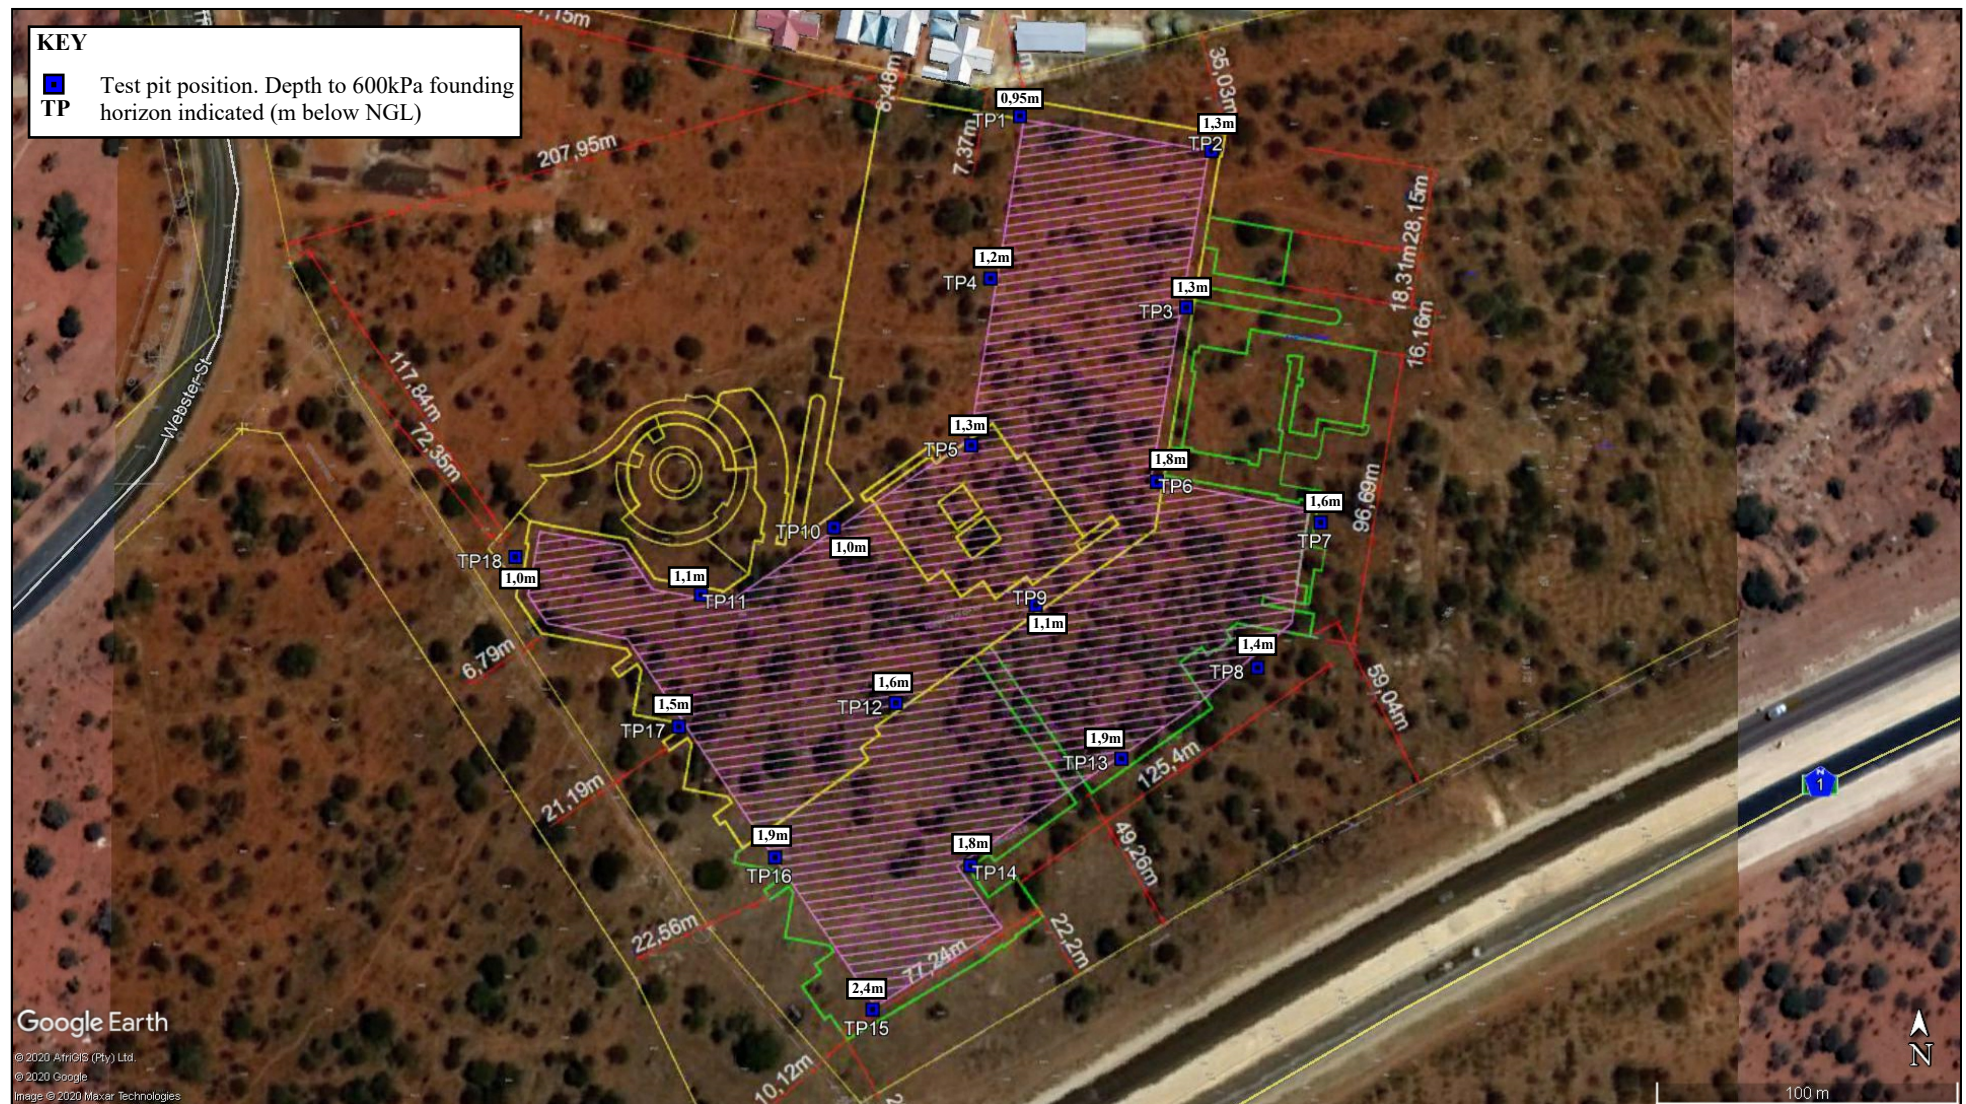
SITE PLAN INDICATING APPROXIMATE LOCATIONS
OF TEST PIT EXCAVATIONS. DEPTHS TO
RECOMMENDED FOUNDING HORIZON INDICATED

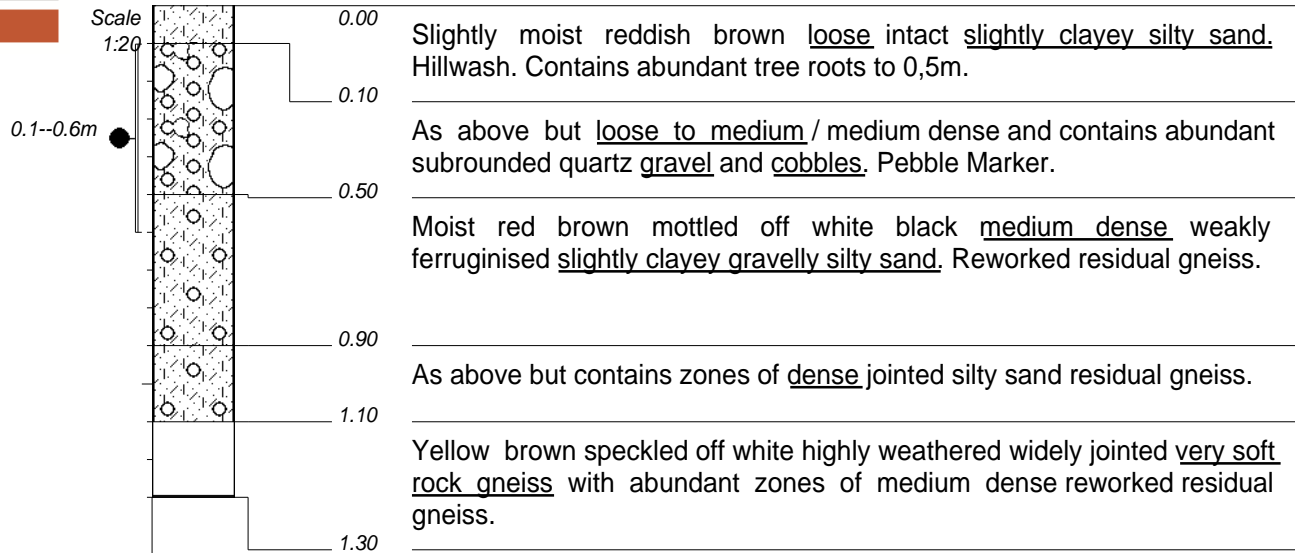
HOLE No: TP02

- 1) Refusal at 1,3m on soft rock gneiss.
- 2) No evidence of water.
- 3) Disturbed sample taken at 0,1--0,6m.

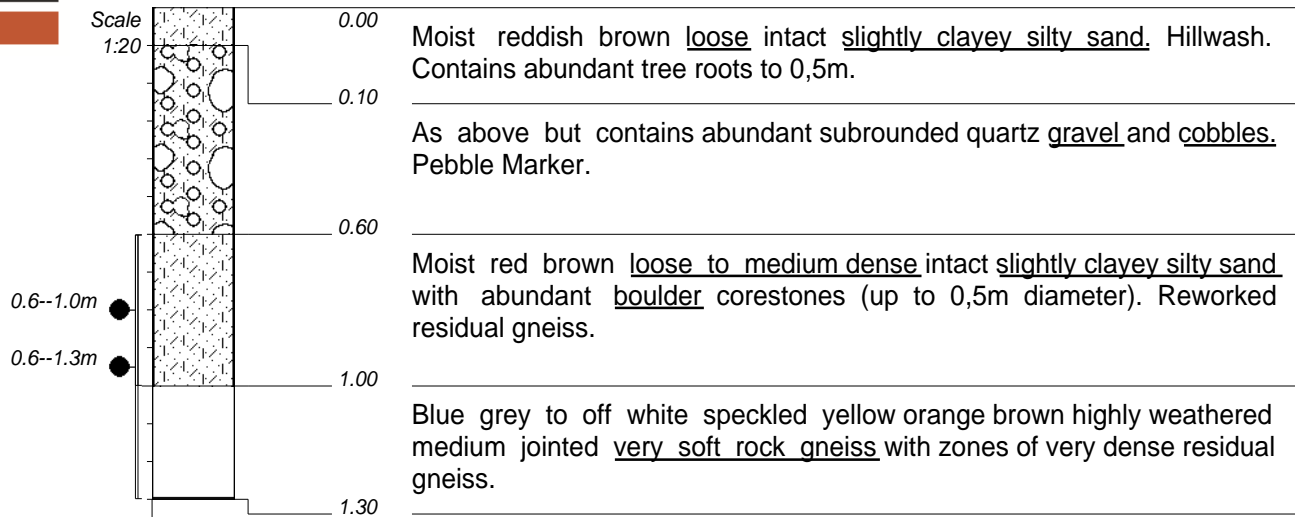
HOLE No: TP04

- 1) Refusal at 1,3m on soft rock gneiss.
- 2) No evidence of water.
- 3) Disturbed samples taken at 0,6--1,3m and 0,6--1,0m.

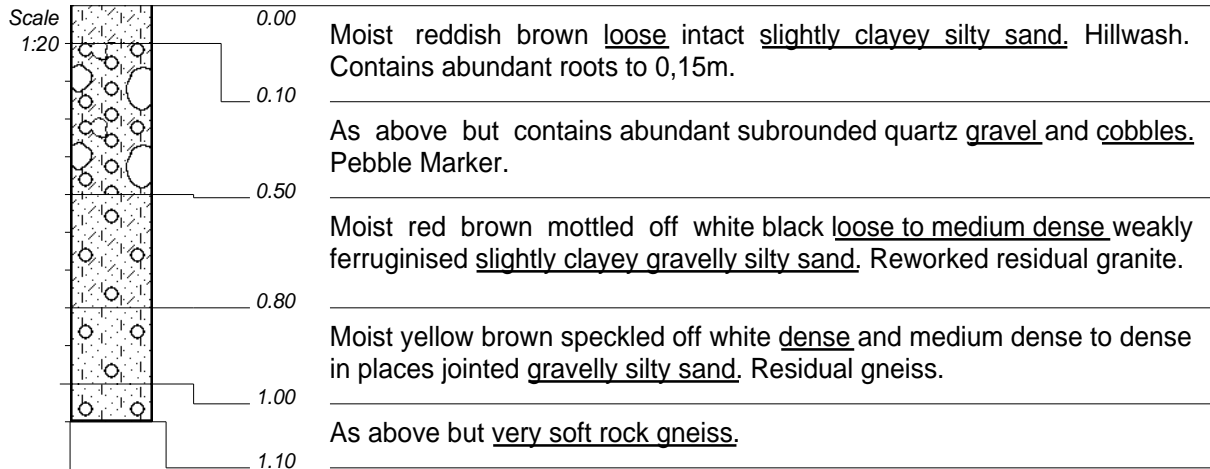
HOLE No: TP08

- 1) Refusal at 1,1m on soft rock gneiss.
- 2) No evidence of water.

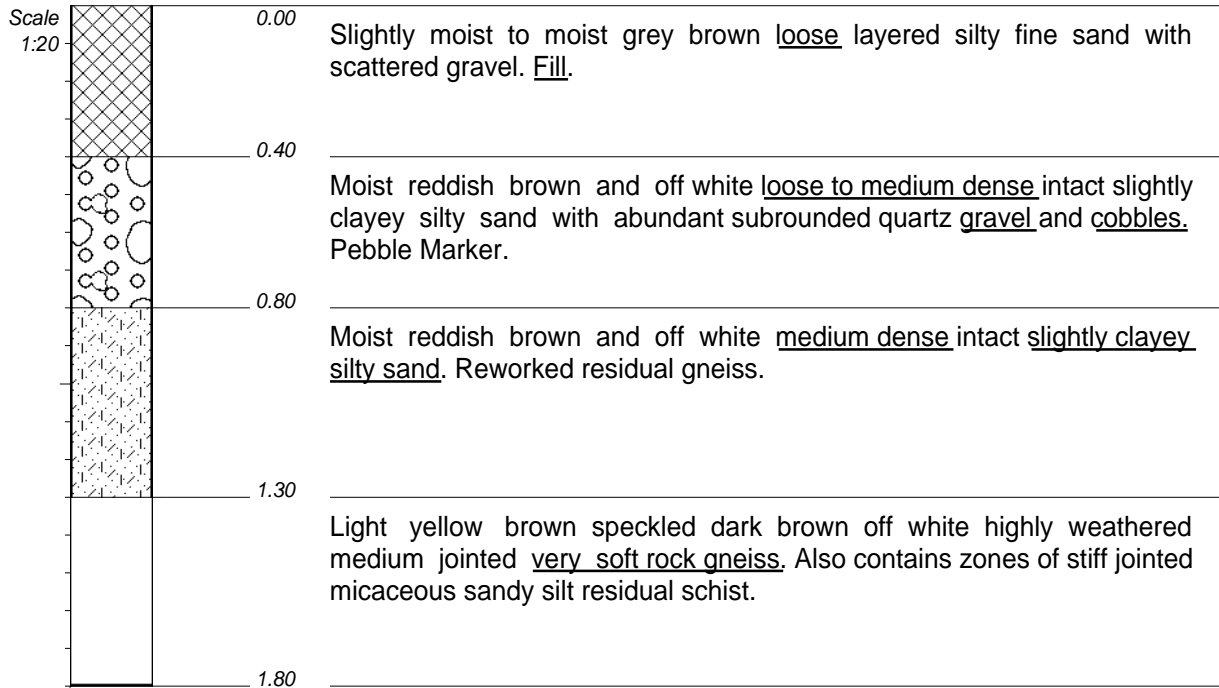
HOLE No: TP13

- 1) Refusal at 1,8m on soft rock gneiss.
- 2) No evidence of water.

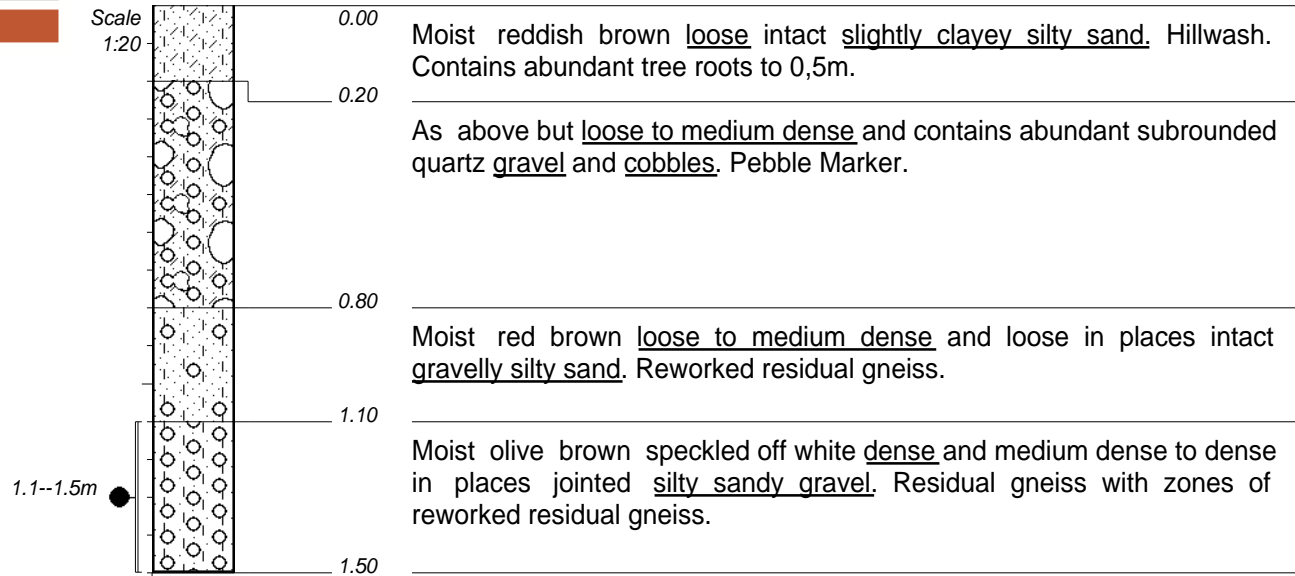
HOLE No: TP16

- 1) Refusal at 1,5m on soft rock gneiss.
- 2) No evidence of water.
- 3) Disturbed sample taken at 1,1--1,5m.

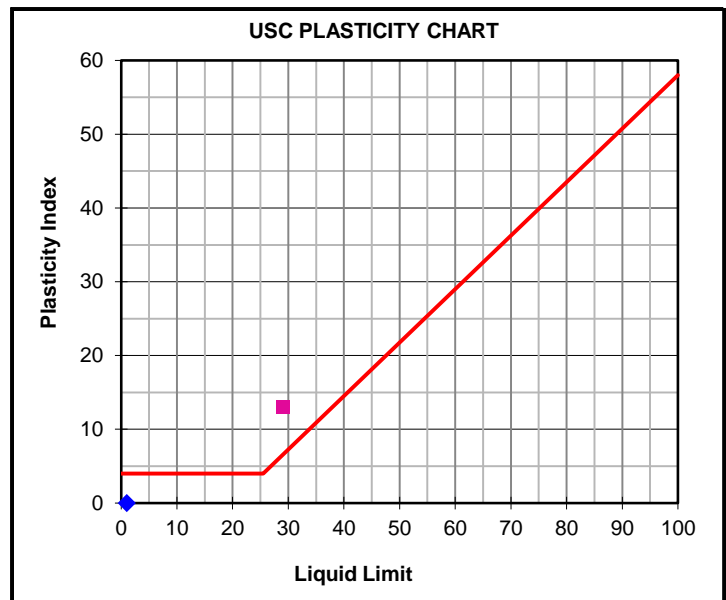
Percentage Passing	100 mm	100	100
	75 mm	100	100
	63 mm	100	100
	50 mm	100	100
	37.5 mm	100	100
	28 mm	100	100
	20 mm	100	100
	14 mm	100	95
	5 mm	89	70
	2 mm	64	44
	1 mm	43	31
	0.425 mm	27	23
	0.250 mm	21	19
	0.150 mm	15	15
0.075 mm	10	11	
Grading Modulus		1.99	2.22

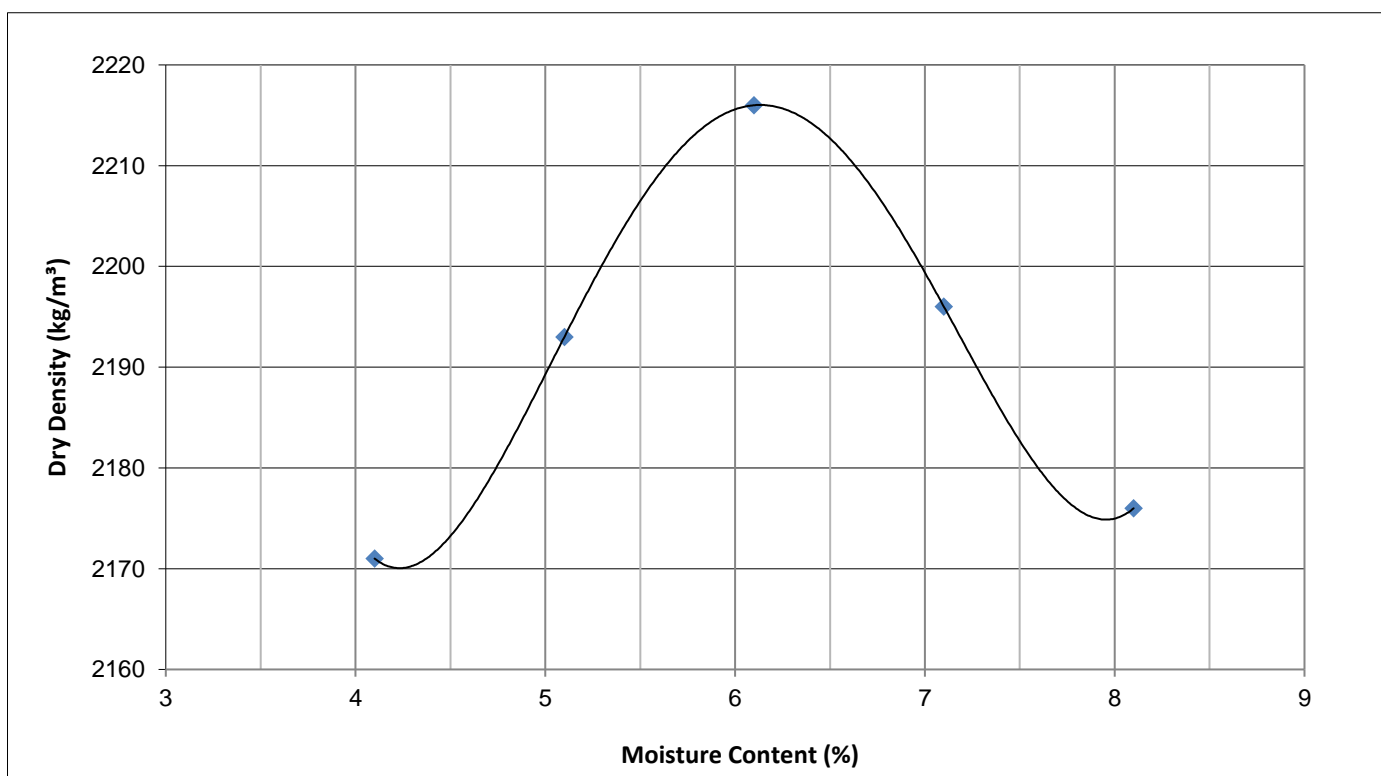
MOISTURE DENSITY RELATIONSHIP

Dry Density	kg/m ³	2171	2193	2216	2196	2176	
Moisture Content	%	4.1	5.1	6.1	7.1	8.1

Max. Dry Density	kg/m ³	2216
Optimum Moisture	%	6.1

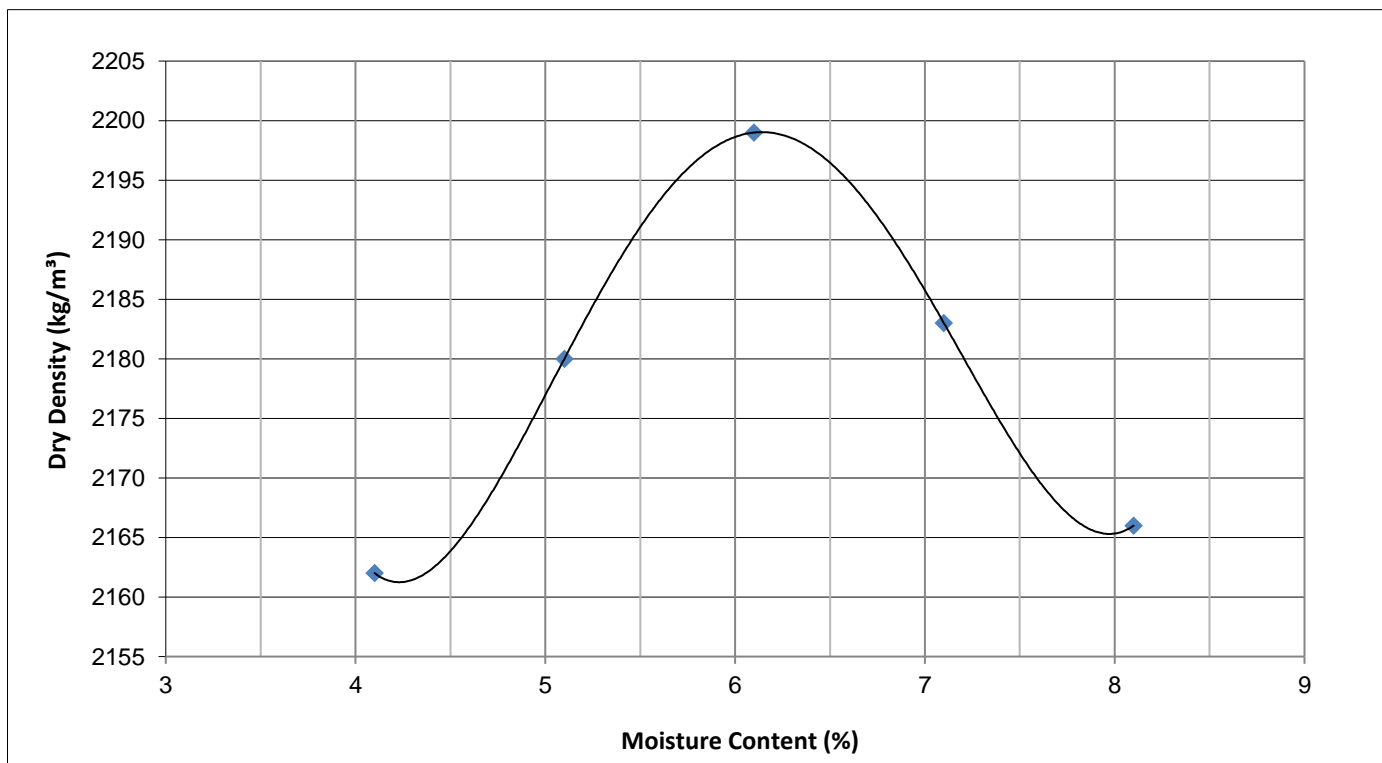
MOISTURE DENSITY RELATIONSHIP

Dry Density	kg/m ³	2162	2180	2199	2183	2166	
Moisture Content	%	4.1	5.1	6.1	7.1	8.1

Max. Dry Density	kg/m ³	2199
Optimum Moisture	%	6.1
