## Work package 2: De-comissioning, demolition and removal

The location of the incinerator is adjacent to the Pikitup Robinson Deep landfill.  
-26.229771967008283, 28.042469059383407

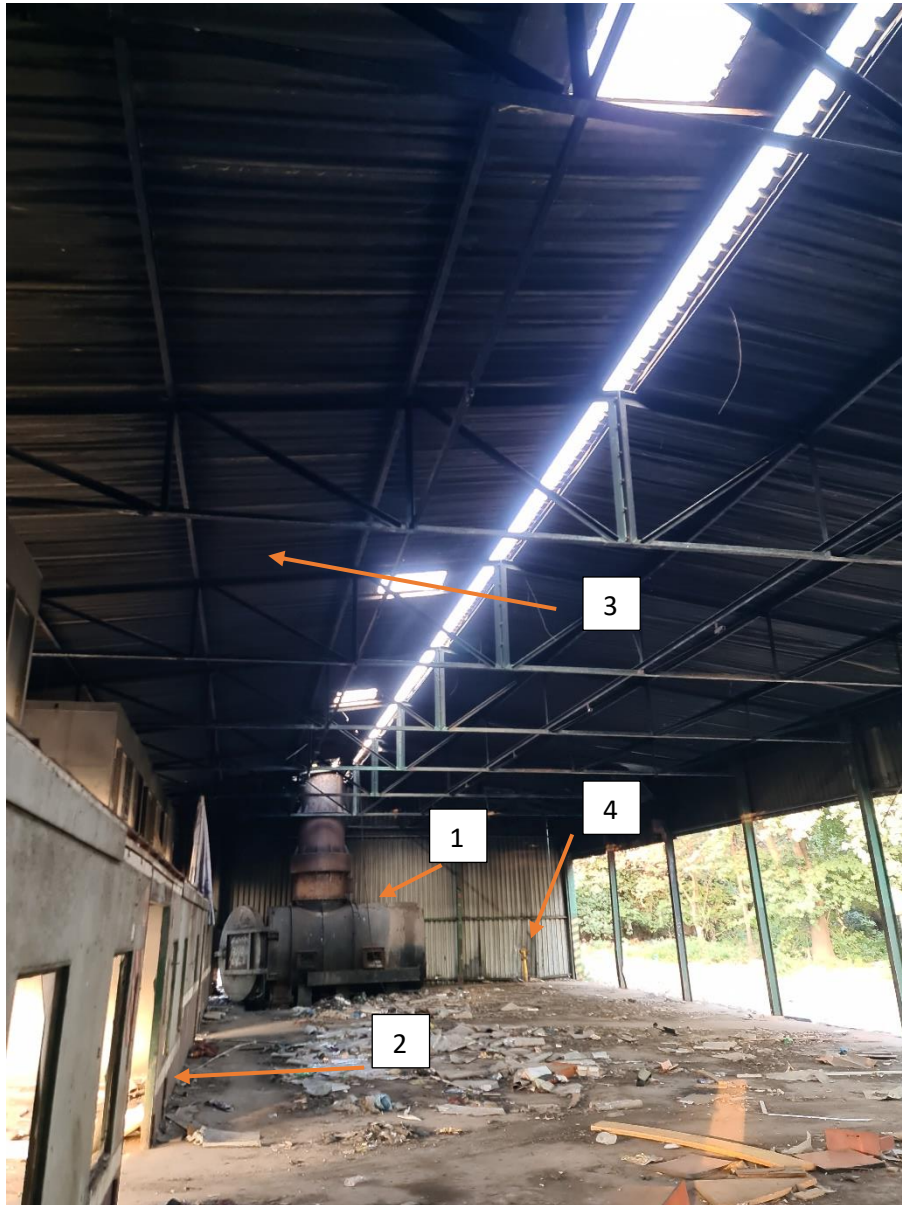
*Figure 2: Inside main building. Incinerator hearth (1) to be removed and disposed of (the chimney extends upwards directly from it). Internal walls to and platform to be removed (2). Roof sheeting to be removed (3). Egoli gas connection to be undisturbed (4).*

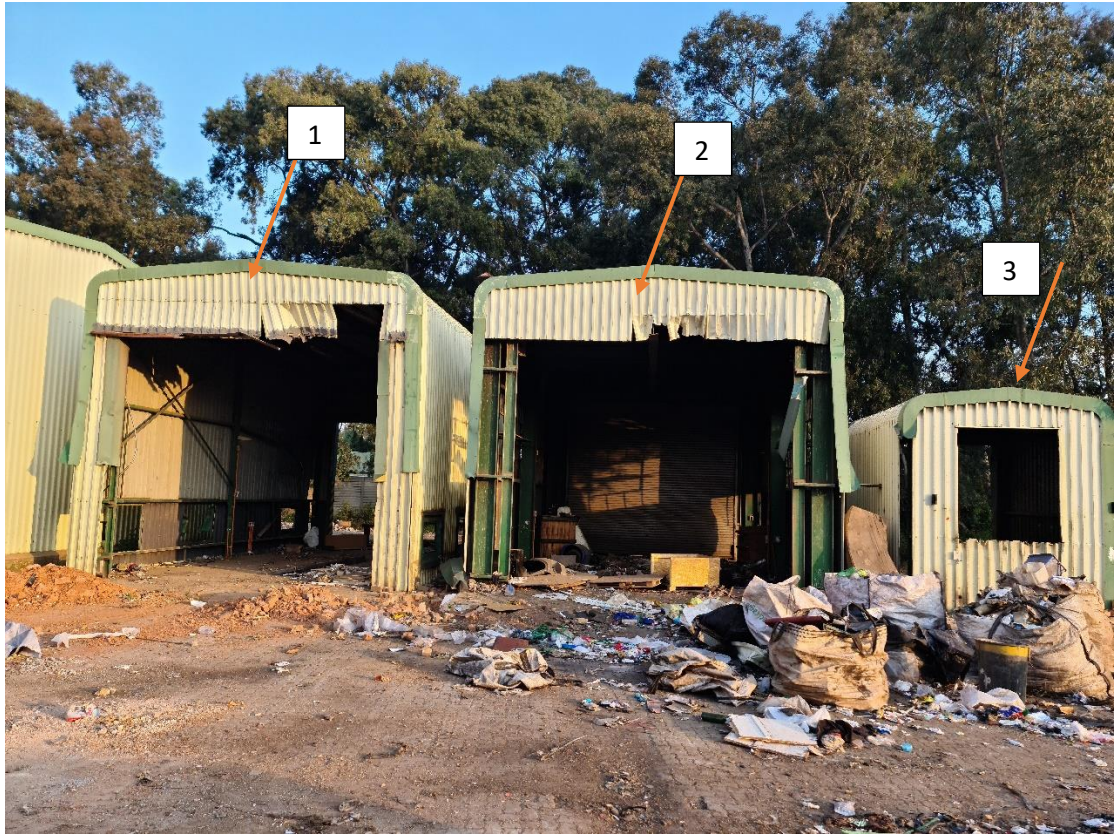
*Figure 3: (1) and (2) are the two identical sheds that need to be stripped of roof sheeting. (2) the roller shutter door needs to be removed also. (3) a small shed that needs to be demolished.*

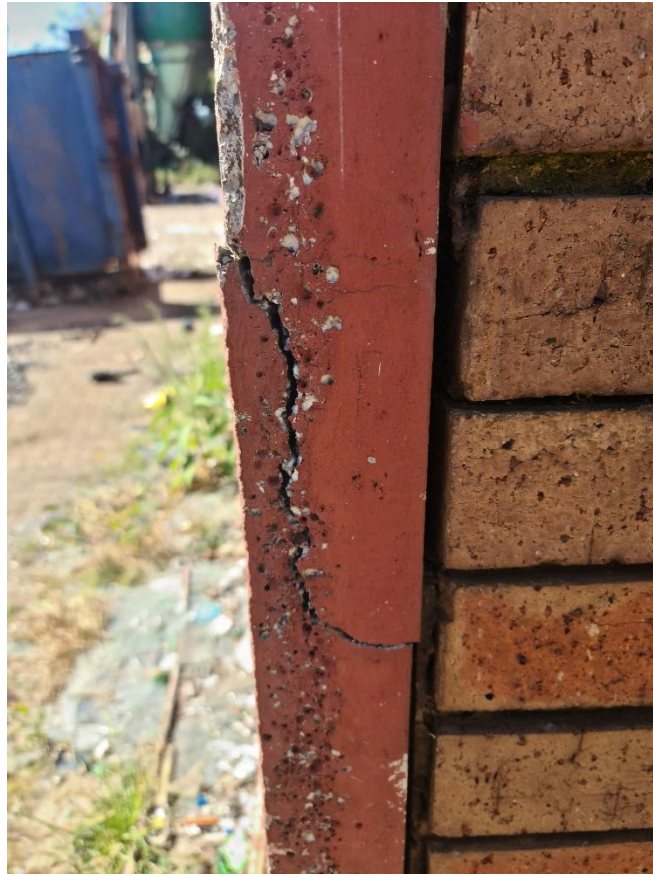
*Figure 4: Side view of cast concrete north wall that is to be demolished. Face brick section should also be demolished.*

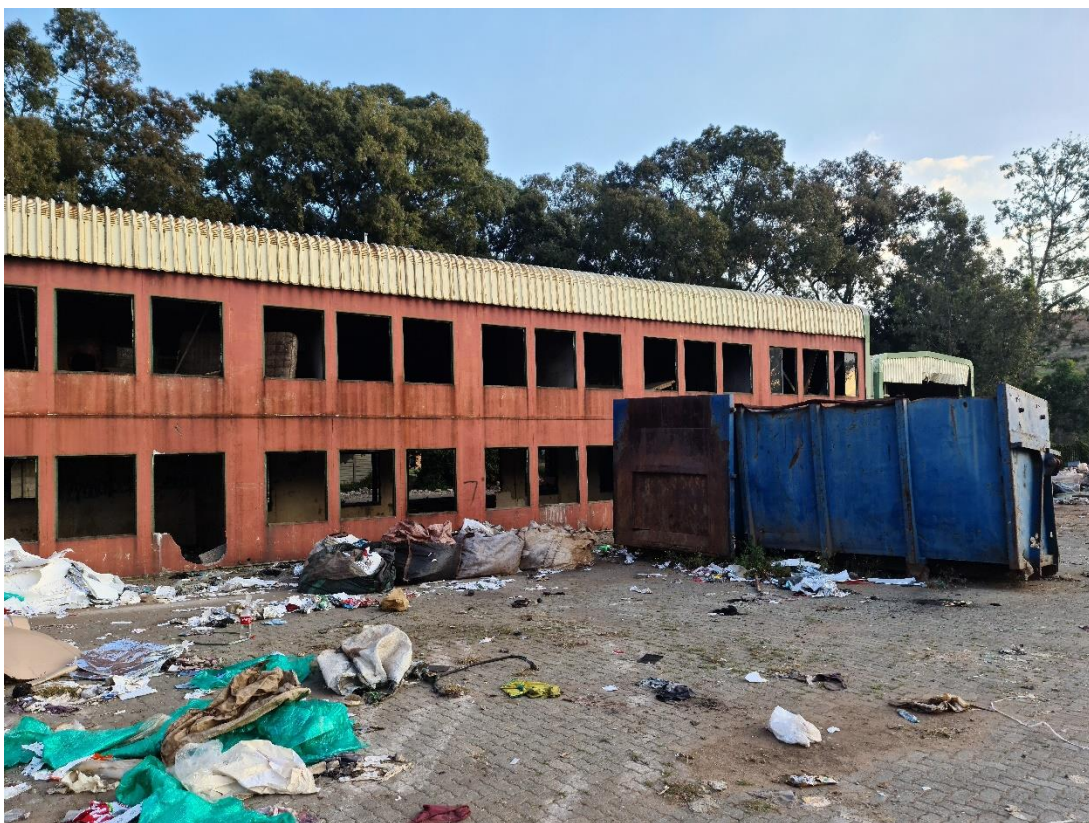
*Figure 5: The red wall with the multiple window frames needs to be demolished.*

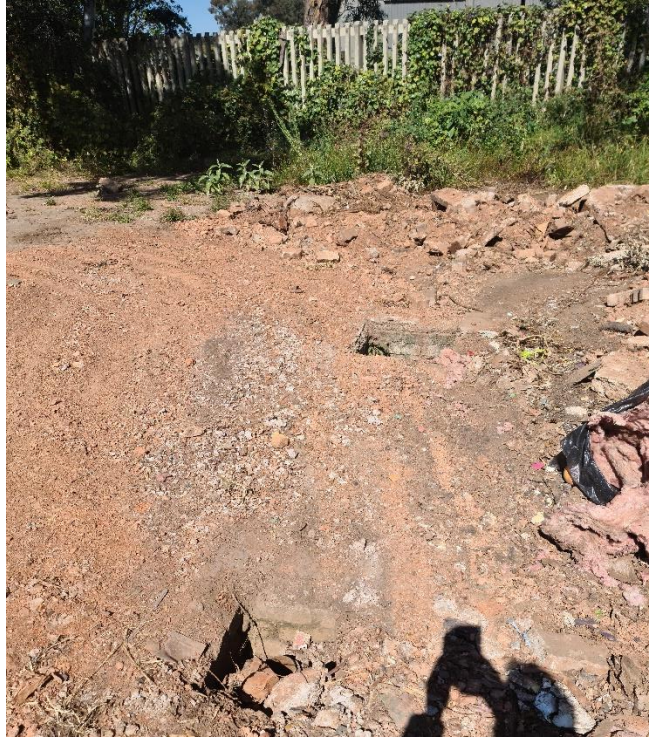
*Figure 6: Location of the underground diesel tanks that need to be excavated and removed.  
Brick paving should be retained on site for later reuse and earth filled back into the hole*

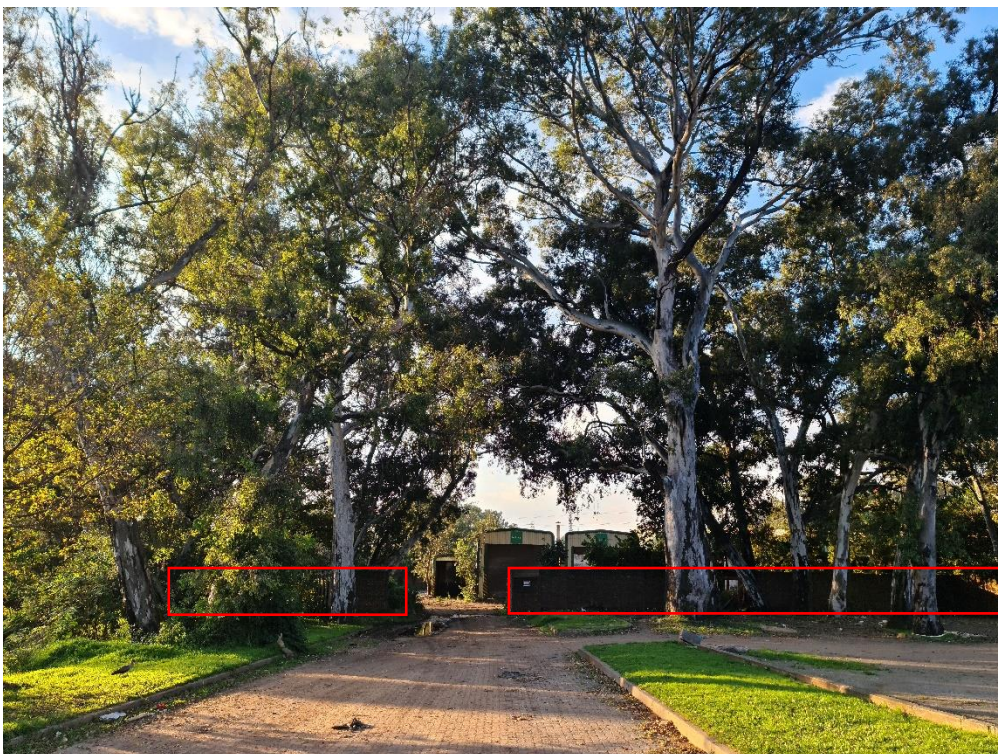
*Figure 7: Concrete fence for demolition highlighted.*

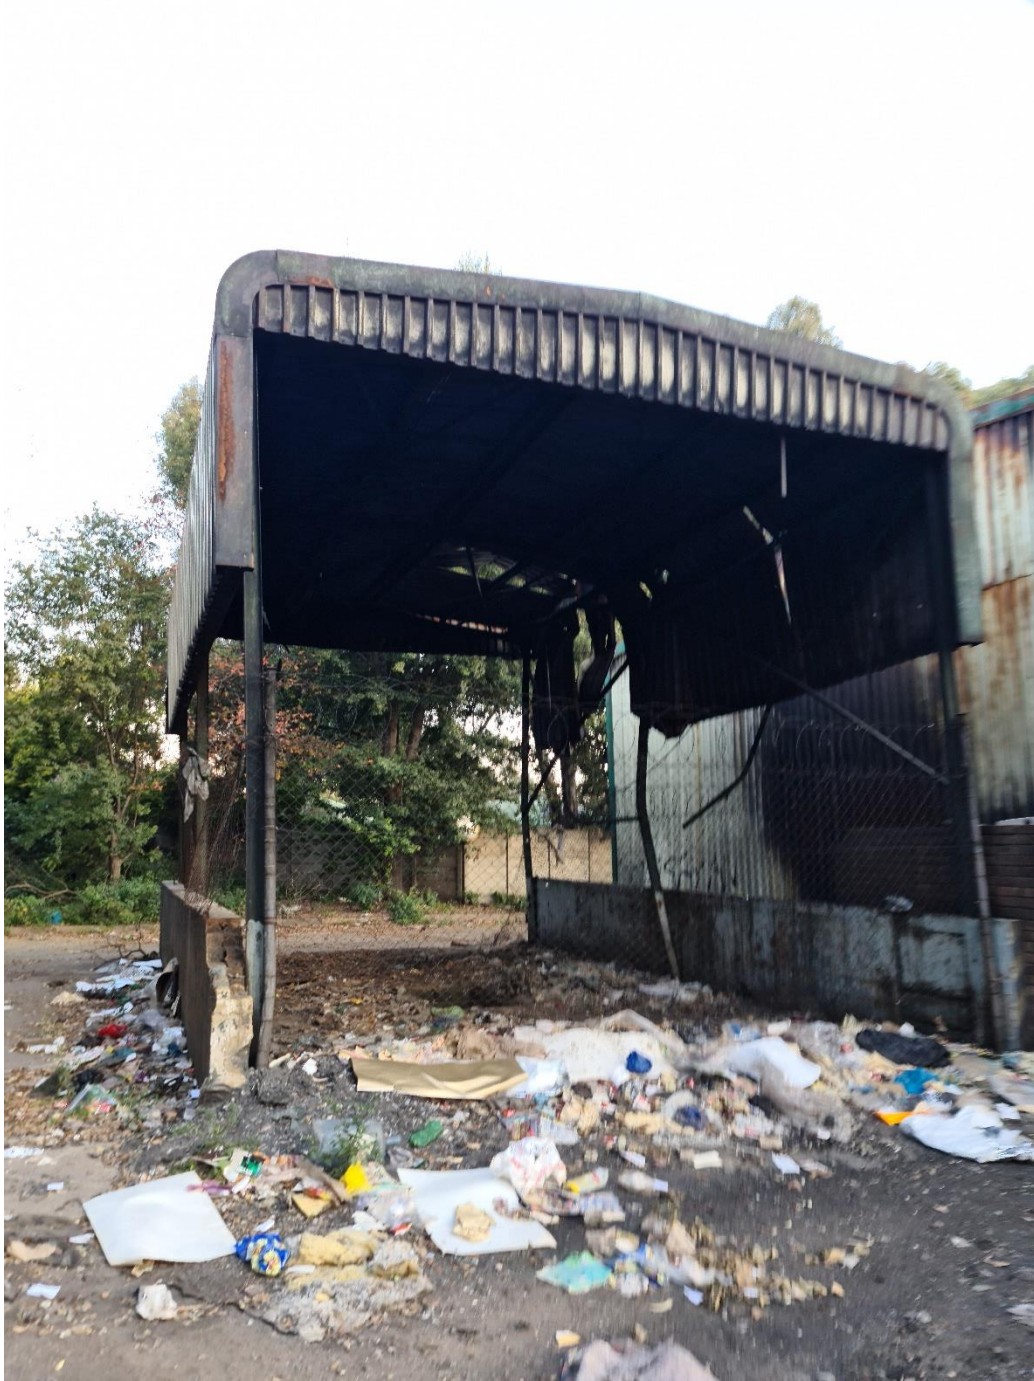
*Figure 8: Old washbay with side walls that needs to be demolished completely.*

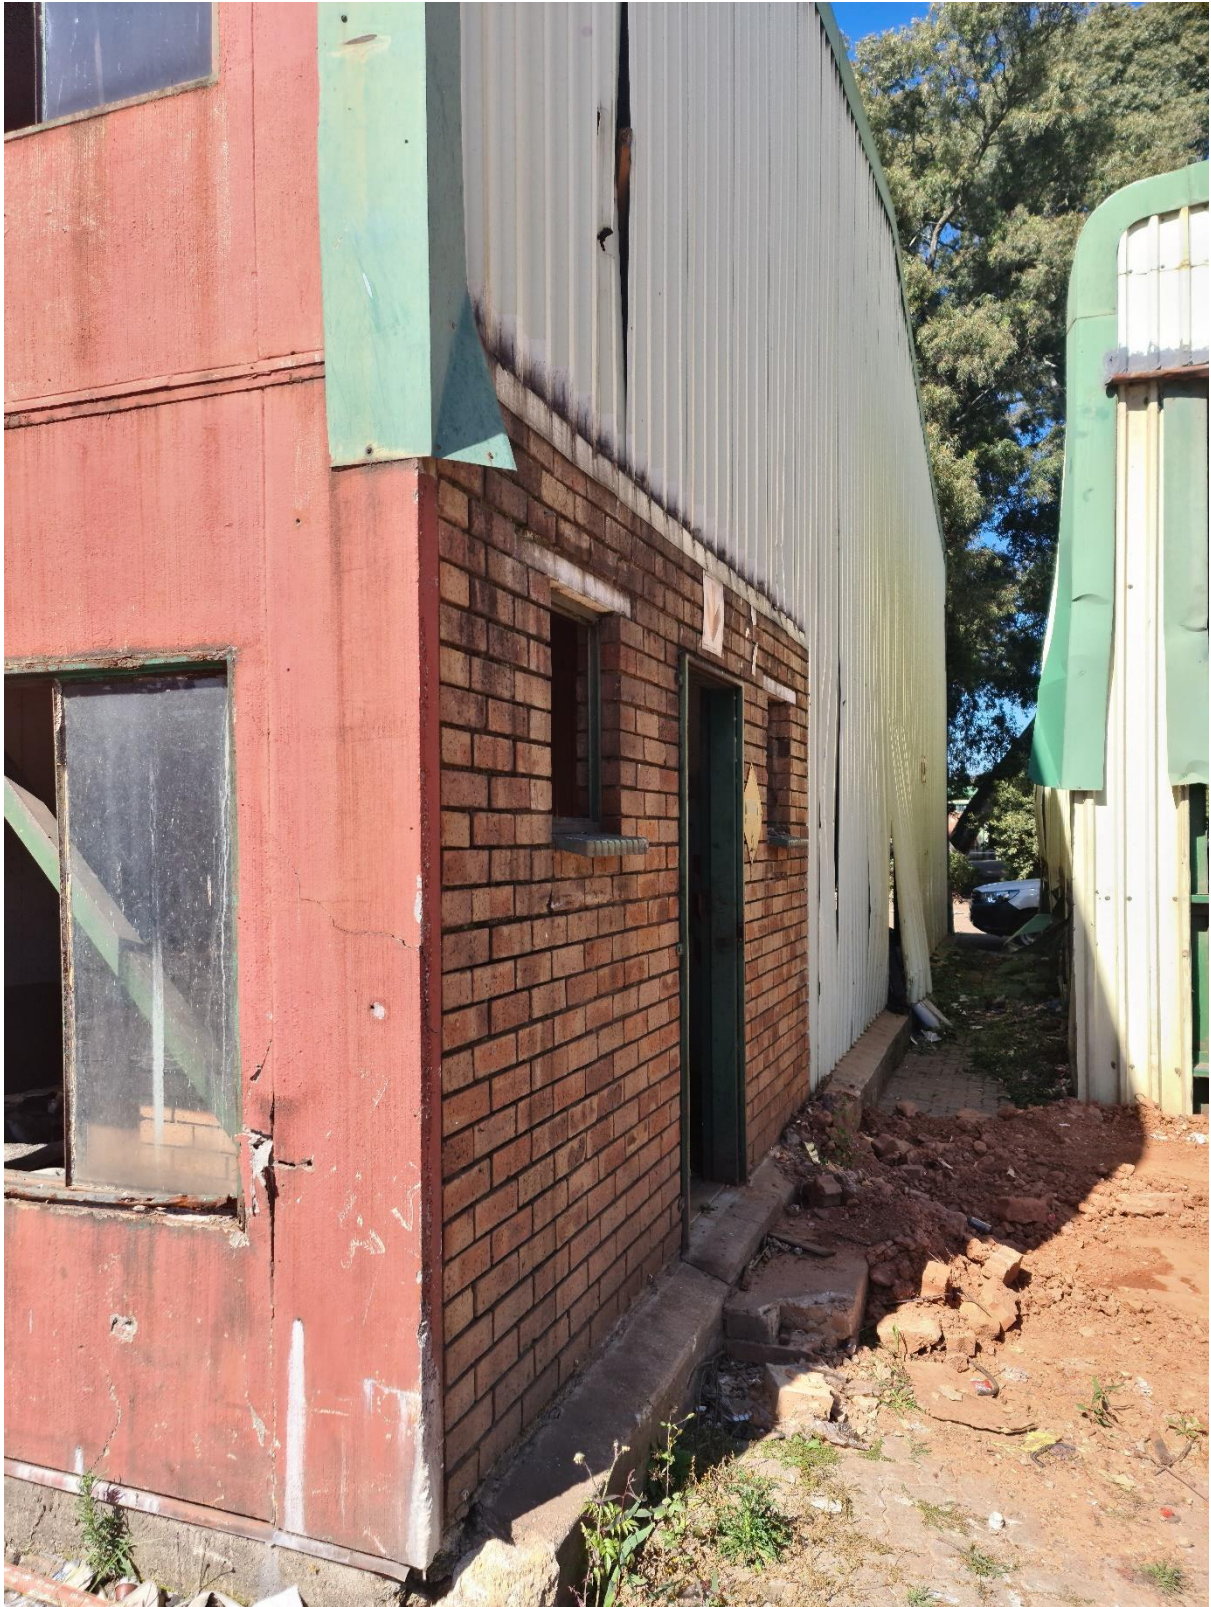
*Figure 9: The western corner of the building showing some of the face brick wall that needs to be demolished. The red concrete wall also needs to be demolished.*

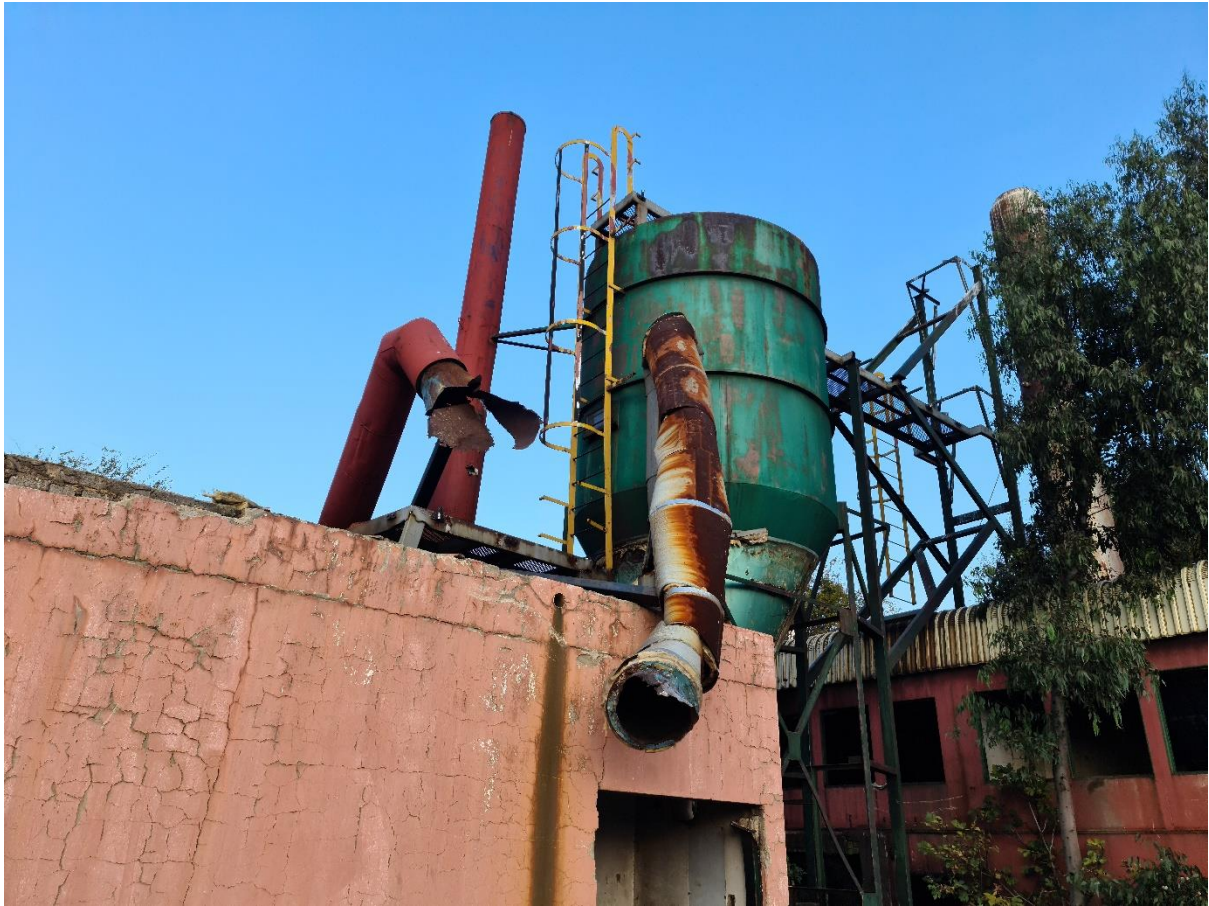
*Figure 10: Another view of the chimney and steel flue gas treatment structure and vessels that needs to be removed. The loose standing pink coloured brick building needs to remain in tact.*
