LEBOMBO PORT OF ENTRY: SITE CLEARANCE AND DEVELOPMENT OF STRUCTURAL PLAN

STATUS QUO REPORT

This project entails all planning work for the Lebombo Land Port of Entry Area Site Clearance. The project is initiated by the client of the National Department of Public Works which is the Border Management Authority (BMA).

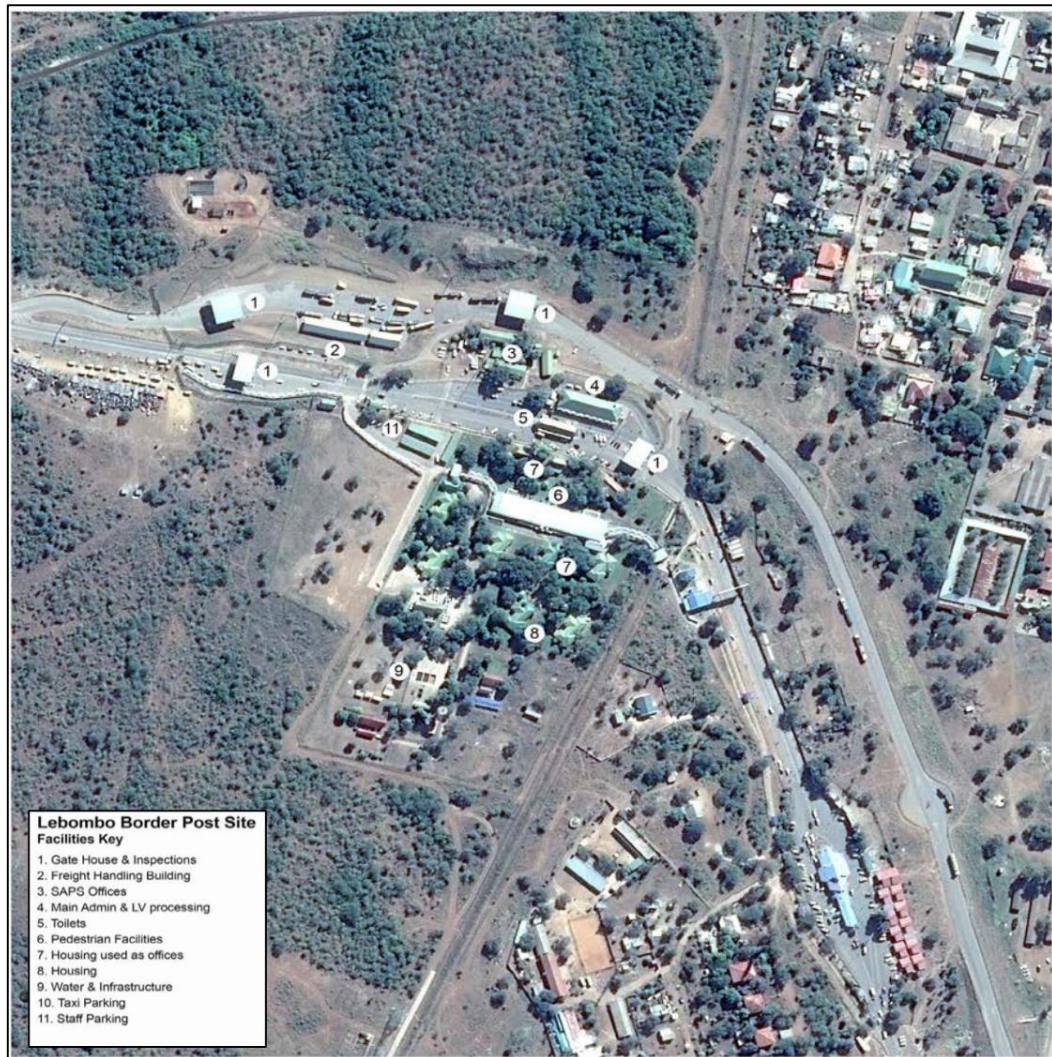
Figure 3-6: Land Use

- Agricultural
- Businesses
- Road/Transport
- Border Post Staff Residences
- Water Treatment
- Border Post South African Side

The land use map is indicated in **Figure 3-6** below.

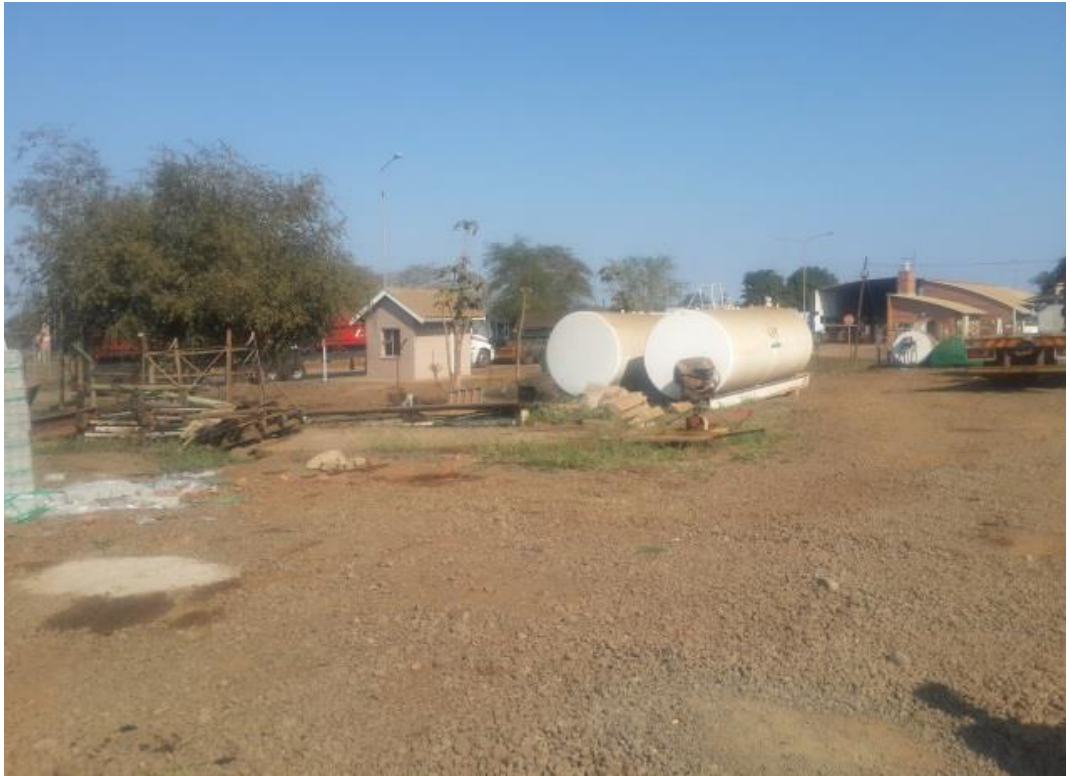
Figure 6-3: Diesel tank

Two above ground diesel tanks are located at the WWTW and at the backup generator. The capacity of each storage tank is 2 000 litres. No safety signs or fire prevention facilities were displayed at the diesel storage tank.

Safety signs and fire prevention facilities should be available at all diesel storage facilities. A risk assessment should be undertaken in consultation with the municipal fire brigade to determine the type and amount of facilities that will be required. Emergency numbers for local authorities (fire department, police, and ambulance) should be placed in a prominent area. Further reference should be made to the controlling regulations covering above-storage tanks for petroleum products as part of the National Building Regulations are incorporated in SANS 10131: Above-ground storage tanks for petroleum products.

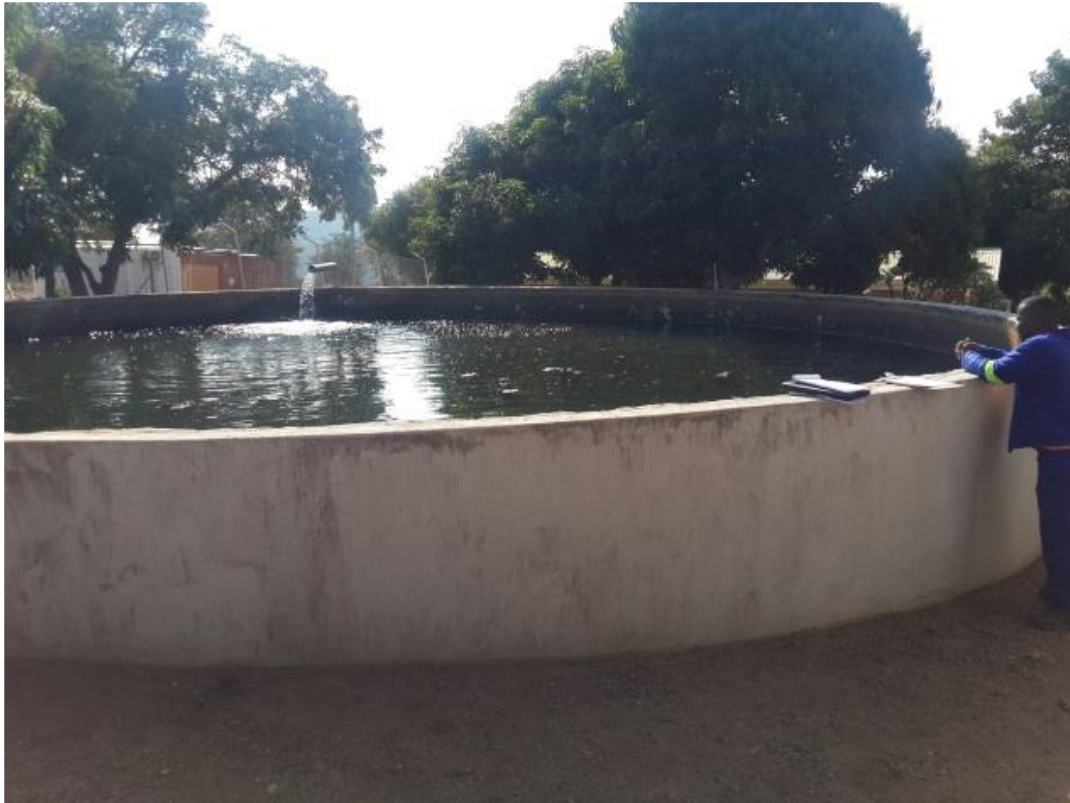
Figure 7-1: Lebombo WWTW

The port of entry has its own private WWTW within their premises. A schematic layout of the WWTW is shown below as taken from the site's maintenance room.

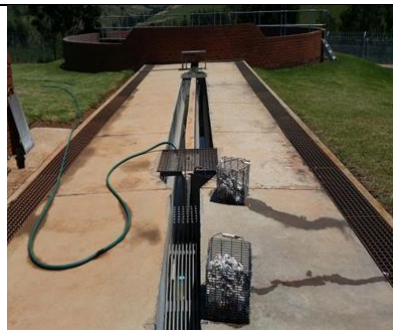
Figure 7-2: WWTW Inlet headworks

During the site visit, only a few minor concerns with regard to the operation of the plant were identified. It was noted that the WWTW is not functioning as it was designed to operate. A few of the concerns are mentioned below:

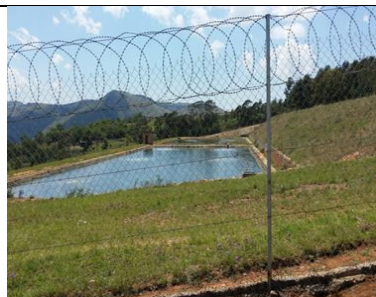
Figure 7-4: WWTW maturation ponds

The perimeter fence around the maturation ponds and reed bed has reached its design life span and animals around the area have access to the ponds.

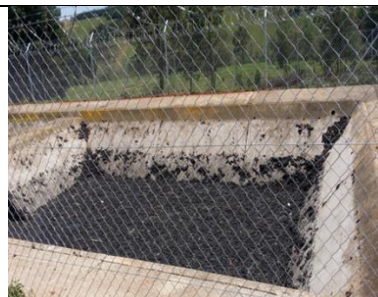
Figure 7-5: WWTW aerobic tank used as a drying bed

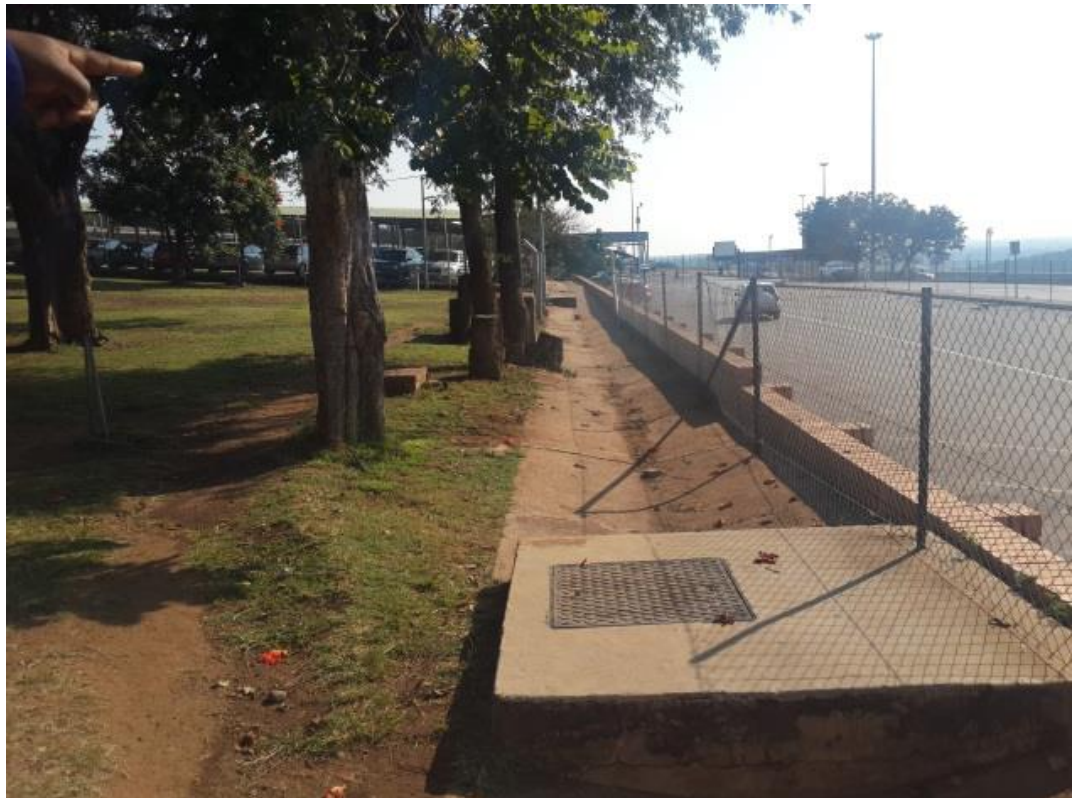
Figure 7-6: Proof of storm water management

The storm water from the site is collected on the site through a network of concrete lined drainage channels and underground pipes. The storm-water drains towards the north of the site into Crocodile River.

The images indicate the condition of the storm-water network.

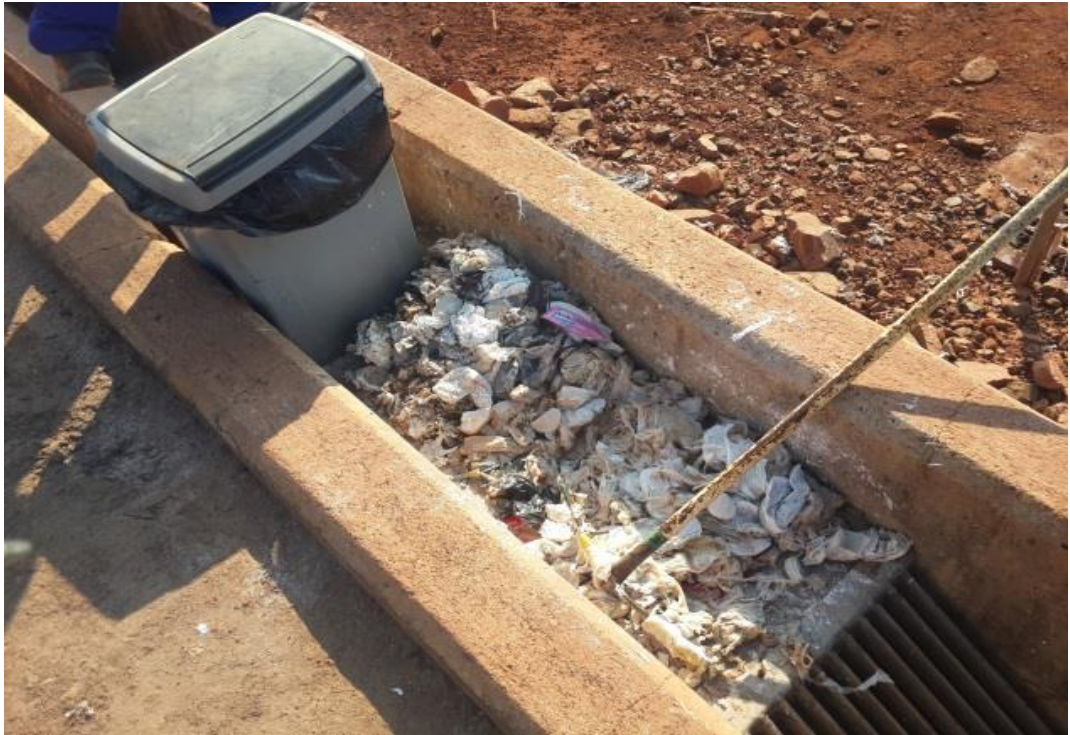
Figure 7-7: Poor housekeeping within the proposed development

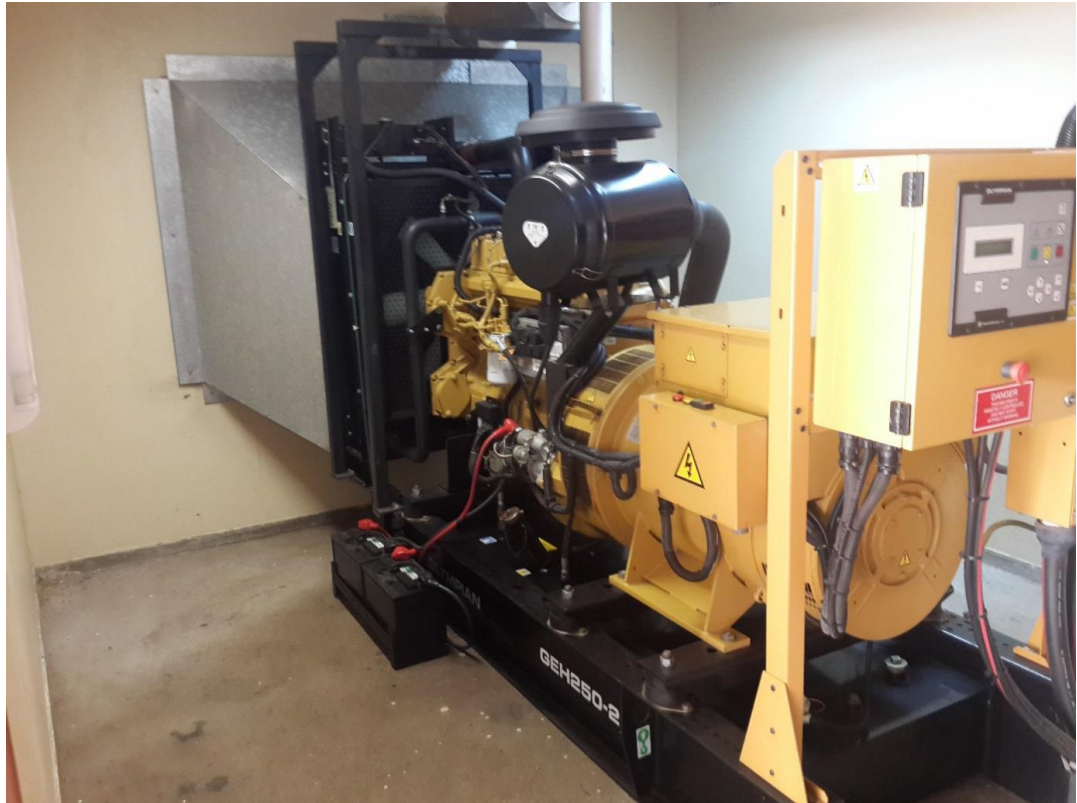
Figure 8-1: Diesel generator

The generator room is to the south of the public parking area, behind the light vehicle inspection area (inbound) and contains a Barlow world (CAT) 280 kVA generator. It is currently unknown which loads are fed from this generator.

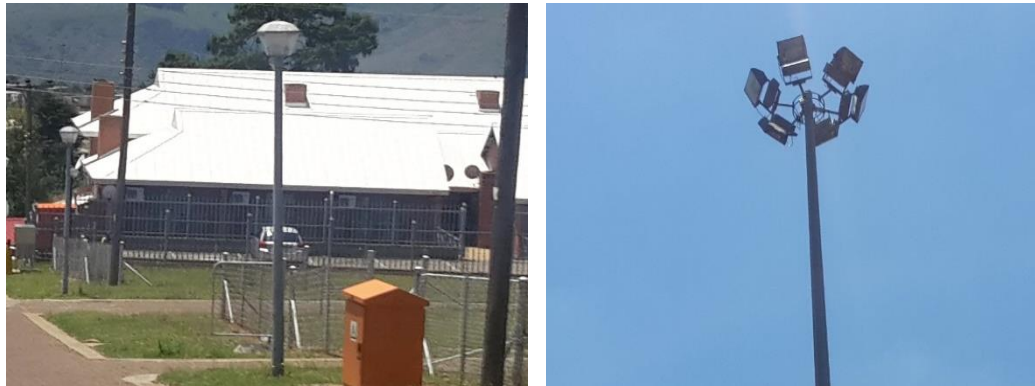
Figure 8-2: Post-top lights and high-mast lights

The lighting on site is achieved by pole mounted street lights and high-mast area lights for the border post, and Post top light fittings for the residential area.
