BLOCK E: ADMIN BLOCK
SCALE - 1:100

**CONDITION ASSESSMENT
KGAUHELO PRIMARY SCHOOL**

EXISTING BLOCKS:
REFURBISHMENT SCOPE OF WORKS

Drawing Number: 082-KPS-103

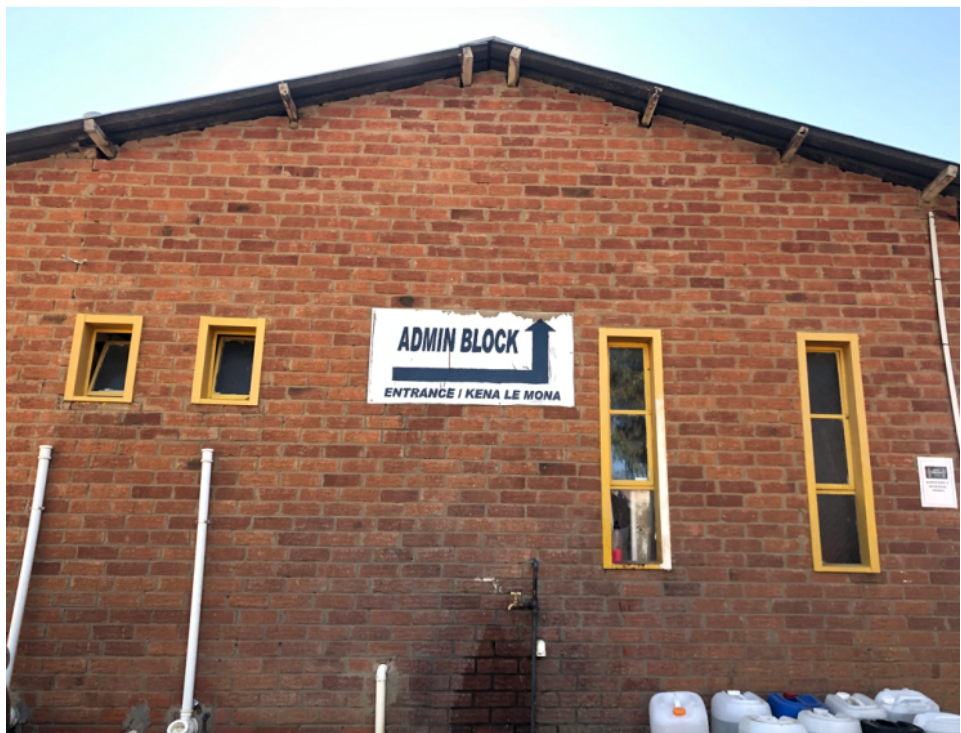
ENTIRE ROOF IS DAMAGED. REMOVE AND REPLACE SHEETING AND TRUSSES:

Remove and replace existing signage with 1300x 700(h) new acrylic signage, fixed to existing wall.

- Brickwork at top of perimeter walls appear loose – replace bricks with similar and ensure best practice / make good.
- Replace 1 x broken window glazing. (SEE BELOW SPECIFICATION.)

- Informal timber wall surrounding sick room in admin office in a poor condition, this wall to be formalised with a proper partition wall which is to be skimmed and painted, including a new door with ironmongery. (SEE BELOW SPECIFICATION.)

- Timber doors in a poor condition. Rub down, prime and re-varnish. Install new door ironmongery including handles. (REFER TO TYPICAL DETAIL.)
- Sanware & plumbing in a poor condition – remove and replace all. Plumbing as per wet services engineer's details. (SEE SPECIFICATION BELOW)

Refer to structural engineers detail for truss and roof sheeting replacement. REFER TO TYPICAL DETAILS FOR ROOF SHEET SPECIFICATION.

Remove existing external timber doors and replace with new as per door schedule below.

Remove existing windows and replace with new as per window schedule below.

- Entire roof is damaged. Remove sheeting & trusses and replace with new including gutters, fascia & barge boards and downpipes, to specialist's detail.

- Remove all ceilings and cornices and replace with new to match, including all skimming and painting. Light fittings and electrical cables to be reused where possible, where not possible, to be replaced if necessary. (REFER TO TYPICAL DETAILS.)

- Corrosion / deterioration to door & window frames, burglar bars and security gates, sand off as much rust, apply rust inhibiting primer to restore the steel, prime and paint. Where it cannot be restored, to be replaced with new to match existing. (REFER TO TYPICAL DETAILS.)

- Replace admin block signage on side elevation with new to match. (SEE BELOW SPECIFICATION.)
- Leaking external water tap – rectify leaks.
- Plaster and paint all unplastered brickwork once structural damage rectification is complete. (REFER TO TYPICAL DETAILS.)

- Remove and install new internal floor finishes & skirting to entire block. (REFER TO TYPICAL VINYL DETAIL.REFER TO TYPICAL TILE DETAIL FOR ABLUTIONS)

Remove broken glazing from 1 x windows T1 (Ablutions) and replace with new 4mm obscure window glazing to match existing. Make good all existing surfaces.

remove existing informal sickroom drywall and replace with new partition wall with new door. Make good existing surfaces. Refer to structural engineers detail for new partition wall. see below specification for new door.
