Project: **CONDITION ASSESSMENT
DR. BOHMER SECONDARY SCHOOL**

Drawing description: **EXISTING BLOCKS:
REFURBISHMENT SCOPE OF WORKS :
A,B & J**

Drawing Number: **082-DBRS-102**

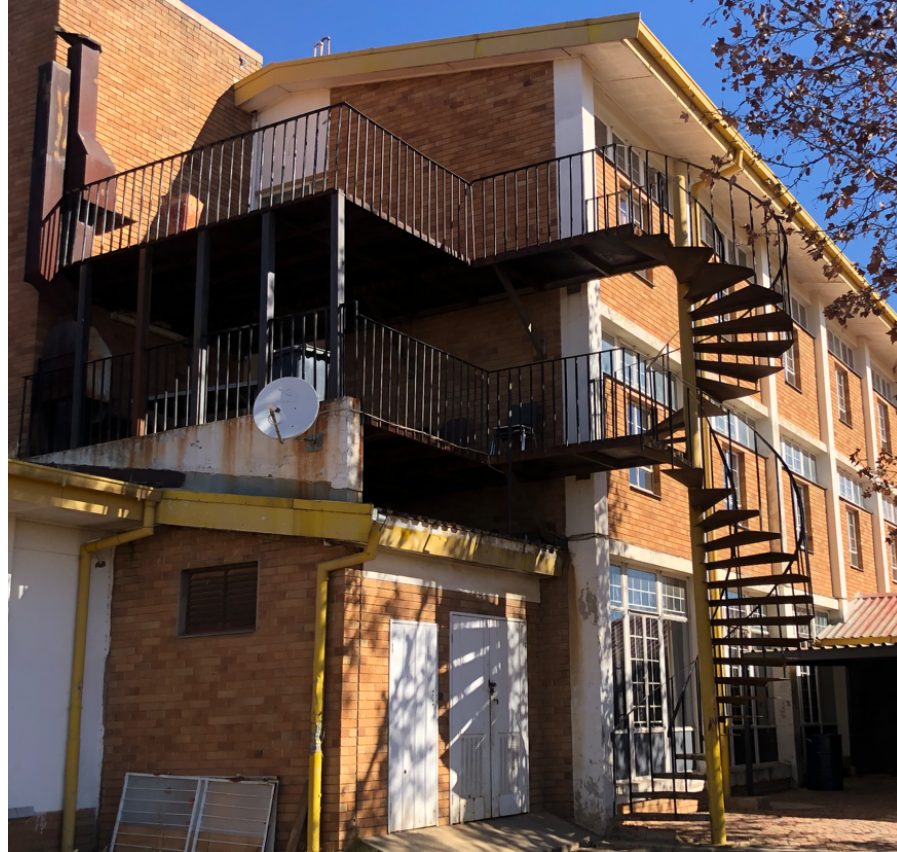
DAMAGED STEEL BALUSTRADES,
LANDINGS AND STAIRCASE

1. Gutters and downpipes are damaged, install new to match existing on site or as per later detail.(REFER TO TYPICAL DETAILS)
2. External steel staircases, balustrades & landing are corroded - remove and replace with new SANS 10400 compliant fire escape staircases with overhead coverings. Refer to Structural Engineer's report.(REFER TO DETAIL BELOW)

Remove and replace with new in compliance with sans 10400 part S, T & M - all to structural engineers detail & design

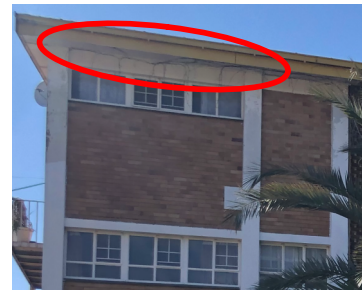
DETERIORATION TO ROOF OVERHANGS
SOFFITS

19. External ceiling to u/s of roof overhang on facades in a poor condition - recommend removing and replacing with new to match.(REFER TO DETAIL BELOW)

Carefully remove existing damaged ceilings boards and cornices. Install new gypsum ceiling boards, 6.4mm thick, with PVC cover strips and covered cornices, to be skimmed until smooth and even. Paint with fully washable matt white PVA.

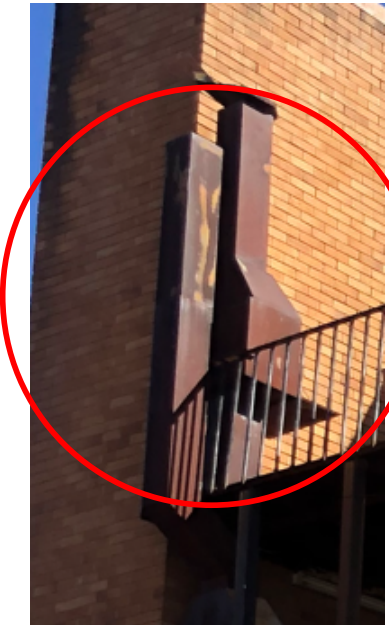
CORROSION TO EXISTING CHIMNEY

3. Chimney at spiral staircase is corroded - remove and replace with new.(REFER TO DETAIL BELOW)
4. Wall at spiral staircase is severely stained with rust marks - recommend rubbing down, priming and repainting.(REFER TO TYPICAL WALL PAINT DETAIL)

Carefully remove and replace corroded chimney with new typical galvanised mild steel chimney and flute to match existing size and connections.

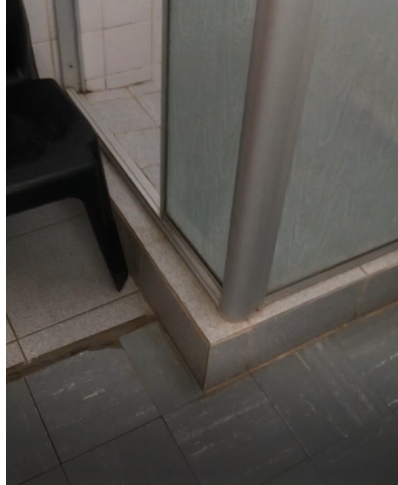
REPLACEMENT OF FLOOR TILES
TO ALL SHOWERS

9. Replace all floor tiles to all showers.(REFER TO DETAIL BELOW)
10. Peeling & flaking paint to internal walls in ablutions - rub down, prime & repaint. (REFER TO TYPICAL DETAILS)

Carefully remove existing shower mosaic tiles and replace with new full body standard white 100x100mm non-slip mosaic tiles including grouting.

Safely remove existing floor tiling in showers and replace with new non-glazed, non-slip 500mm x 500mm x 13mm thick clay tiles, Type B1, laid on high polymer cement based adhesives. Specification & colour to be confirmed.

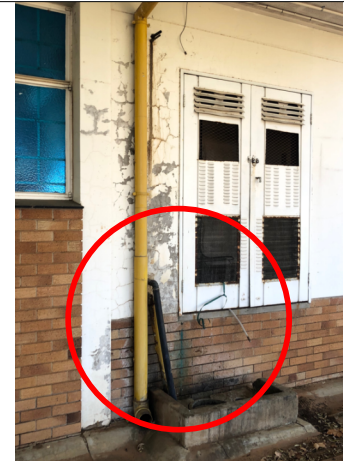
WATER DAMAGE TO EXTERNAL
WALLS BY DUCT DOOR

5. Water damage & damp to external walls at duct door. Locate source of leak / damp and repair / replace. Waterproof and repaint walls (REFER TO DETAIL BELOW)

Investigate ,find and fix/repair any leaks. Install new waterproofing or Bricksel as required. Rub down , prime and repaint affected areas

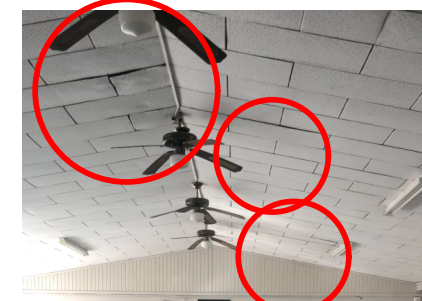
WATER DAMAGE TO DINING AREA CEILING

6. Corrosion and deterioration to external duct doors. Remove and replace with new (REFER TO DETAIL BELOW)
 7. No access into Block B for assessment.
- From looking through window: ceiling tiles in dining hall in a poor condition - appears to be water damaged - recommend removing and replacing with new to match. (REFER TO DETAIL BELOW)

Investigate ,find and fix/repair any leaks from roof above.

Carefully remove existing damaged ceilings tiles . Install new pelican or equally approved perforated ceiling tiles to match existing, including priming and painting.

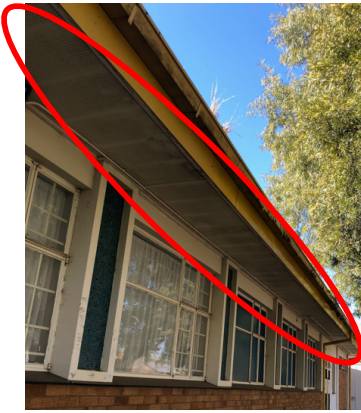
DETERIORATION TO ROOF OVERHANG
SOFFITS

3. External paintwork in a poor condition, rub down walls, prime and repaint.(REFER TO TYPICAL DETAILS)
 4. External ceiling to u/s of roof overhang on facades in a poor condition - recommend removing and replacing with new to match.(REFER TO DETAIL BELOW)

Carefully remove existing damaged ceilings boards and cornices. Install new gypsum ceiling boards, 6.4mm thick, with PVC cover strips and covered cornices, to be skimmed until smooth and even. Paint with fully washable matt white PVA.
