Project: **CONDITION ASSESSMENT RESEAMOHETSE PRIMARY SCHOOL**

Drawing description: **EXISTING BLOCKS: REFURBISHMENT SCOPE OF WORKS : H, I, & J**

Drawing Number: 082-RSPS-103

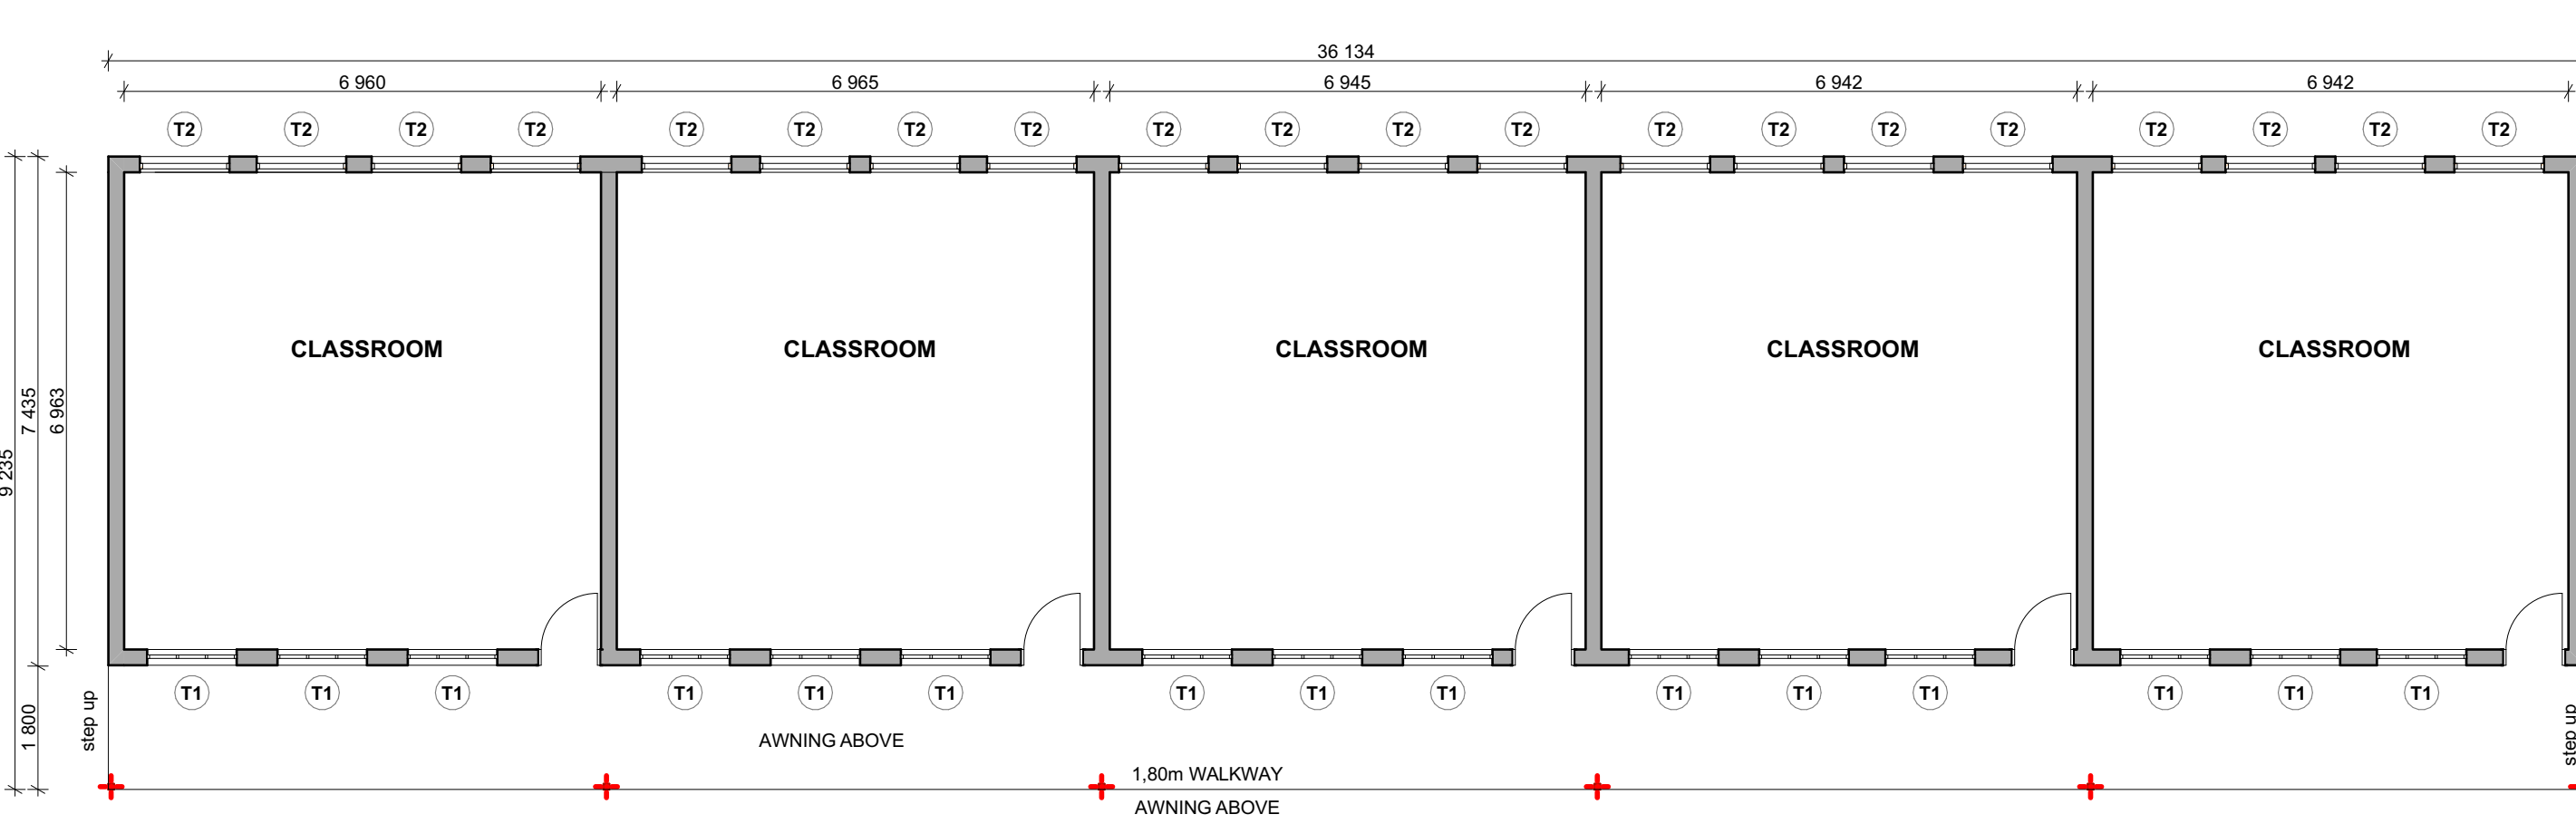
BLOCK H CLASSROOMS

INSTALLATION OF NEW VINYL FILM ON CLASSROOM WINDOWS:

Carefully remove existing paint from window glazing. Install new obscure vinyl film to all Type T2 windows lower panes to reduce glare. Sample to be provided to architect for approval.

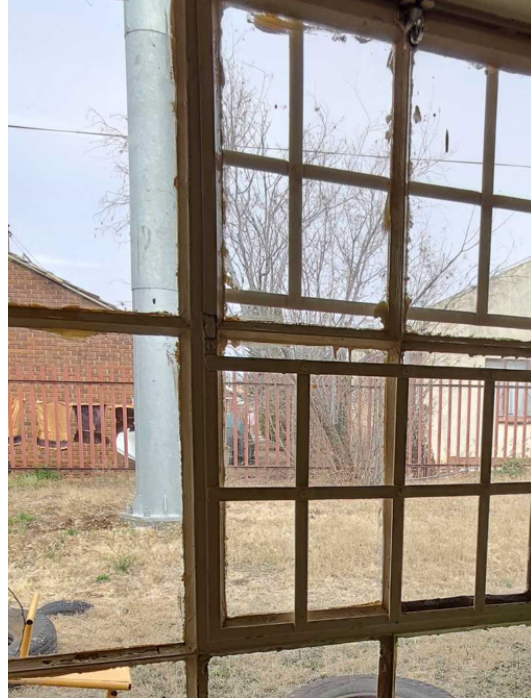
DETERIORATING WINDOW PUTTY

Carefully remove existing paint from window glazing, putty from frames and replace with new putty or silicone beading.

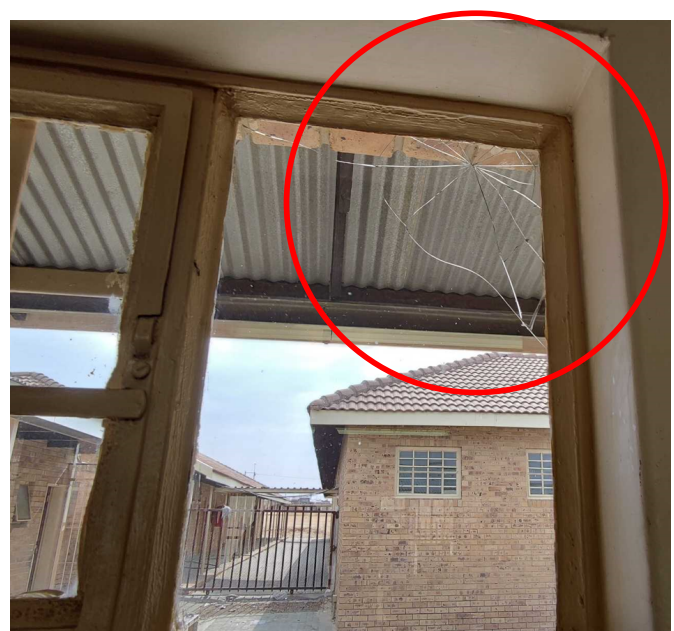
REPLACEMENT OF DAMAGED WINDOW GLAZING

Remove & replace 3x damaged T1 window panes with new to match existing.

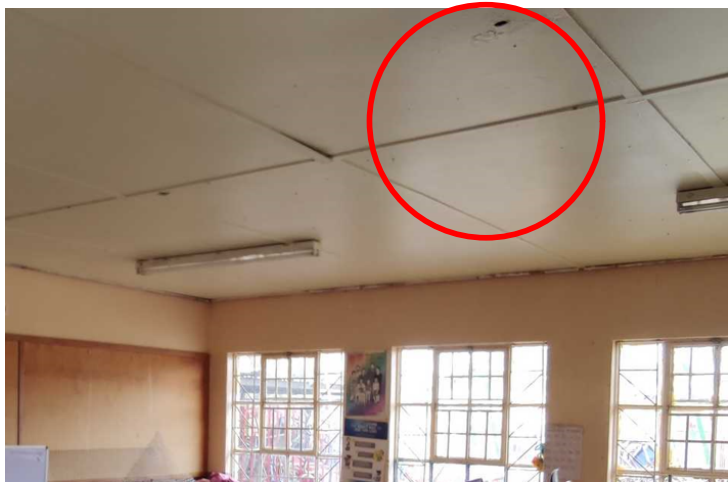
DEFLECTING/DAMAGED CEILING BOARDS

Carefully remove existing damaged ceiling boards and cornices and replace ceiling boards with new gypsum ceiling boards, 6.4mm thick, with PVC cover strips and coved cornices, to be skimmed until smooth and even. Paint with fully washable matt white PVA.

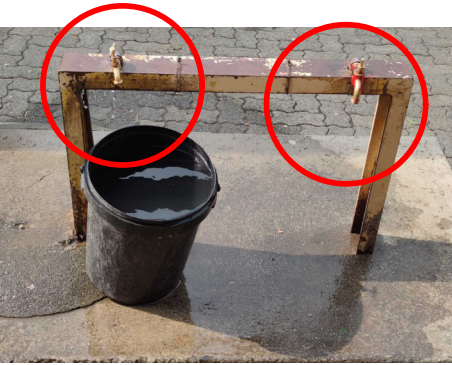
LEAKS NOTED : INVESTIGATE LEAKS AT OUTDOOR DRINKING WATER TAP

Leaks noted: investigate all plumbing and sanware equipment. Isolate/repair all leaks. Where a leak cannot be repaired, replace plumbing/sanware with new per sanware schedule below.

- TAP: INSTALL 2X NEW TAPS**
Plumline 10-year warranty. Moderna Chrome hose bib tap (Code: 038736)
• Mixer: Moderna Chrome hose bib tap (Code: 038736)
• Material: DZR (dezincification resistant brass) Brass
• Finish: Chrome

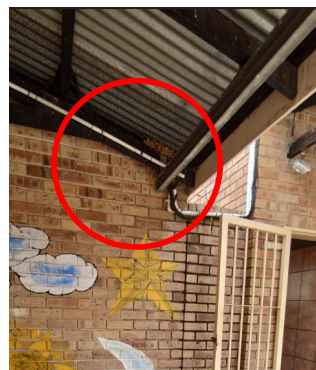
REMOVAL OF BIRDS NESTS FROM WALKWAY

Carefully remove birds nests along walkways and safely relocate .

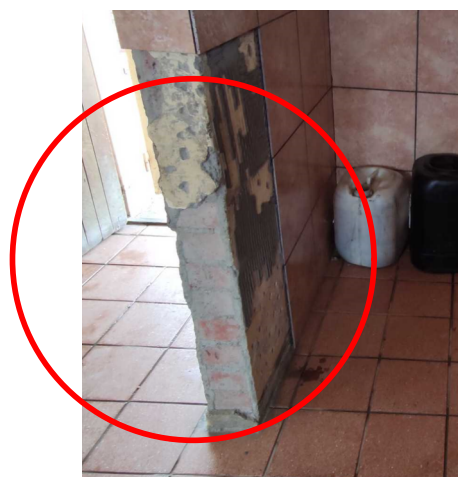
MISSING FLOOR/WALL TILES

Replace missing floor/wall tiles with new to match existing.

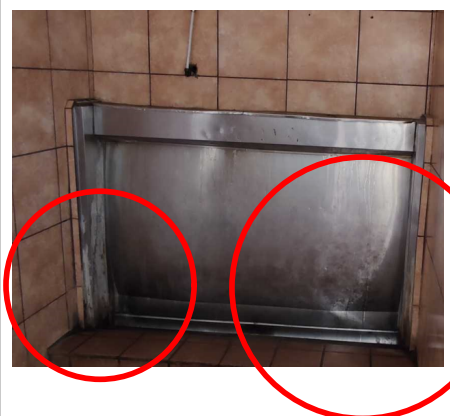
REPLACE DAMAGED STEEL URINAL AND TILES AROUND

Remove and install new: Kwikot Model KCB1021830 Grade 304 (18/10) Stainless Steel curved back urinal (Code: KCB102), size 1830mm long with built in flushing tank, 12mm adjustable drip cock and centre outlet with back sprayed with vermin proof bitumastic sound deadening fixed to wall with anchor bolts, all in accordance with manufacturer's recommendations.

Remove and replace damaged floor tiles with new to match existing.

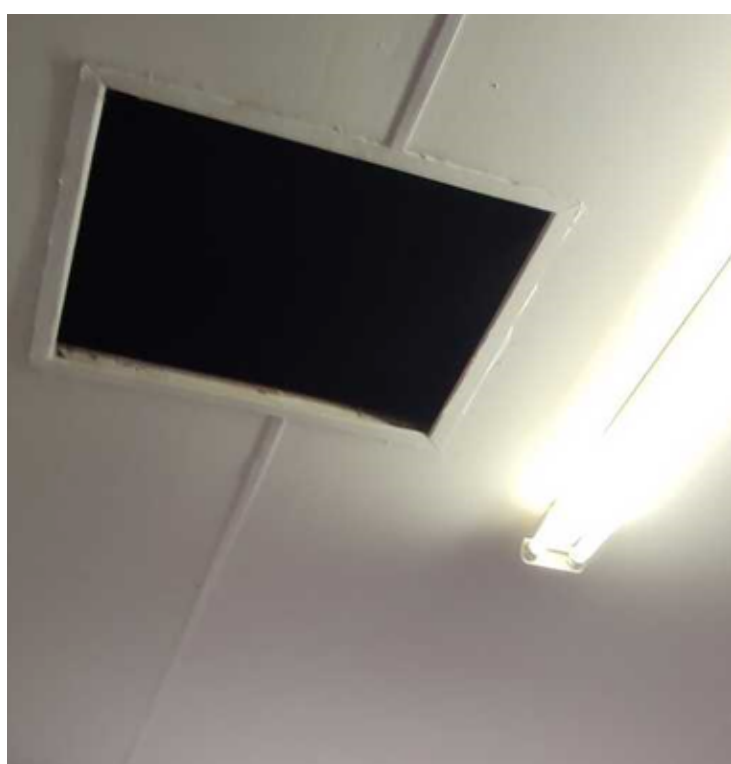
REPLACE 1X TRAP DOOR

Remove and replace damaged Trap Door with new to match existing including skimming and painting.

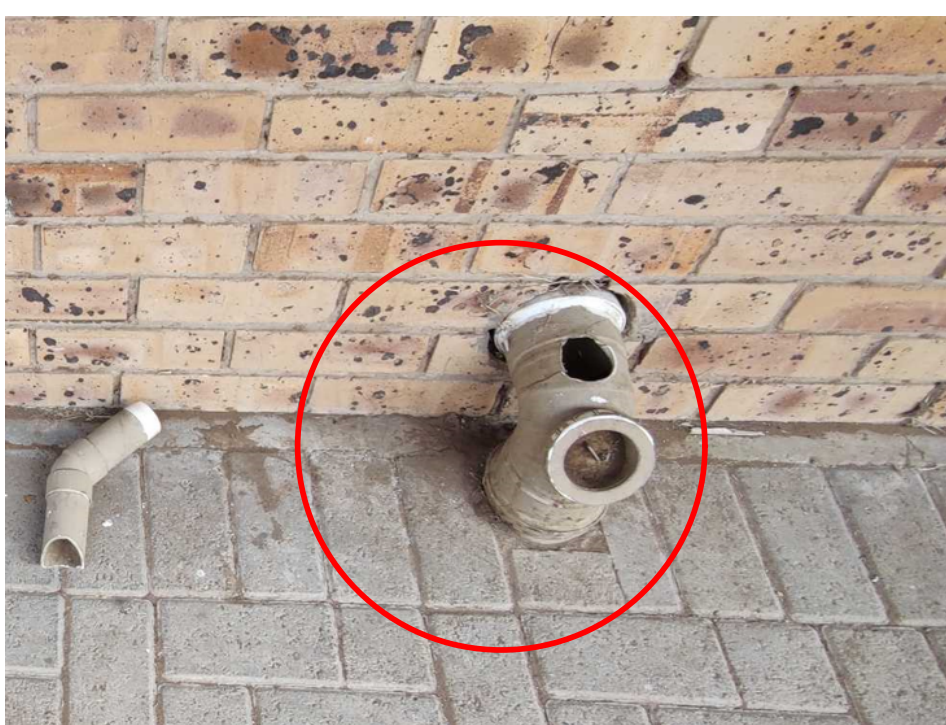
DAMAGED WASTE PIPE

Replace damaged pipe with new upvc waste pipe in compliance with sams 10400 part p

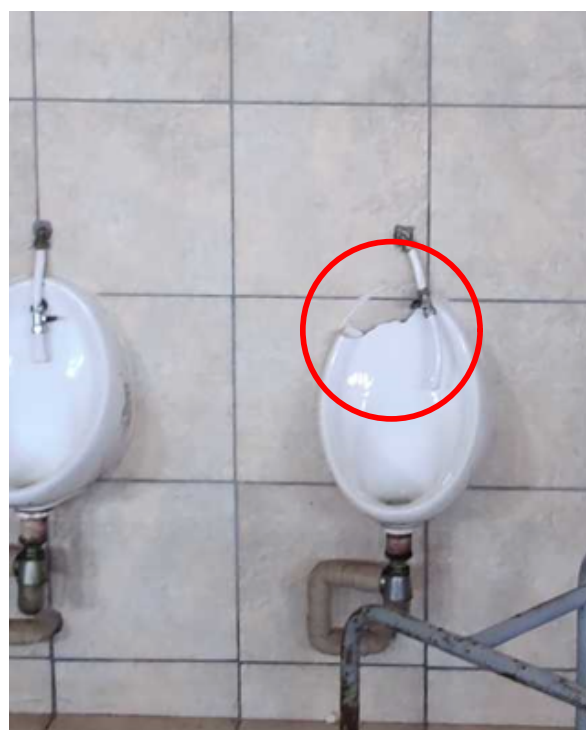
DAMAGED URINAL

Replace damaged 1X damaged urinal with new Lecico Atlas 40cm urinal colour White, with back inlet and waste outlet including wall mounting brackets and connected to water supply, sealed with silicone sealant where urinal meets wall.
•Material: Vitreous China,
• Urinal code: ATLBOXURi0B40BE

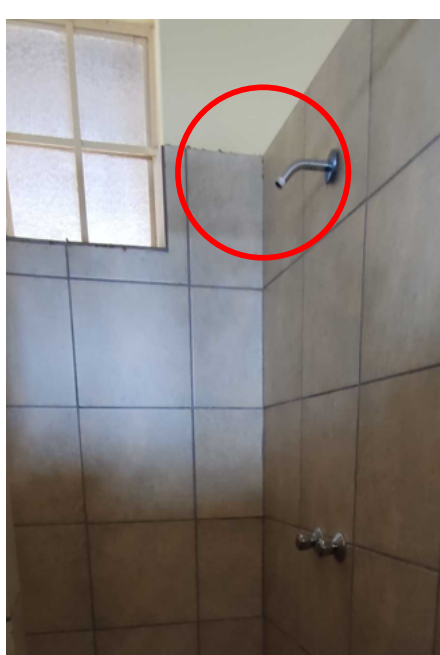
MISSING SHOWERHEAD

Replace 1x missing showerhead with new to match existing showerheads.

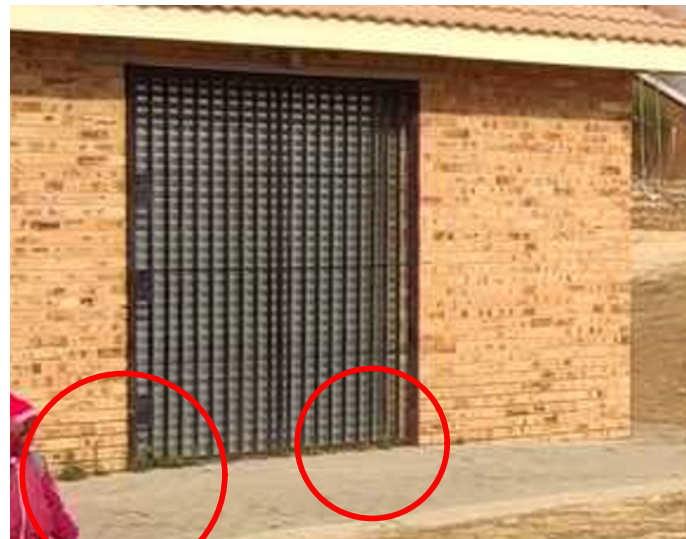
REMOVAL OF VEGETATION AROUND BUILDING FACADES

Remove all vegetation growing along building facades and treat spots accordingly with relevant pesticides.
