- BLOCK C - CLASSROOMS: Scope of Work**

## CONDITION ASSESSMENT HTS WELKOM SCHOOL

**EXISTING BUILDINGS  
REFURBISHMENT SCOPE OF WORKS**

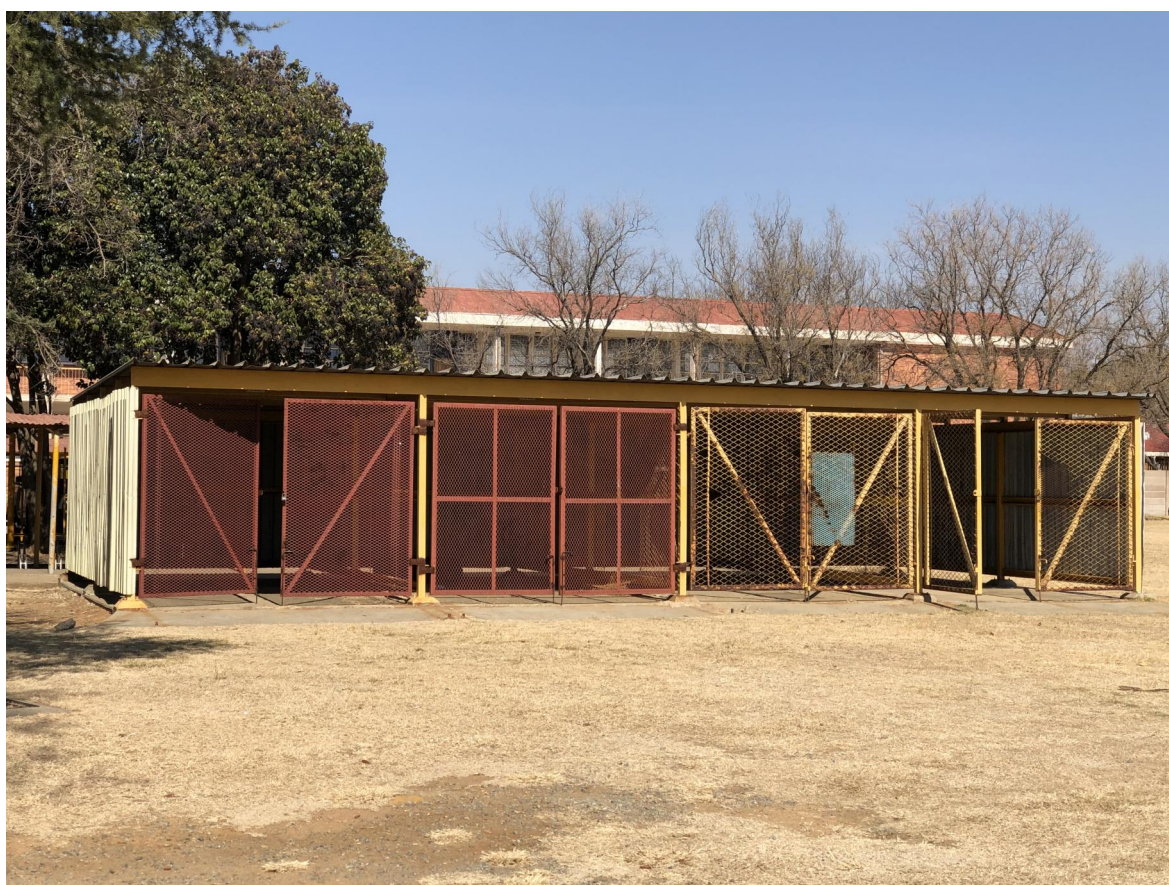
- BLOCK T - CARPORTS: Scope of Works**

1. 2 x double entrance gates are corroded and damaged, remove and replace with new to match.
2. Steel support member and wall cladding are corroded - refer to Engineer's report for repair work.
