**TENDER NUMBER: RFP082/2026**

**APPOINTMENT OF A CONTRACTOR FOR DRILLING AND GROUTING WORKS FOR THE TZANEEN DAM PROJECT**

**CLARIFICATION QUESTIONS: RFP082/2026**

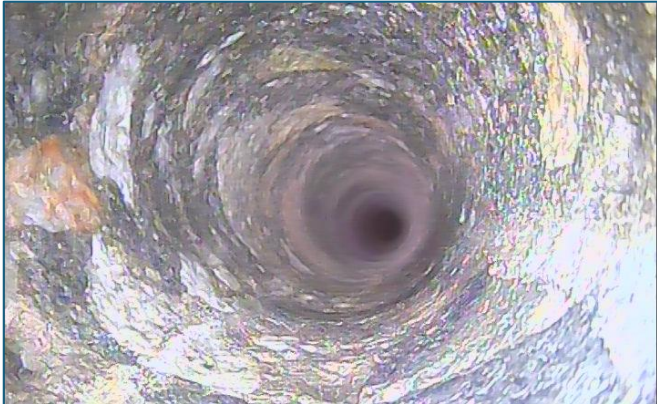
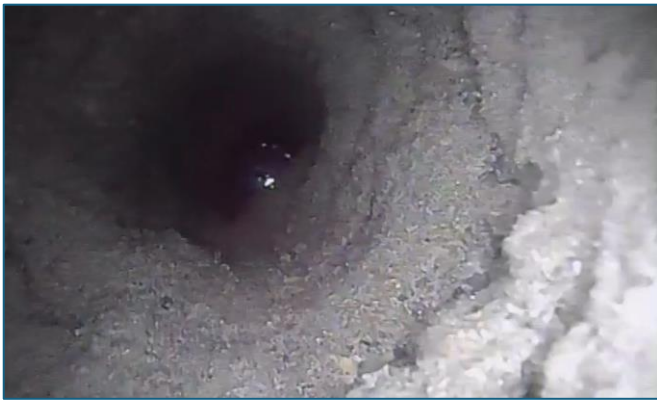
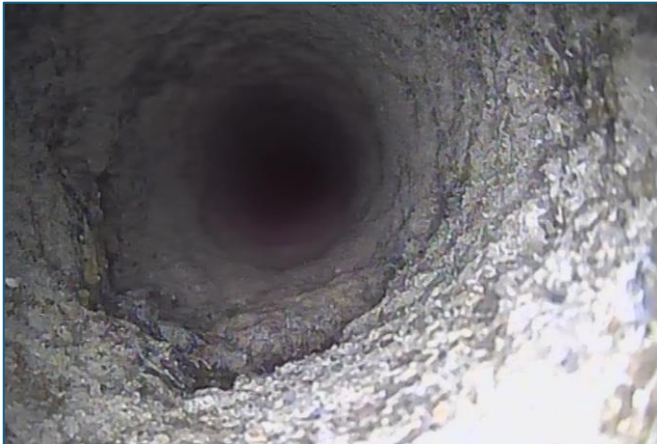
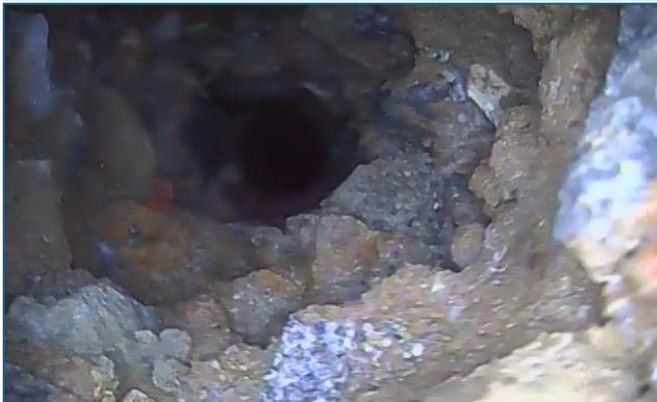
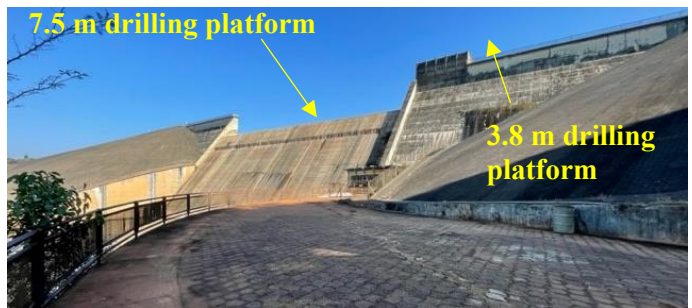
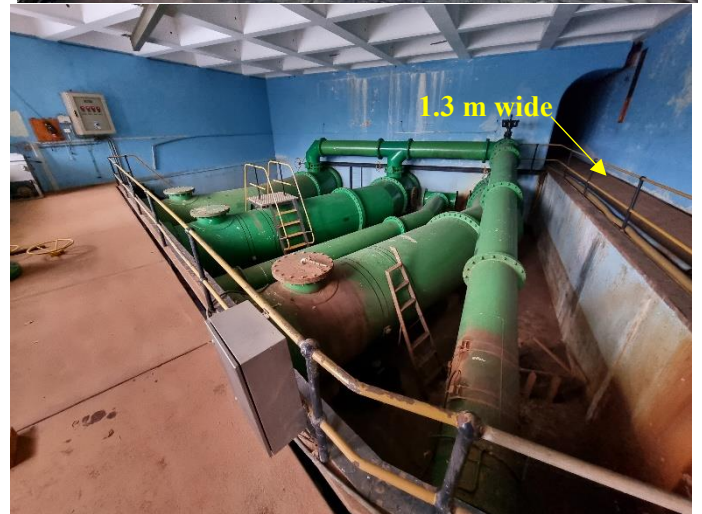
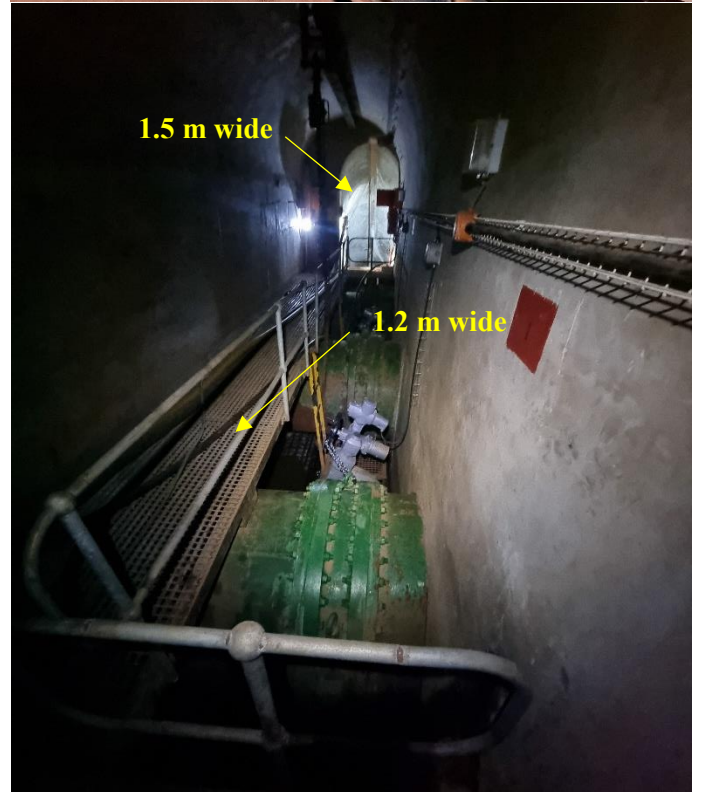
| # | QUESTION | RESPONSE |
|---|---|---|
| 1 | <p>a) Please confirm the size of drainage holes already drilled?</p> <p>b) Are these holes currently dry or if not which are leaking and how big is the leak?</p> <p>c) Can you confirm if cavities were intercepted in the currently drilled grout curtain holes? If yes confirm size of cavity.</p> <p>d) Can you please give the dimensions of the gallery.</p> <p>e) Is there ventilation and lighting in the gallery.</p> <p>f) Please show a photo of the entrance into the gallery is <u>access a walk in</u> entrance or is crane required for drilling equipment?</p> <p>g) Can water from the dam be used for Drilling and Grouting operations.</p> | <p>a) The existing drainage holes are 75 mm in diameter.</p> <p>b) The drainage holes are partially flowing. Seepage has been observed in approximately 4 holes with a strong flow of water into the gallery. Water is pumped from the gallery.</p> <p>c) Yes. Cavities were intercepted in the boreholes. Refer to the attached historical data for holes G1 - G11 for information on the cavities.</p> <p>d) The gallery has approximate internal dimensions of 1.5 m × 2.4 m.</p> <p>SECTION 01-01<br/>DETAIL OF GALLERY<br/>SCALE 1:20</p> <p>e) There is ventilation available and there is no lighting in the Gallery.</p> <p>f) The gallery entrance is walk-in. Crane is not required for the mobilization of drilling equipment inside the gallery. A photograph of the entrance is attached below.</p> <p>g) Water for site use is extracted from the designated water extraction point located downstream of the dam wall at the stream low-level bridge (400 m distance from dam wall)</p> |

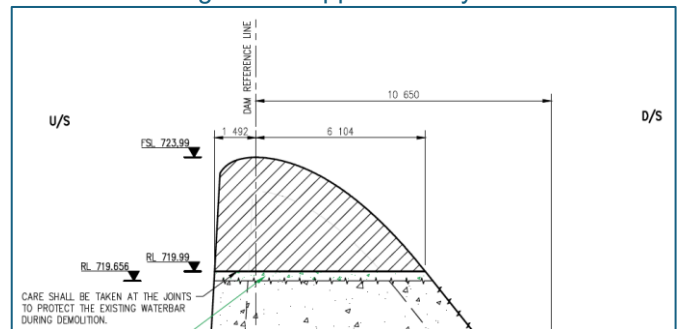
- h) Bidders are required to submit their responses through the online submission link, which will be issued upon request. Email submissions will **not** be considered.
- i) Grouting drawings are included as Drawing 9368.331 R2. It should be noted that the scope of works are not for curtain grouting, rather seepage grouting on the dam spillway and tongue wall.
- j) Historical grouting records are available. The recorded permeability values, grout takes and grout mix consistencies are provided as an annexure.
- k) Attached drawing 9368-304 R2 indicating the available drilling area on top of the demolished spillway. The available working area is approximately 7.5 m.

- l) The Contract requires the Contractor to develop and submit a detailed drilling and grouting methodology for the Engineer's review prior to commencing the Works.
- m) Grouting can be carried out through the existing drainage holes that have already been drilled from the dam crest to the gallery roof, or new grouting holes can be drilled. Upon completion of grouting in the drainage holes, these drainage holes require to be reopened to restore their drainage function.
