Project: **CONDITION ASSESSMENT
LIKUBU PRIMARY SCHOOL**

Drawing description: **EXISTING BLOCKS:
REFURBISHMENT SCOPE OF WORKS**

Drawing Number: 082-LPS-101	Revision: C
-----------------------------	-------------

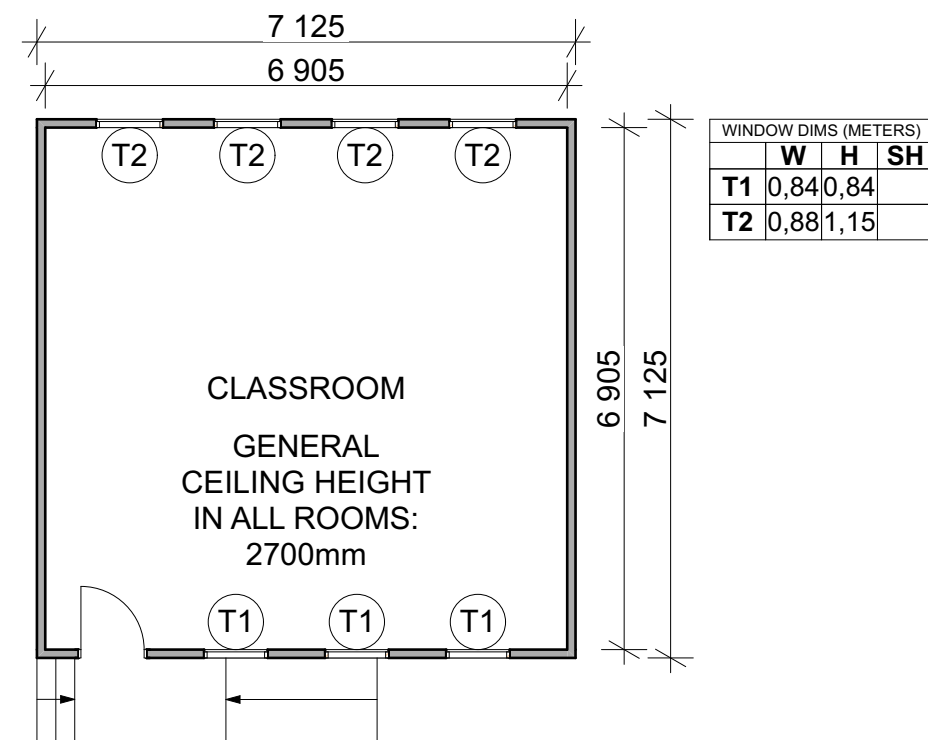
**BLOCK G: EXISTING
CLASSROOM GROUND
FLOOR PLAN 1:100
AREAS: BUILDING: 51m²**

1. No barge boards installed, install new to match existing on site or as per later detail.
2. Gutters are corroding and downpipes are missing, remove and install new gutters and downpipe.

3. External paintwork in a poor condition, rub down walls, prime and repaint.
4. Vandalism to be cleaned off external brickwork.
5. Window frames paintwork is deteriorating, rub down, prime and repaint.

6. Damaged external light fittings to be removed and replaced with new as per Electrical Engineer's specifications.
7. Existing fascia boards to be repainted.

8. Ceiling in walkway to be removed and replaced with new, including skimming and painting.
9. Timber doors in a poor condition. Rub down and re-varnish.

10. Damaged tiles on walkway to be removed and replaced with new.
11. Missing brickwork on walkway upstand to be replaced with new to match.
12. Internal tiled floor finishes in a poor condition, remove and replace with new, including skirtings.

13. Internal paintwork in a poor condition, rub down walls, prime and repaint.
14. Missing light fittings to be replaced with new.
15. Steel sink WHB in a poor condition - remove and replace with new WHB's.

16. Water damaged concrete plinths below urinals to be repaired and made good. Holes around pipework to be covered or filled in.
17. Damaged wall / brickwork behind urinal tap to be made good.

18. Stored furniture in service passage to be removed and all plumbing to be checked for any damage or leaks.

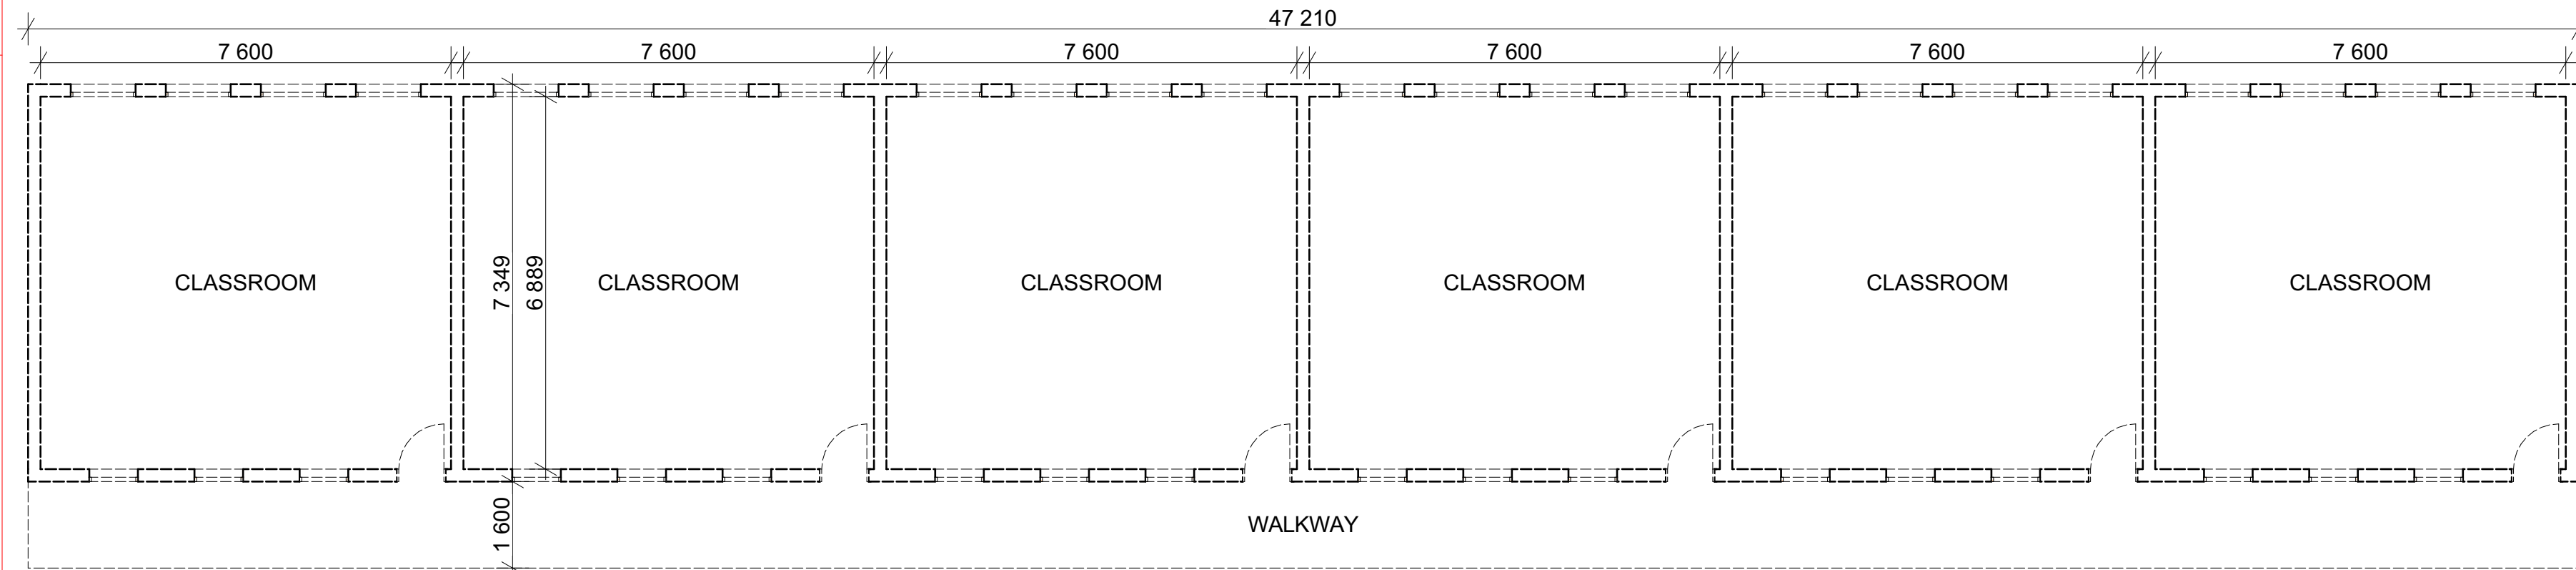
**BLOCK E: TO BE DEMOLISHED
EXISTING CLASSROOM
GROUND FLOOR PLAN
SCALE - 1:100**

1. Gutters and downpipes are damaged, install new to match existing on site or as per later detail. (REFER TO TYPICAL DETAILS).
2. Some barge boards missing, install new to match existing. (REFER TO TYPICAL DETAILS).

3. Corrosion to window frames, sand off as much rust as possible, apply rust inhibiting primer to restore the steel, prime and paint. Where it cannot be restored, to be replaced with new to match existing. (REFER TO TYPICAL DETAILS).

4. Internal paintwork in a poor condition, rub down walls, prime and repaint. (REFER TO TYPICAL DETAILS).
5. Internal tile floor finishes in a poor condition, remove and replace with new, including skirtings. (REFER TO TYPICAL DETAILS).

6. WC's are improperly constructed and in a poor condition. Recommend removing and replacing with new sanware to later detail. (SEE BELOW FOR SPECIFICATION).

7. Missing light fittings to be replaced with new.
8. Internal cubicle doors to be rubbed down, primed and repainted. (REFER TO TYPICAL DETAILS).
9. Damaged plumbing - repair or replace.

10. Stored furniture in service passage to be removed and all plumbing to be checked for any damage or leaks.
11. Any corroded window louvers to be repaired but if repair is not possible, replace with new to match.

12. Water damaged concrete plinth below urinals to be repaired and made good.
13. Service drain at back of toilets to be made good.

REPLACE ALL BATHROOM SANWARE:

NEW BATHROOM SANWARE SPECIFICATIONS:

WC: Leticio Madison close couple suite colour White, seat and cover bolted to bowl with metal washers and rubber gaskets, 100mm outlet with cistern connected to 15mm water supply with foot of bowl sealed to floor with abe Dow Corning acetoxy silicone sealant. Material: Vitreous China, Pan code: MADBOXDFL0SCSBIE.
