CONDITION ASSESSMENT
LIKUBU PRIMARY SCHOOL

EXISTING BLOCKS:
REFURBISHMENT SCOPE OF WORKS

Drawing Number: 082-LPS-102

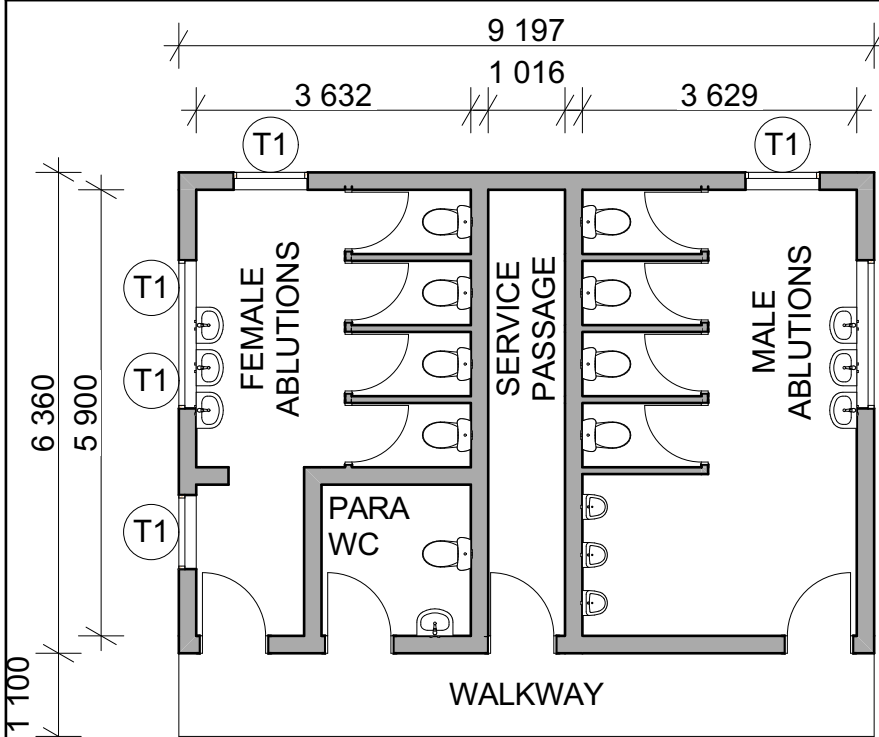
BLOCK O: EXISTING ABLUTIONS
GROUND FLOOR PLAN 1:100
AREAS: BUILDING: 40m²
WALKWAY: 10m²

- Gutters and downpipes are damaged, install new to match existing on site or as per later detail. (REFER TO TYPICAL DETAILS).
- Deterioration of barge boards - rub down and repaint. (REFER TO TYPICAL DETAILS).

- Concrete ramp leading to walkway is non compliant, remove and install new compliant ramp with handrails, to comply with SANS 10400. (REFER TO TYPICAL DETAILS).

- Brick filler to tops of brickwork walls / underside of roof to close off gaps.
- Timber purlins in a poor condition - refer to Structural Engineer's report.

- Stored furniture in service passage to be removed and all plumbing to be checked for any damage or leaks.
- Internal paintwork in a poor condition, rub down walls, prime and repaint. (REFER TO TYPICAL DETAILS).

- 1 x mismatched plastic tap to be removed and replaced with new to match others.
- 1 x damaged toilet seat to be removed and replaced with new to match.

- Could not gain access to paraplegic ablution as it was locked.
- From outside, it appears that the paraplegic ablution doors grabrail is positioned incorrectly, reposition grabrail and ensure that there is a grabrail on the internal face of the door, as per SANS 10400.

- Structural Damage noted, refer to Structural Engineer's report.
- Remove and replace damaged mirror and splashback tile behind WHB. (SEE BELOW FOR SPECIFICATION).

- Water damaged ceiling and cornice to be removed and replaced with new to match, including skimming and painting. (REFER TO TYPICAL DETAILS).
- Corroded burglar guards over windows, remove and replace with new.

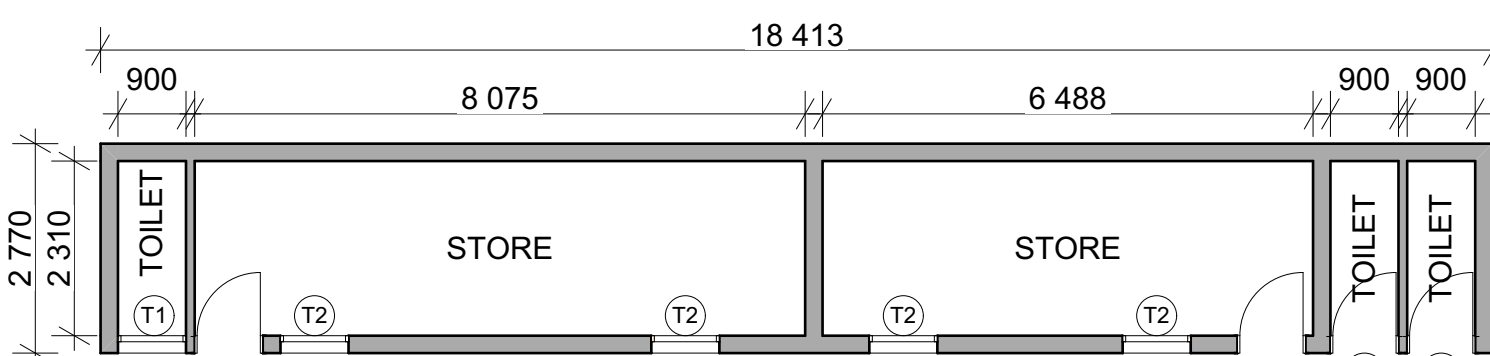
BLOCK N: EXISTING STORE ROOM AND ABLUTION
GROUND FLOOR PLAN 1:100

- Structural Damage noted, refer to Structural Engineer's report.
- Remove and replace timber entrance doors with new. (REFER TO SPEC BELOW).
- External paintwork in a poor condition, rub down walls, prime and repaint. (REFER TO TYPICAL DETAILS).

- Timber roof structural members to be repaired or replaced as per Structural Engineer's recommendation.
- Replace 1 x damaged mesh window with new to match existing. (REFER TO SPEC BELOW).

- Remove and replace roof sheeting with new. (REFER TO SPEC BELOW).
- External aprons in a poor condition - refer to structural engineer's recommendations for repair or replacement.

- Internal paintwork in a poor condition, rub down walls, prime and repaint. (REFER TO TYPICAL DETAILS).
- Internal ceilings in a poor condition, remove and replace with new including cornices. (REFER TO TYPICAL DETAILS).

- Corrosion to burglar bars / guards, sand off as much rust as possible, apply rust inhibiting primer to restore the steel, prime and paint. Where it cannot be restored, to be replaced with new to match existing. (REFER TO TYPICAL DETAILS).

- Corrosion to window frames, sand off as much rust as possible, apply rust inhibiting primer to restore the steel, prime and paint. Where it cannot be restored, to be replaced with new to match existing. (REFER TO TYPICAL DETAILS).

- Internal floor cracks to be repaired as per structural engineer's recommendations.
- Replace 2 x missing windows with new (above doors). (REFER TO SPEC BELOW).

- Replace all WC's & WHB's with new. Could not gain access into toilets so could not assess condition.

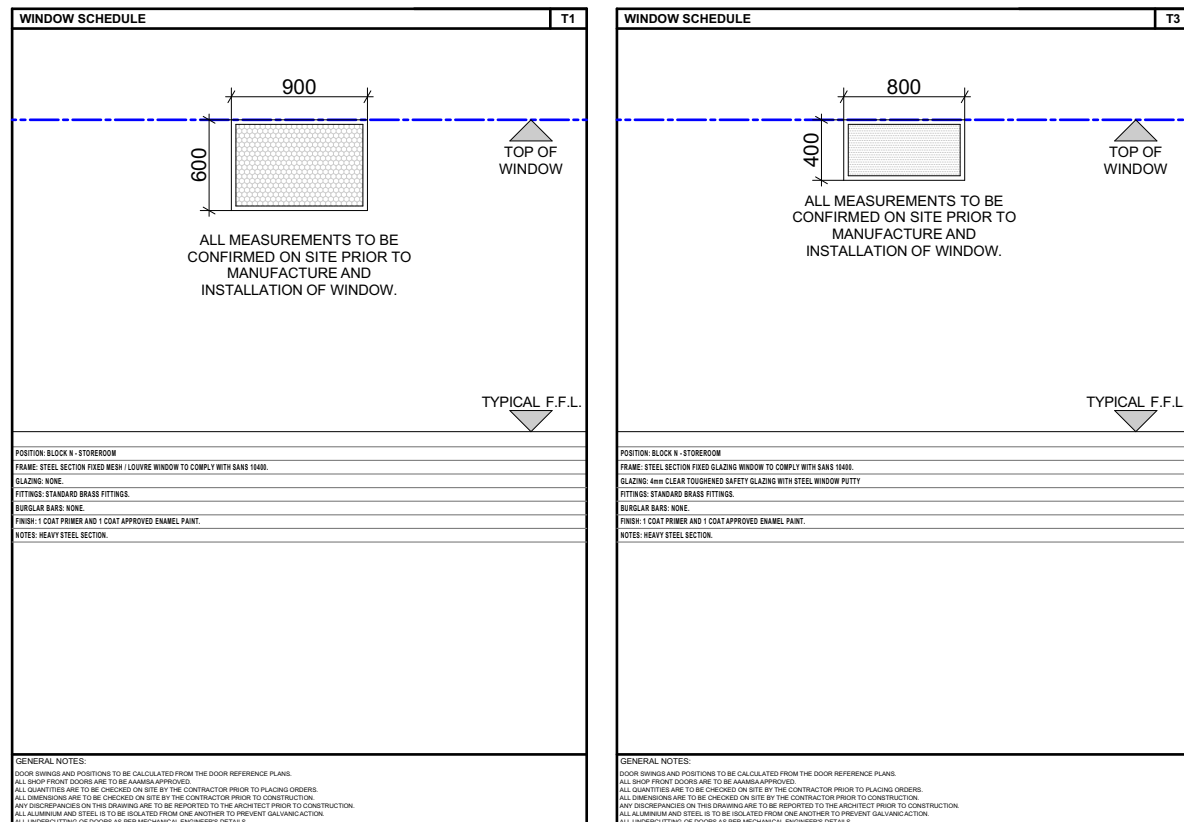
REPLACE 2 x MISSING T3 WINDOWS WITH NEW TO MATCH EXISTING.
