# OSHOEK SITE CLEARANCE

## CIVIL ENGINEERING STATUS QUO REPORT

DRAFT REPORT  
REVISION 00  
NOVEMBER 2017

**Prepared by:**  
Delta Built Environment Consultants (Pty) Ltd

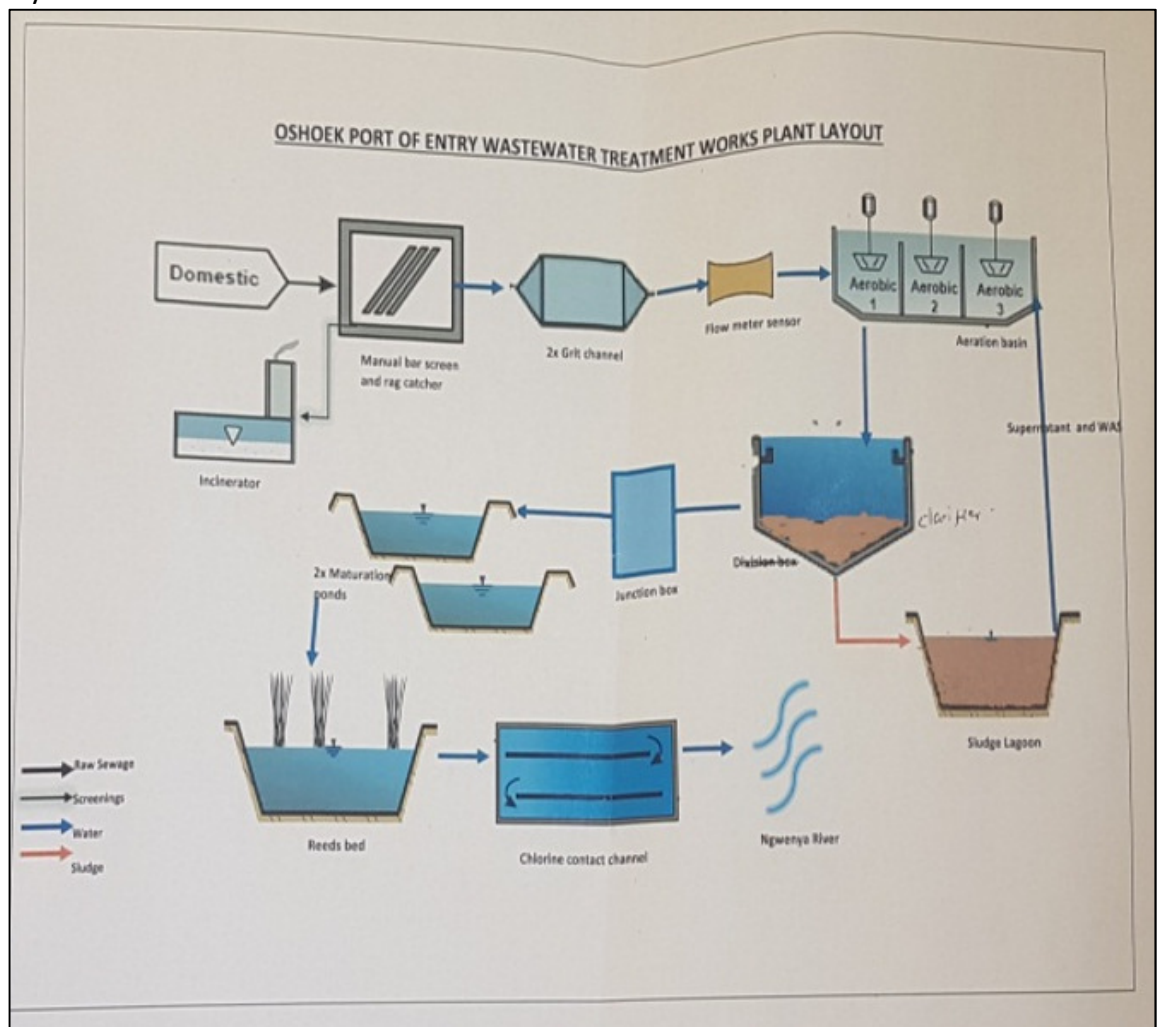
Figure 3-6: Schematic layout of the WWTW

The port of entry has its own private WWTW within their premises. A schematic layout of the WWTW is shown below as taken from the site's maintenance room.

There were just a few minor concerns about the operation of the plant, during the site visit. It was noted that the WWTW is not functioning as it was designed to operate. A few of the concerns are mentioned below:
