Project: **CONDITION ASSESSMENT
DR. BOHMER SECONDARY SCHOOL**

Drawing description: **EXISTING BLOCKS:
REFURBISHMENT SCOPE OF WORKS :
S.T.U & V**

Drawing Number: 082-DRBS-104

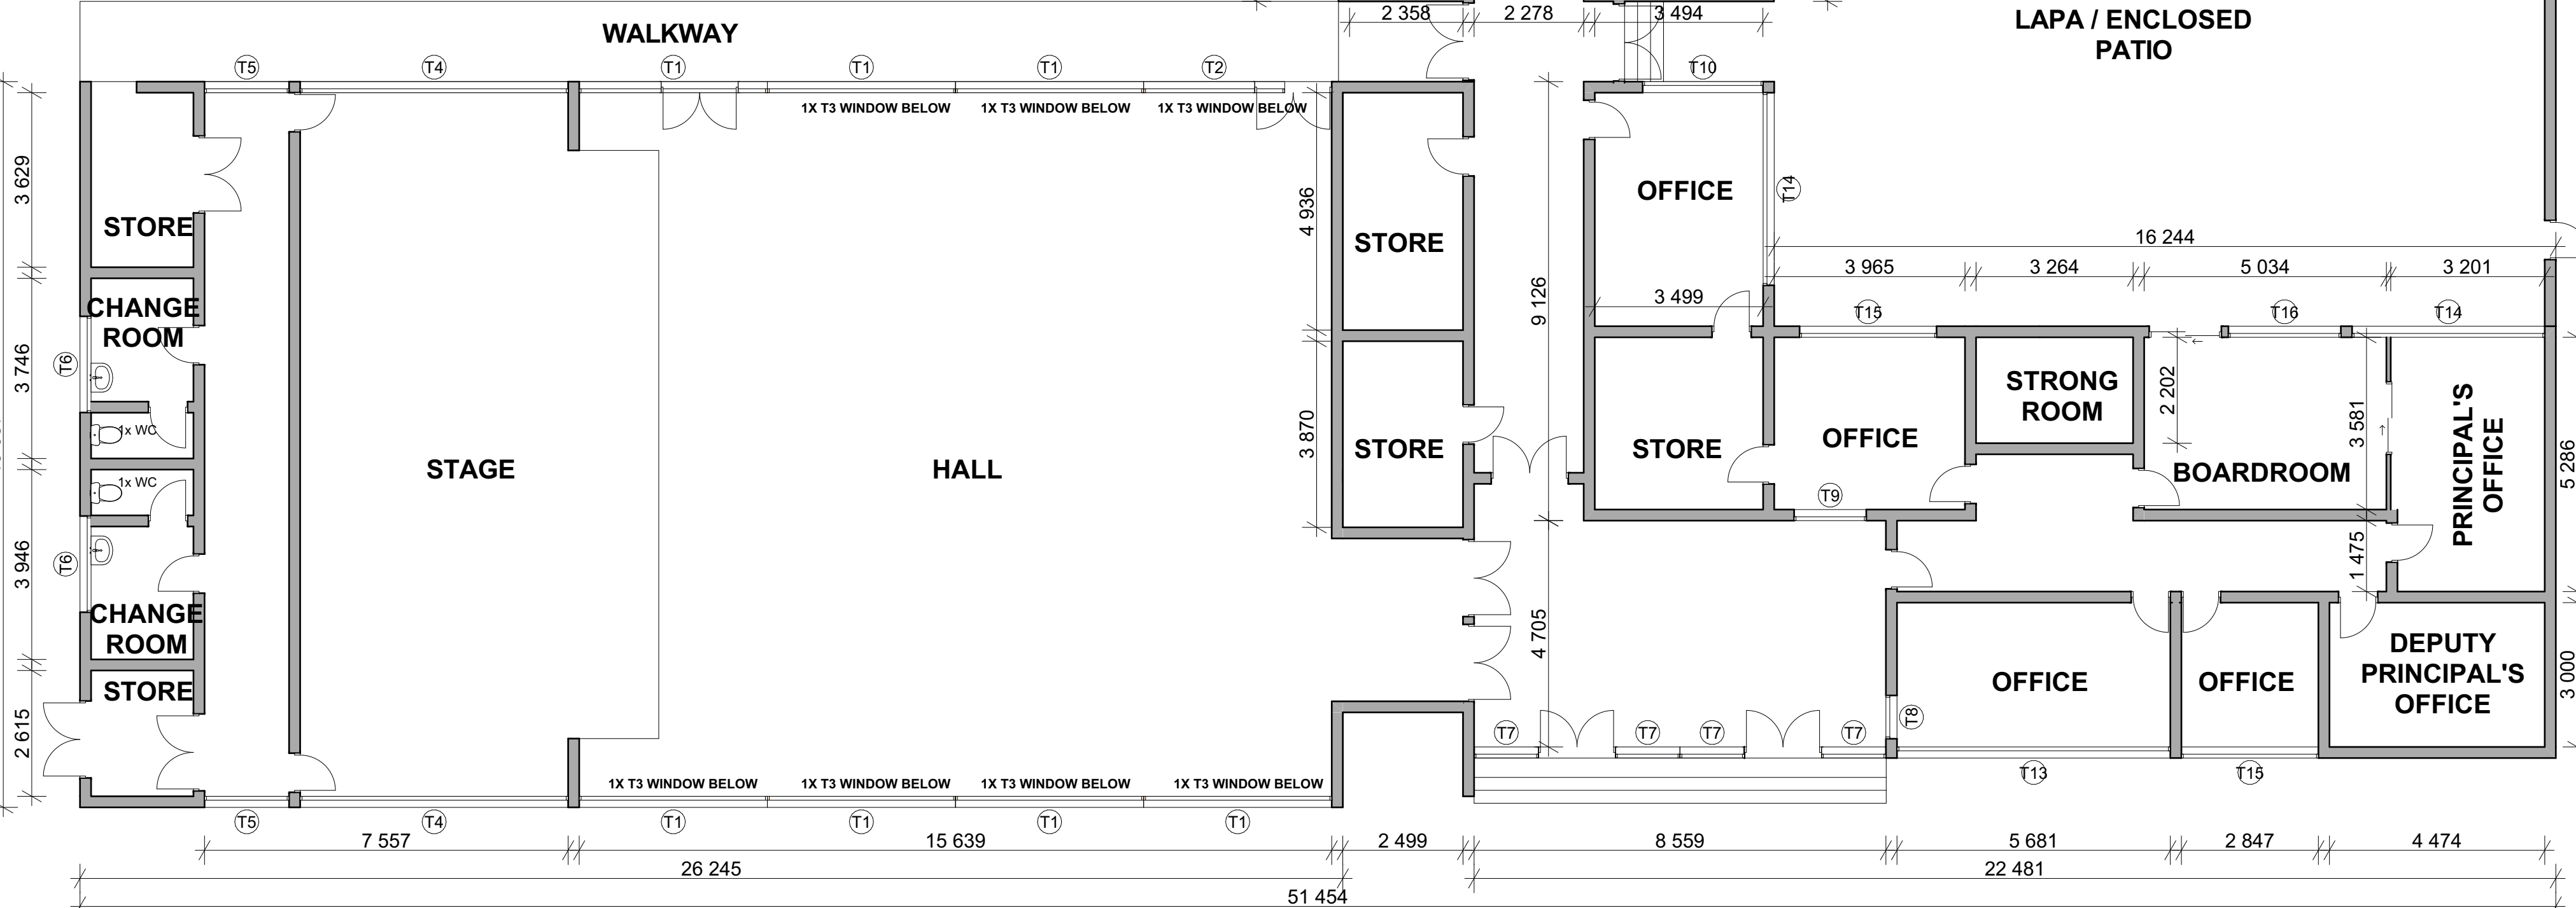
**BLOCK W1-ADMIN
FLOOR PLAN - SCALE 1:100**

1. In good condition
