Project:
CONDITION ASSESSMENT HTS WELKOM SCHOOL

Drawing description:
EXISTING BUILDINGS REFURBISHMENT SCOPE OF WORKS

| Drawing Number: | 082-HTSWEL-102 | Revision: A |

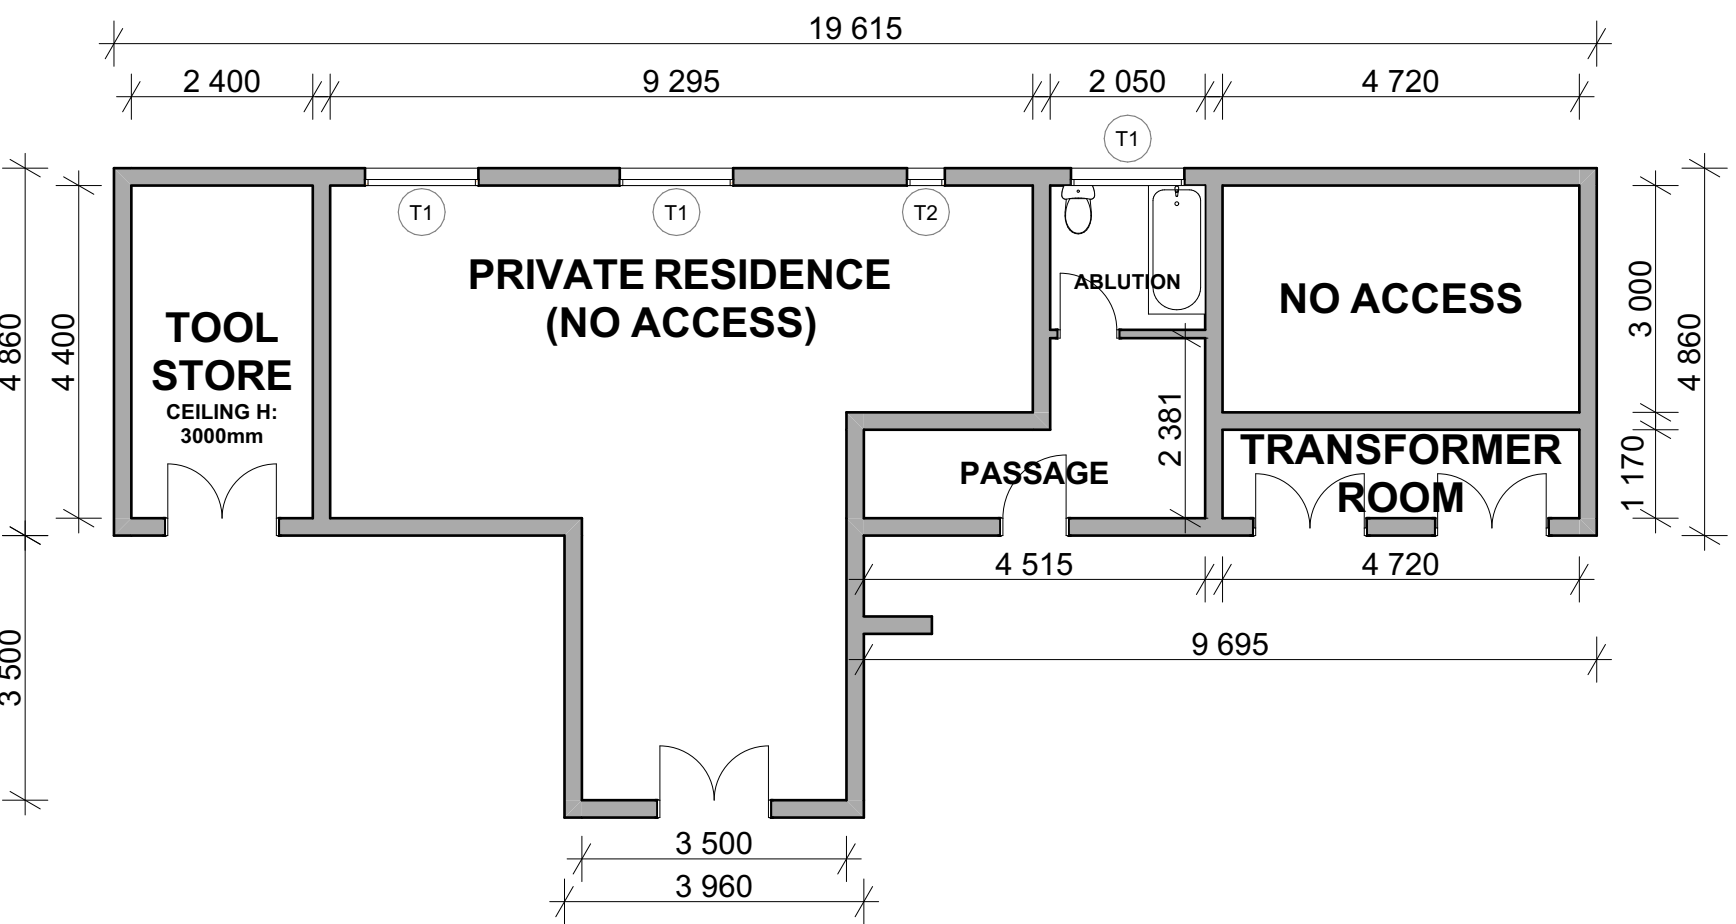
BLOCK N - CARETAKERS RESIDENCE, TRANSFORMER ROOM & STORE FLOOR PLAN - SCALE 1:100

1. Gutters and downpipes are damaged, install new to match existing on site or as per later detail. REFER TO TYPICAL DETAILS.
2. External paintwork in a poor condition, rub down walls, prime and repaint. REFER TO TYPICAL DETAILS.

3. 1 x window T1 missing glazing panel and has been boarded up - remove and replace with new glazing to match existing. REFER TO IMAGE BELOW.
4. All external and internal doors, door frames, windows and window frames in a poor condition. Rub down, prime and repaint or re-varnish to match existing. REFER TO TYPICAL DETAILS.

5. Water damage to ceilings, remove all affected panels and cornices and replace with new to match, including skimming and painting. Roof sheeting and trusses to be inspected for leaks / damage and to be repaired or replaced. REFER TO TYPICAL DETAILS.

6. Bathroom in a poor condition - remove all fittings and replace only if the bathroom is still required to be used by the end user. REFER TO SPECS BELOW.

7. Internal paintwork in a poor condition, rub down walls, prime and repaint. REFER TO TYPICAL DETAILS.
8. Internal floor finishes in a poor condition, remove and replace with new, including skirtings. REFER TO TYPICAL DETAILS.

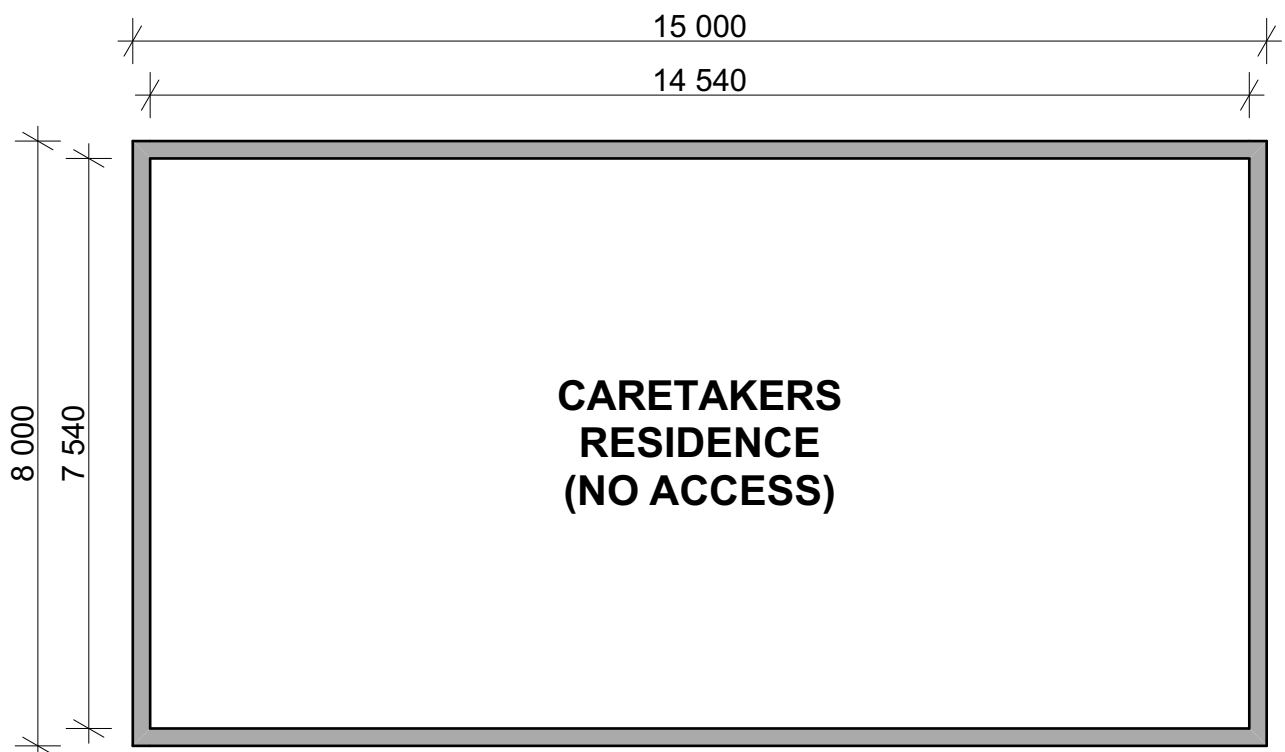
BLOCK P - CARETAKERS RESIDENCE GROUND FLOOR PLAN - SCALE 1:100

1. No access for assessment.
2. No gutters or downpipes installed. Install new to match existing on site or as per later detail.

REPLACE SANWARE IN BATHROOM

REPLACE DAMAGED CEILING TILES WITH NEW TO MATCH EXISTING.

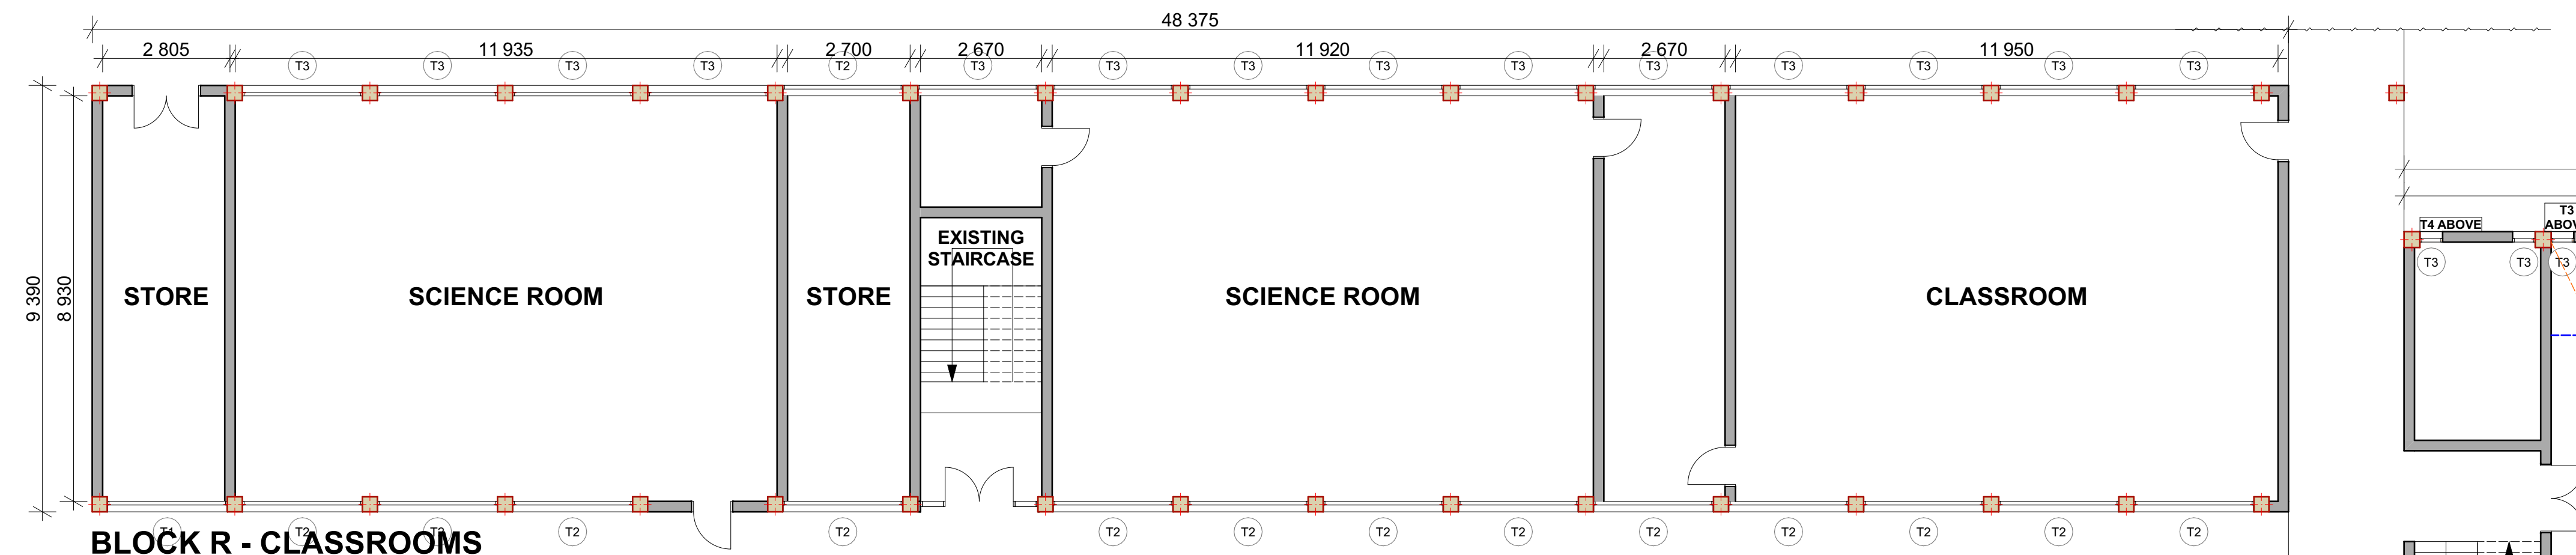
BLOCK R - CLASSROOMS GROUND FLOOR PLAN SCALE 1:100

1. Roof sheeting is asbestos - remove safely as a matter of urgency as per Health & Safety standards and install new roof sheeting. REFER TO SPEC BELOW.
2. Install new fascia & barge boards, gutters and downpipes. REFER TO TYPICAL DETAILS.
3. Some of the ceiling tiles in the library are damaged and are to be replaced with new to match existing. REFER TO IMAGE BELOW.
4. Cracks noted on internal walls, refer to Structural Engineer's report for repair. Once repair work is done, prime and repaint.
5. Vinyl floors to be removed and replaced with new. REFER TO TYPICAL DETAILS.

REPLACE ROOF SHEETING.

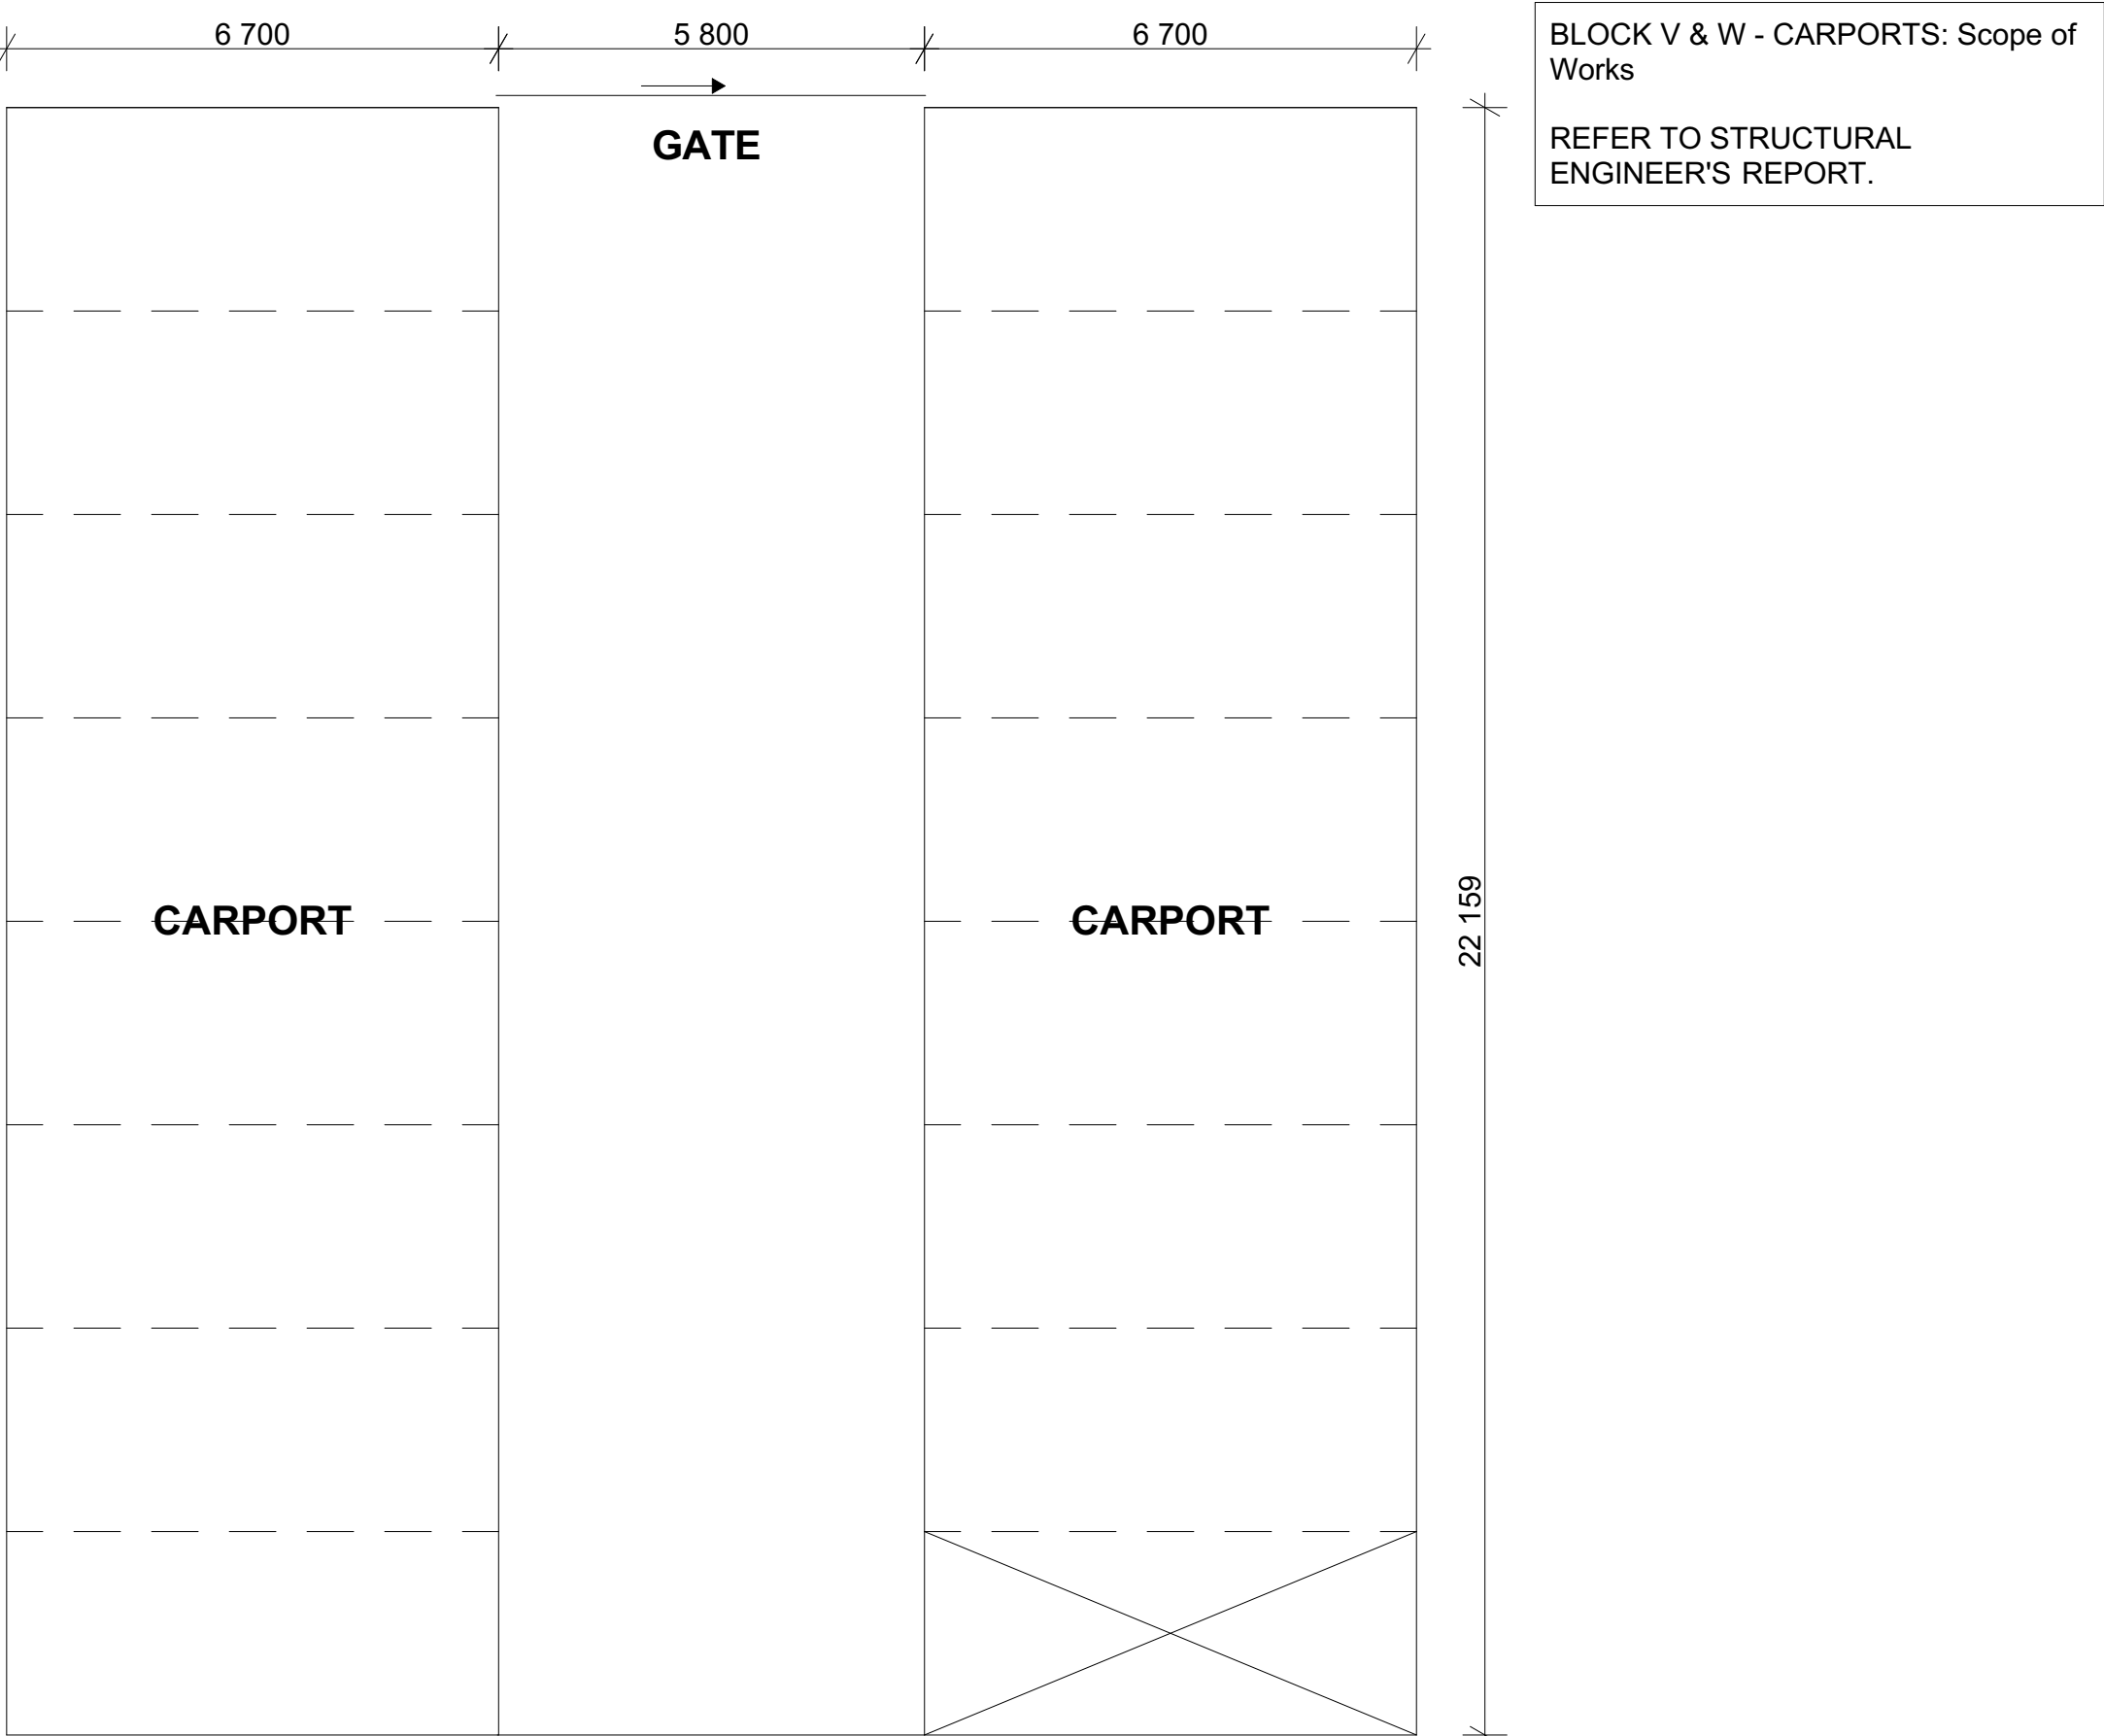
BLOCK V - CARPORT FLOOR PLAN - SCALE 1:100

BLOCK V & W - CARPORTS: Scope of Works
REFER TO STRUCTURAL ENGINEER'S REPORT.
