Project:
**CONDITION ASSESSMENT
HTS WELKOM SCHOOL**

Drawing description:
**EXISTING BUILDINGS
REFURBISHMENT SCOPE OF WORKS**

Drawing Number:	082-HTSWEL-103	Revision:	A
-----------------	----------------	-----------	---

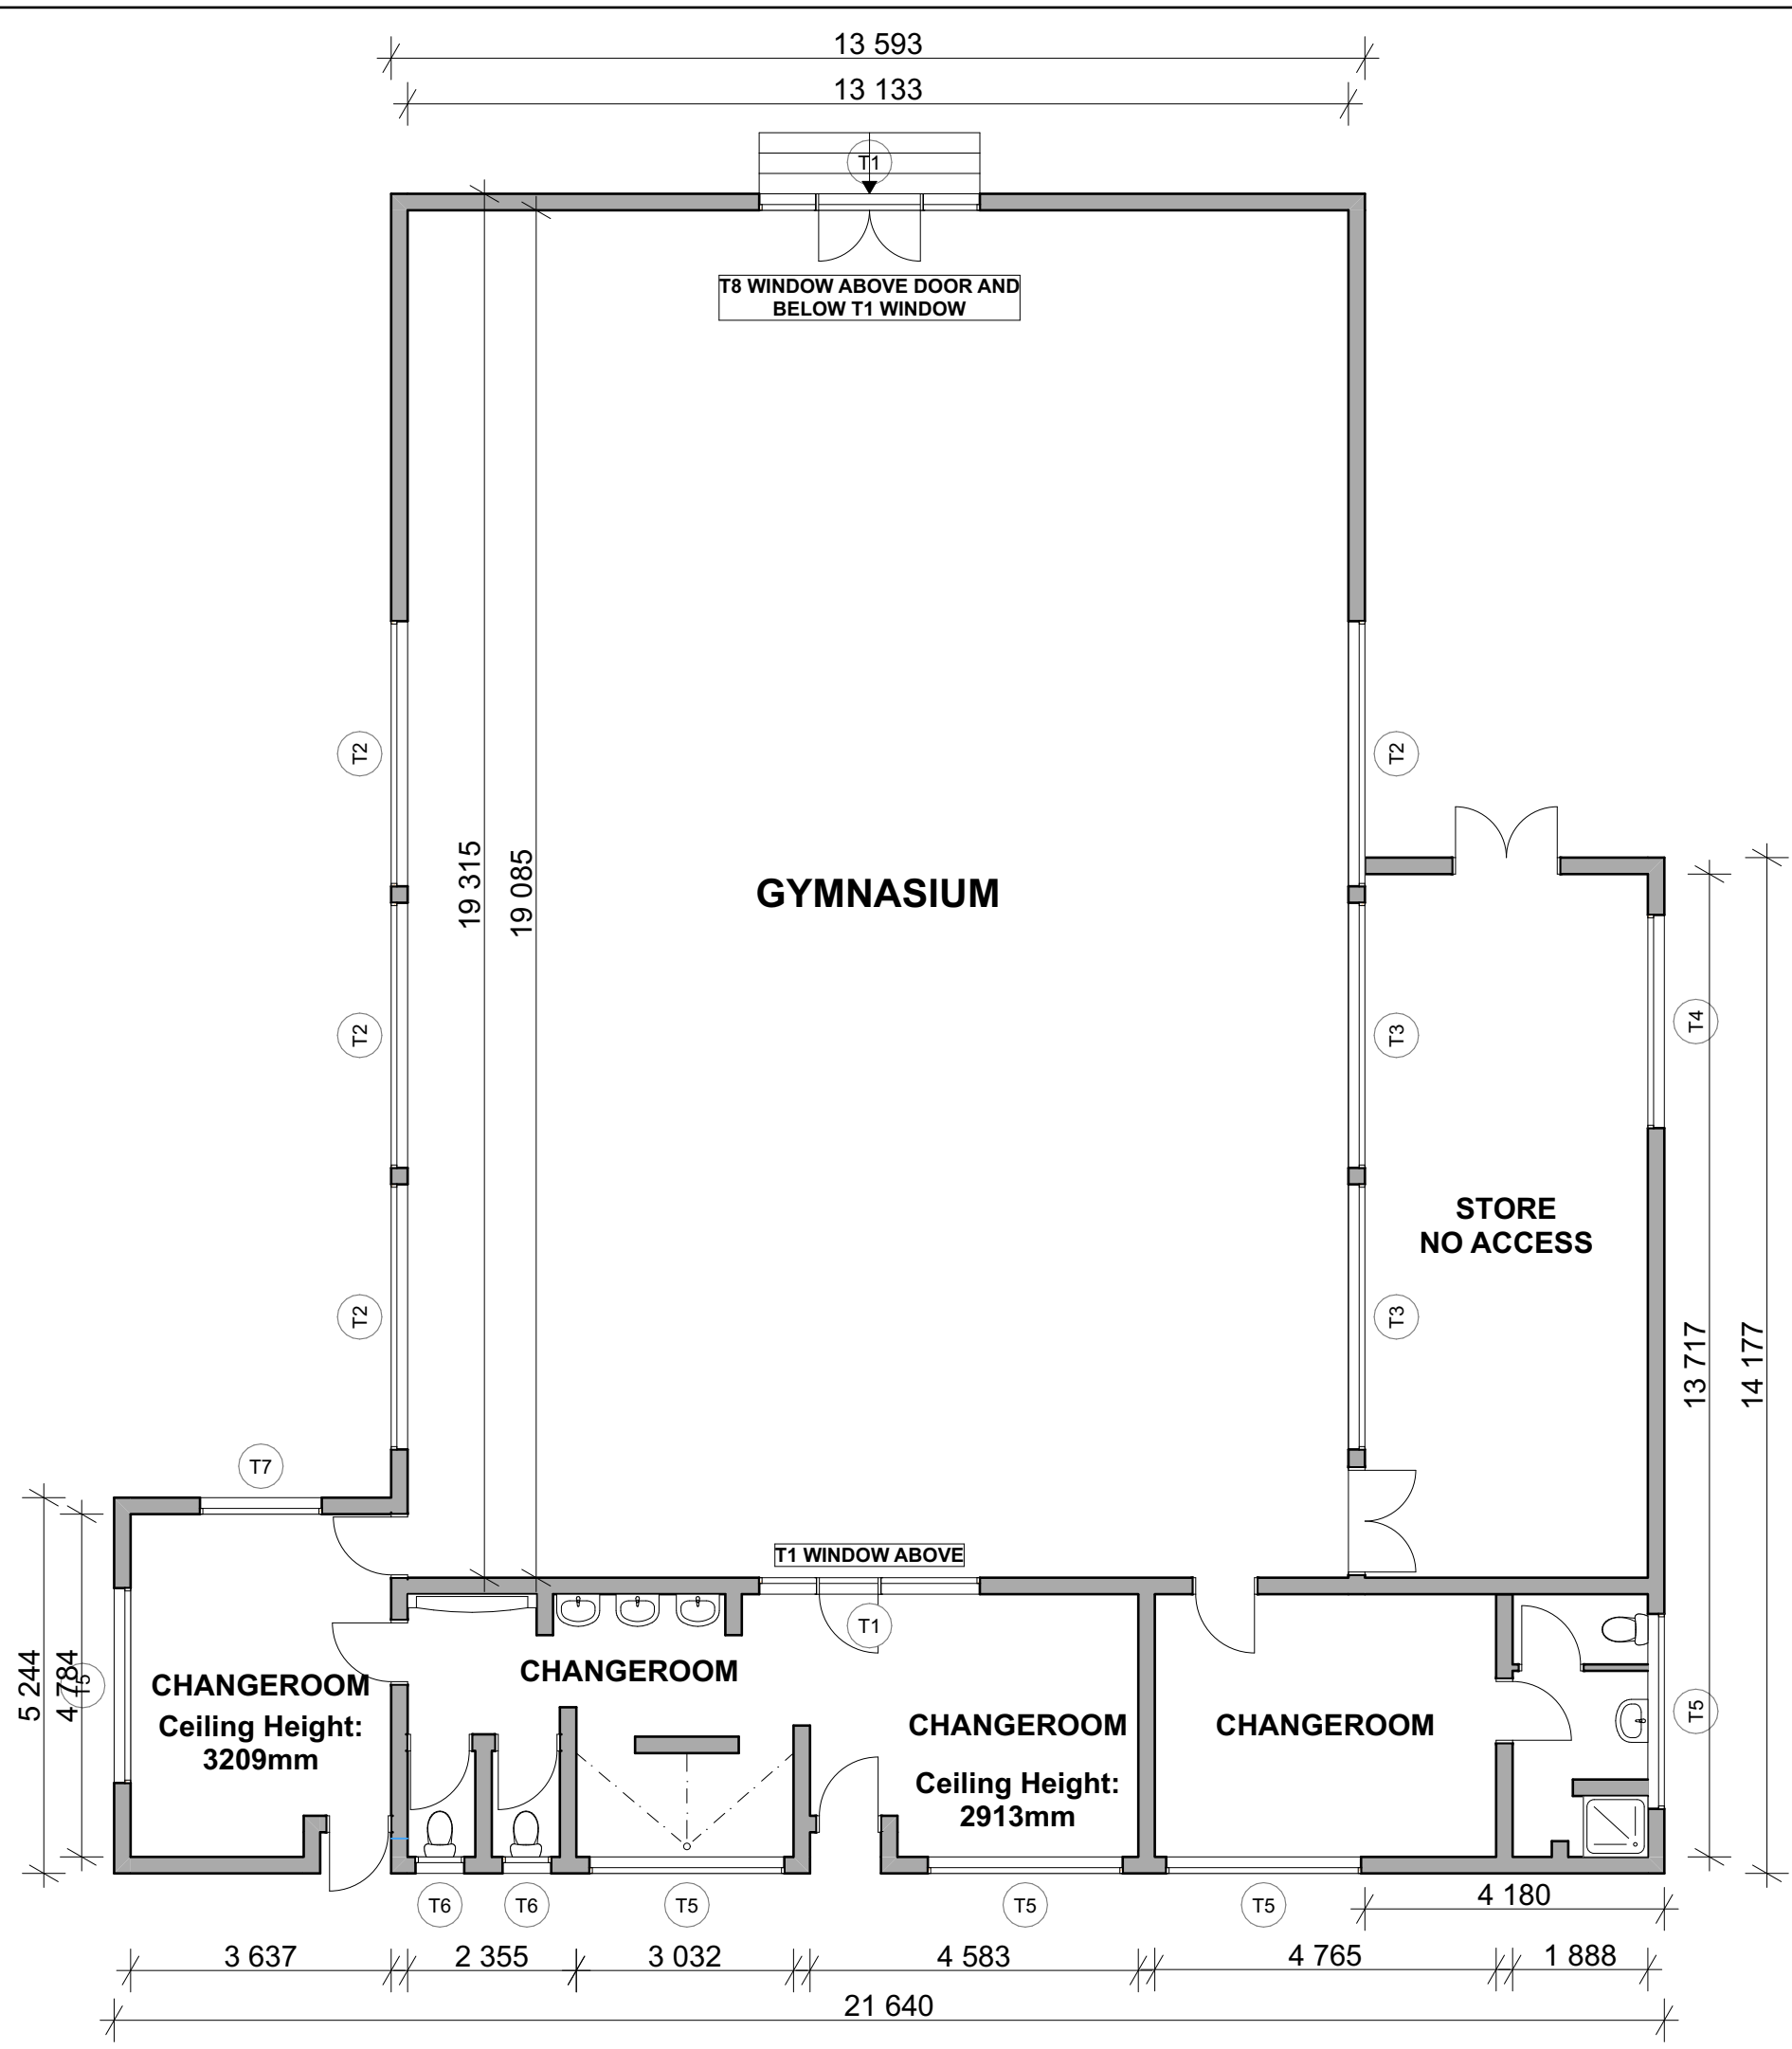
**BLOCK S - GYM
FLOOR PLAN
SCALE 1:100**

1. Refer to Structural Engineer's report for repairs to roof damage. Recommend resealing / waterproofing box gutter roof on high level roof and RC columns over main gymnasium (on either side of the building) and recommend resealing / waterproofing RC roof slab on lower roof over ablutions & changerooms. REFER TO IMAGES BELOW.

2. Once waterproofing / resealing and structural work is complete, external paintwork in a poor condition, rub down walls, prime and repaint. REFER TO TYPICAL DETAILS.

3. Corrosion to window frames, sand off as much rust as possible, apply rust inhibiting primer to restore the steel, prime and paint. Where it cannot be restored, to be replaced with new to match existing. REFER TO TYPICAL DETAILS.

4. Water damage to slabs in changerooms, ablutions and office - refer to Engineer's report for repairworks. New waterproofing, primer and paint to u/s of slabs and to peeling paint on walls. REFER TO IMAGES BELOW AND TYPICAL DETAILS.

5. Internal paintwork in a poor condition, rub down walls, prime and repaint. REFER TO TYPICAL DETAILS.
6. Internal vinyl floor finishes in the gymnasium and store is in a poor condition and to be removed. Once structural work is complete, replace with new, including skirtings. REFER TO TYPICAL VINYL FLOOR FINISHES DETAILS AND IMAGE BELOW.

7. Internal walls tiles in ablutions in a poor condition - recommend removing and replacing with new to match. REFER TO SPEC BELOW.
8. Steel urinal is corroded and should be replaced with new. REFER TO SPEC BELOW.

9. No floor finishes installed in ablutions & changeroom - recommend installing new floor finishes. REFER TO SPEC BELOW.
10. Damaged light fittings to be removed and new are to be installed as per Electrical Engineer's specifications.

11. Changeroom timber benches to be removed and replaced with new. REFER TO SPEC BELOW.
12. Office: replace floor finishes. REFER TO TYPICAL VINYL FLOOR FINISHES DETAILS.

13. Office: repaint walls. REFER TO TYPICAL DETAILS.
14. Office ablutions: rub down and repaint walls. REFER TO TYPICAL DETAILS.
15. External plumbing fittings in a poor condition - inspect all plumbing and repair/replace. REFER TO IMAGE BELOW.

16. External gully is damaged - make good.

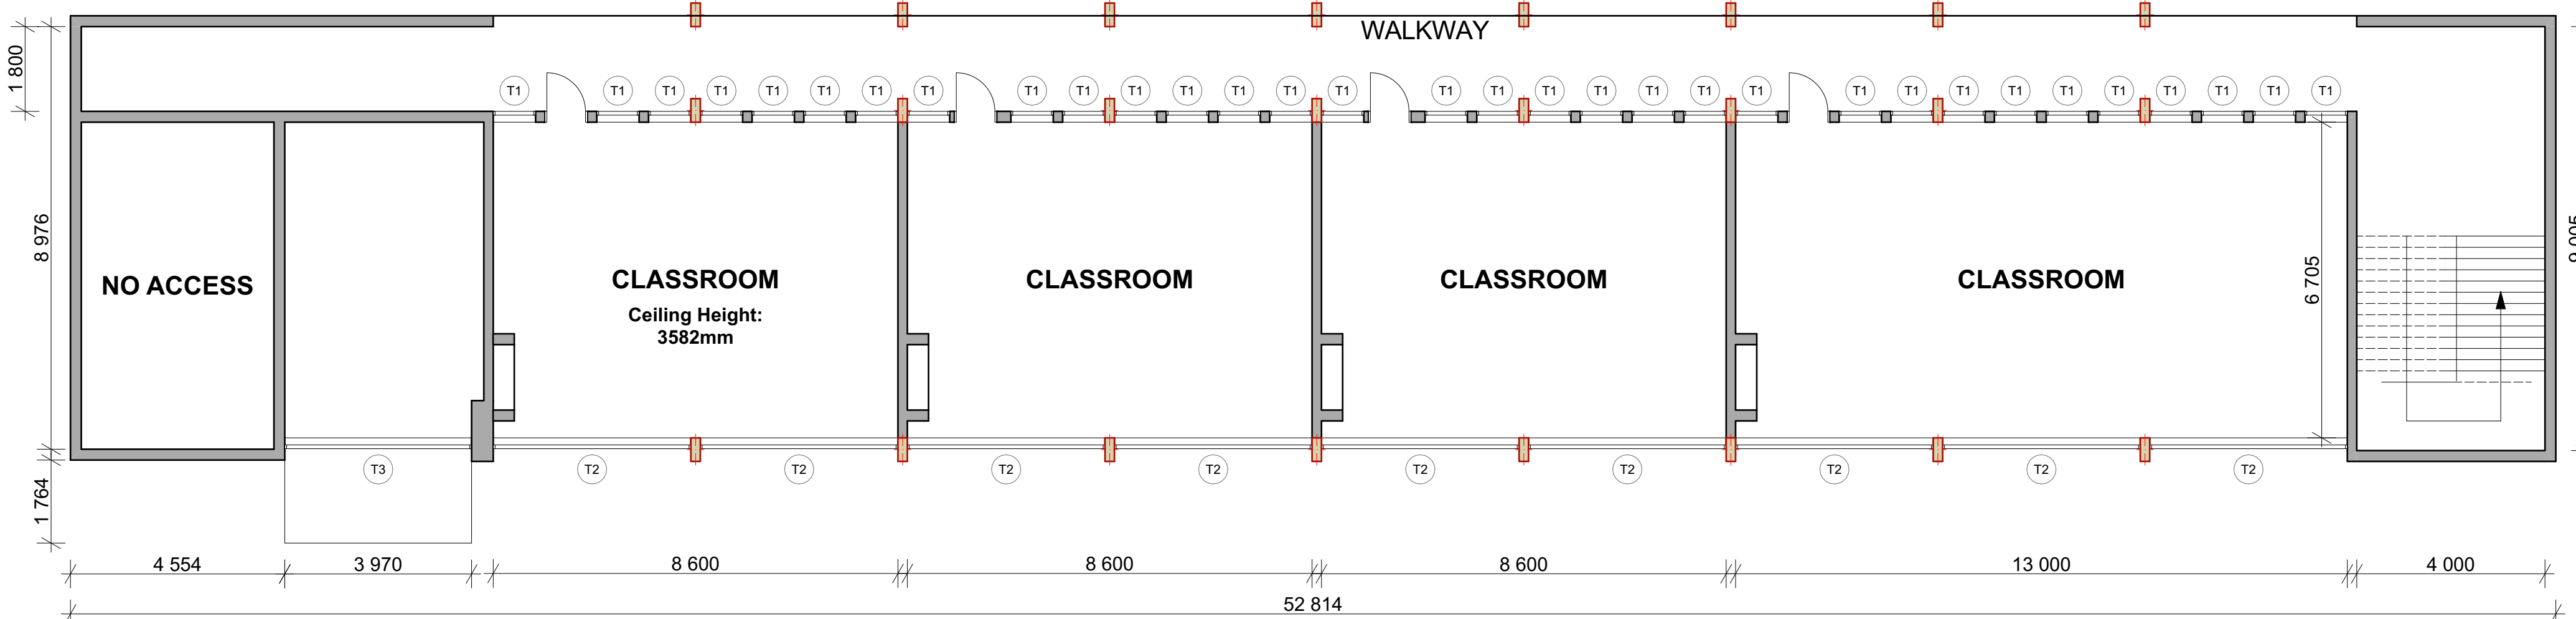
**BLOCK X - FIRST FLOOR CLASSROOMS
FLOOR PLAN - SCALE 1:100**

1. All balustrades in a poor condition. Rub down, prime and repaint. REFER TO IMAGE BELOW.
2. Entrance canopy roof - rub down u/s of canopy and repaint. Reseal / waterproof canopy. REFER TO IMAGE BELOW.

3. Corrosion to steel cladding on facades of building - recommend removing panels which exhibit corrosion and replace with new to match existing. REFER TO IMAGE BELOW.

6. Ceiling in staircase in a poor condition - recommend removing and replacing with new, including new light fittings. REFER TO TYPICAL CEILING DETAILS AND IMAGE BELOW.

7. Paintwork on stairs in a poor condition - recommend rubbing down, prime and repaint. REFER TO TYPICAL DETAILS.
8. Internal paintwork in a poor condition, rub down walls, prime and repaint. REFER TO TYPICAL DETAILS.

9. Internal floor finishes in a poor condition, remove and replace with new, including skirtings. REFER TO TYPICAL VINYL FLOOR FINISHES DETAILS.
10. External paintwork in a poor condition, rub down walls, prime and repaint.

11. Cracks noted on internal walls, refer to Structural Engineer's report for repair. Once repair work is done, prime and repaint.
12. Water damage to some of the ceilings, remove and replace with new including skimming, painting and cornices.

13. Corrosion to window frames, sand off as much rust as possible, apply rust inhibiting primer to restore the steel, prime and paint. Where it cannot be restored, to be replaced with new to match existing.
