Project:
CONDITION ASSESSMENT
HTS WELKOM SCHOOL

Drawing description:
EXISTING BUILDINGS
REFURBISHMENT SCOPE OF WORKS

Drawing Number:
082-HTSWEL-106

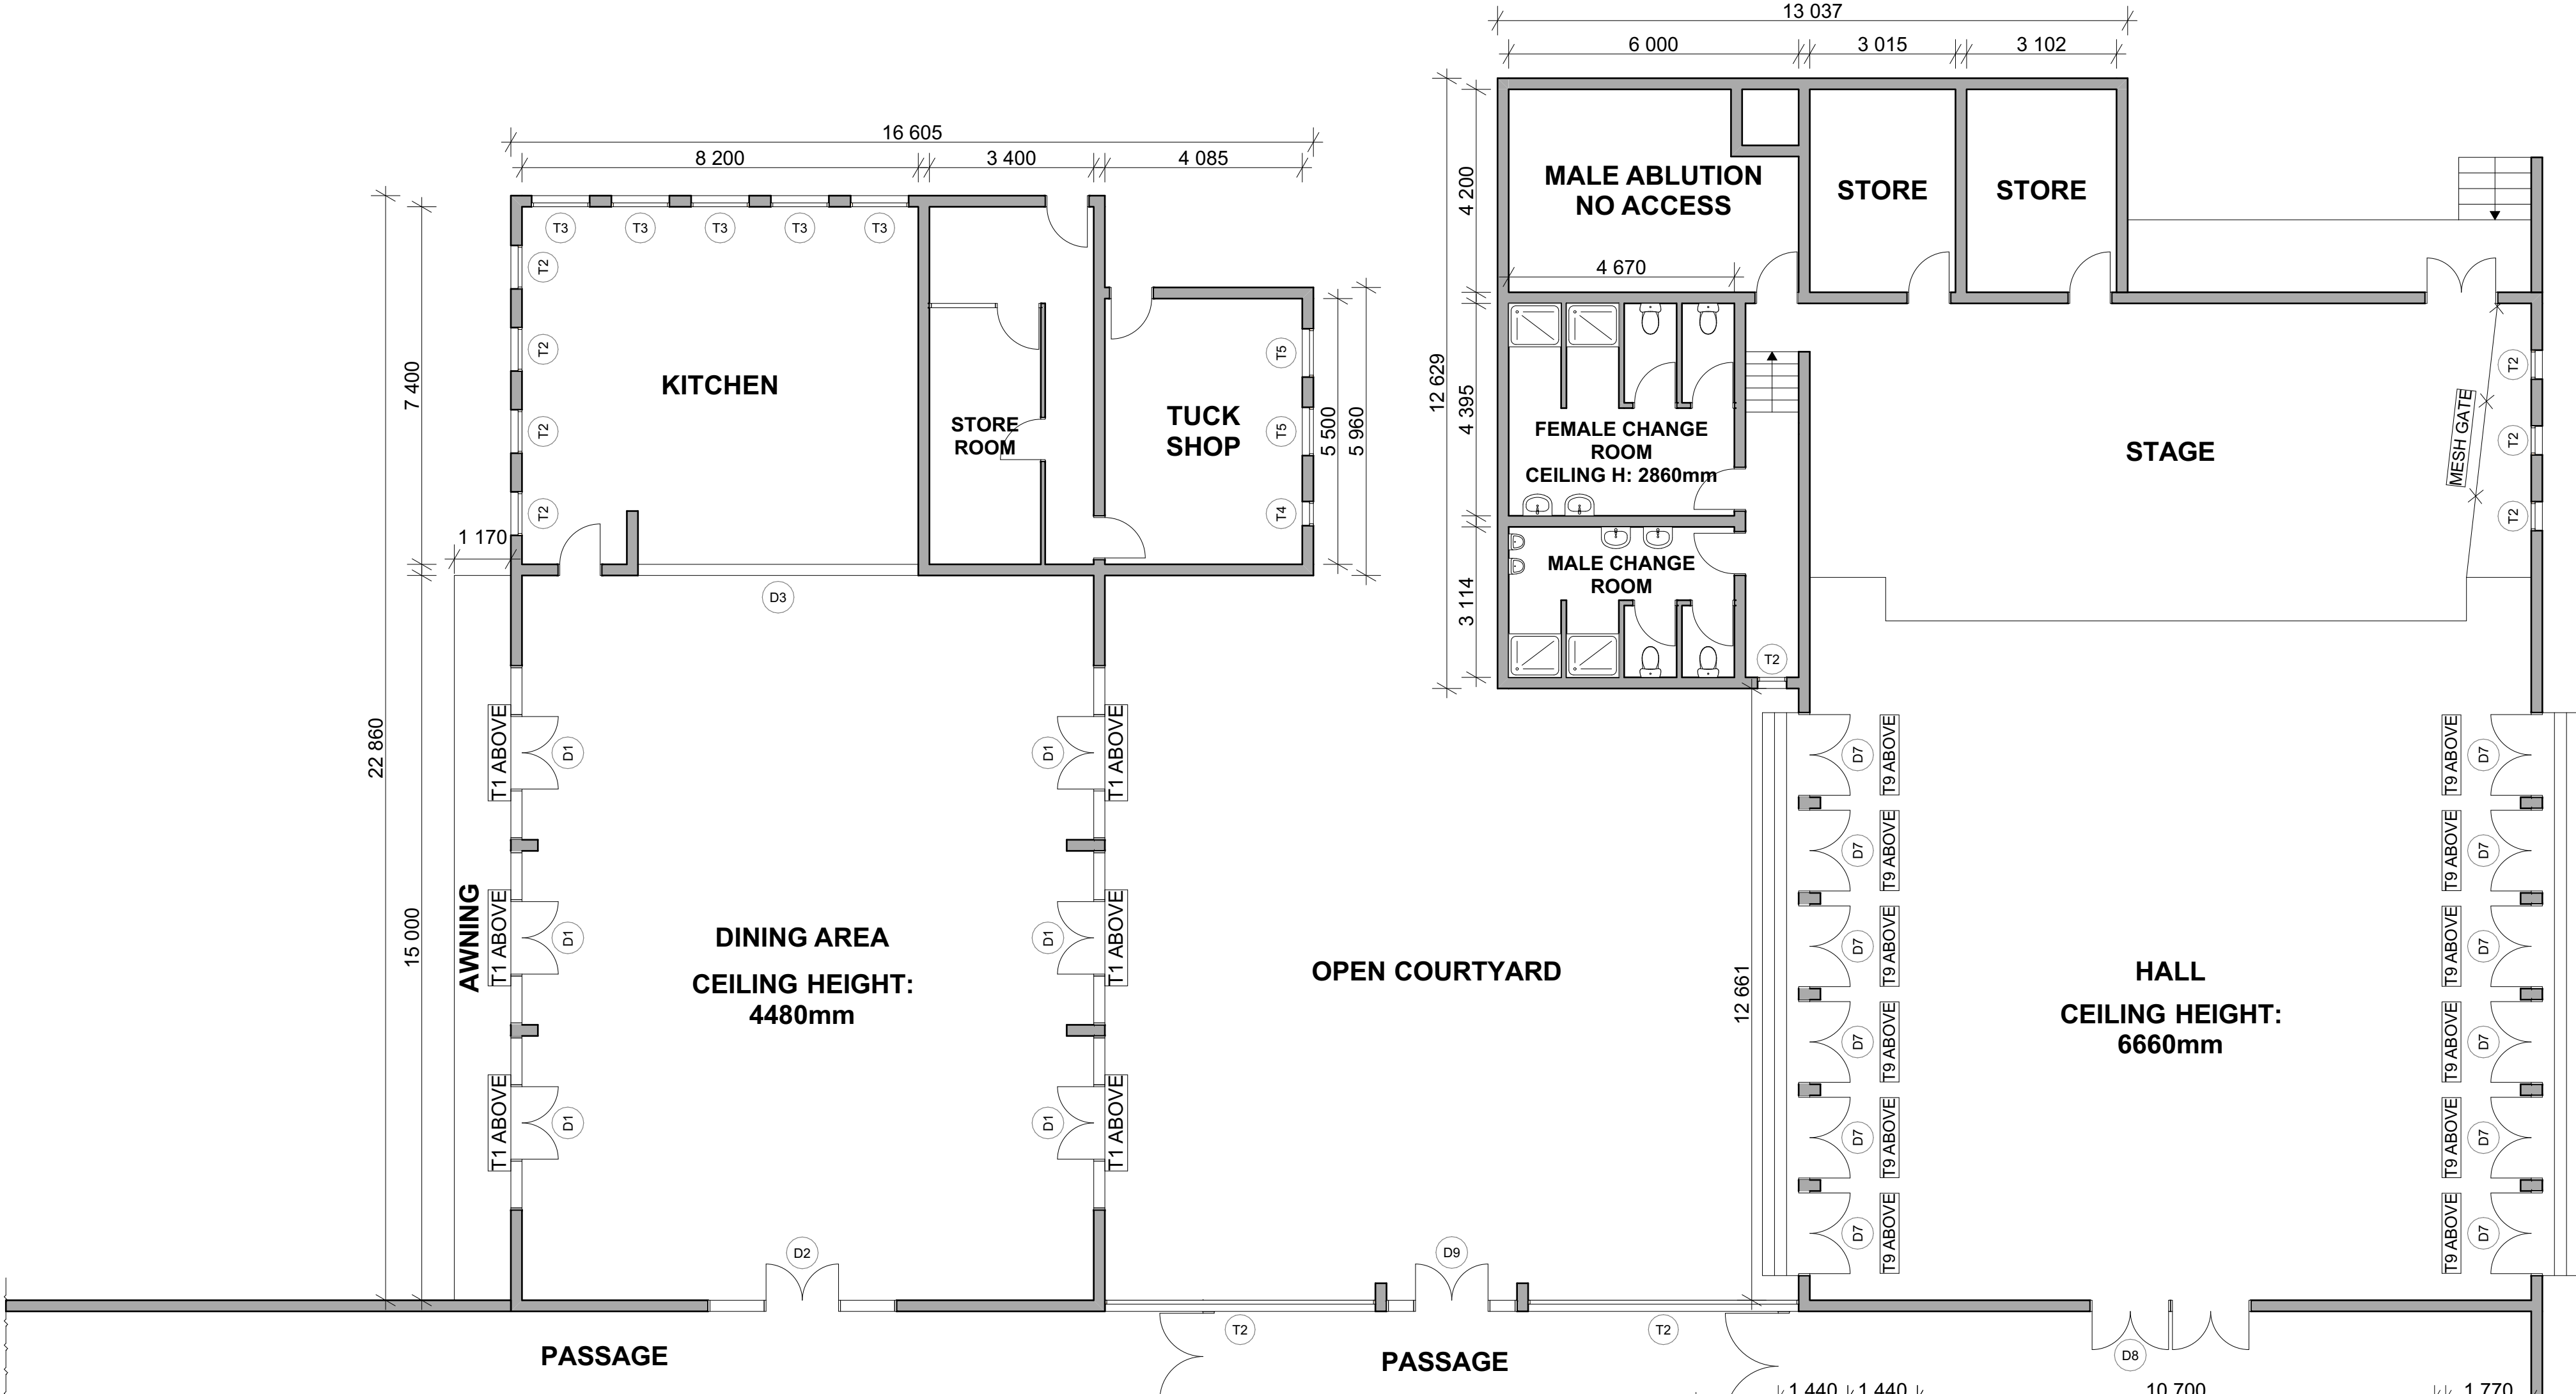
BLOCK J - DINING & KITCHEN
GROUND FLOOR PLAN
SCALE 1:100

- BLOCK J - DINING AND KITCHEN: Scope of Works**
1. Water damage to some of the wall cladding panels - remove and replace with new to match. REFER TO IMAGE BELOW.
 2. Water damage and peeling paint on the kitchen walls - rub down paint and repaint. REFER TO IMAGE BELOW.
 3. WHB in kitchen in a poor condition - remove and replace with new. REFER TO SPEC BELOW.
 4. Structural damage to floors in tuckshop - refer to Structural Engineer's report.
 5. Flaking & peeling paint to walls and ceilings in passage / store & tuckshop in kitchen - rub down, prime and repaint.
 6. Rub down and repaint doors leading into kitchen. REFER TO IMAGES BELOW.
 7. Additional coat of paint required to ceiling in kitchen.
 8. Some ceiling panels in dining hall are damaged. Remove and replace with new. REFER TO IMAGE BELOW.

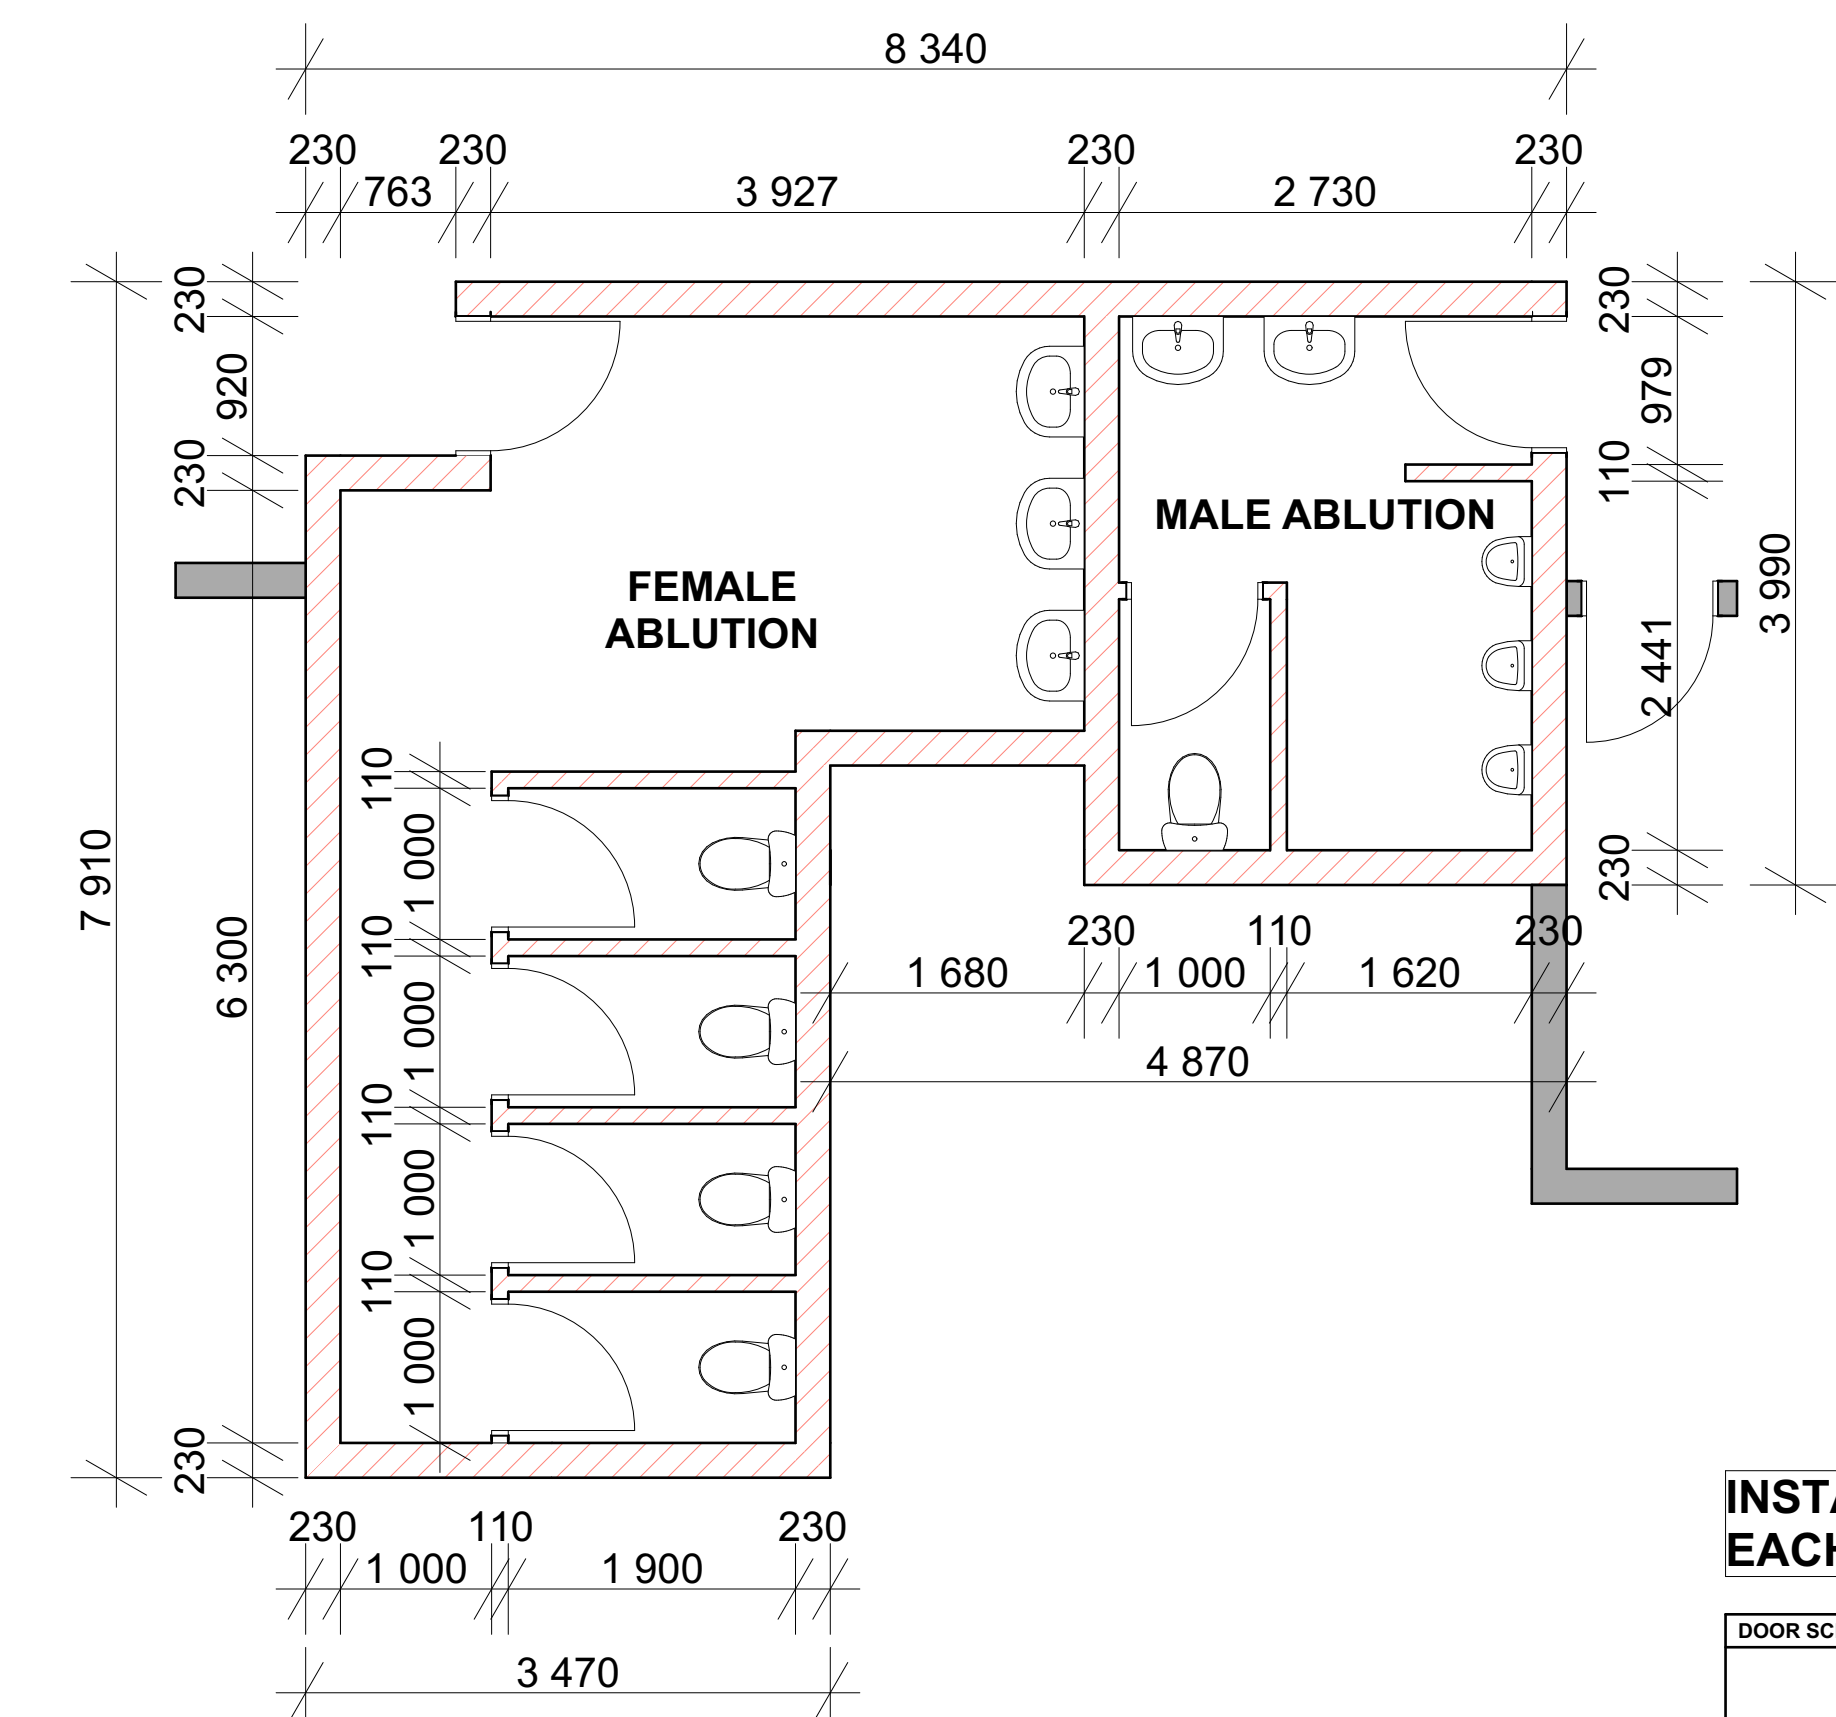
BLOCK K - HALL
GROUND FLOOR PLAN
SCALE 1:100

AS PER ENGINEER'S RECOMMENDATIONS ENTIRE FEMALE AND MALE ABLUTIONS AT HALL ENTRANCE IS TO BE DEMOLISHED AND REBUILT.

4. As per Structural Engineer's report - due to extensive damage on toilets, they are to be reconstructed - to match existing, as per detailed design. REFER TO SPECS BELOW.

REPLACE SANWARE:

Basins: Install 3 x new WHB per ablution - Lecico Atlas 50cm basin in white vitreous china pre-punched for 2 x tap holes. W: 500, H:175 and D: 410
Taps: Each sink to be fitted with 2 x Cobra star pillar taps.
Mirrors: 1 x mirror per basin - new 4mm polished mirrors 300 x 200mm.
Urinals: Remove existing and install new urinals - Lecico Atlas BS60 white vitreous china urinals with top entry spreaders, wall brackets and waste. W: 410, H:665 and D: 315.
WC: Lecico Madison close couple suite colour White, seat and cover bolted to bowl with metal washers and rubber gaskets, 100mm outlet with cistern connected to 15mm water supply with foot of bowl sealed to floor with abe Dow Corning aceoxley silicone sealant. Material: Vitreous China, Pan code: MADBCXDFLUSCSBE.

REPLACE WALL AND FLOOR TILES WITH NEW:

Remove existing wall and floor tiles and replace with new as follows: wall tiles to be 400 x 400 salt and pepper wall tiles, spec to be confirmed. 5 rows high around entire ablution interior walls.
Floor tiles to be 400 x 400 salt and pepper tiles. Spec to be confirmed.

REMAINDER OF WALLS ABOVE TILING TO BE PLASTERED, PRIMED AND PAINTED.
