**CONDITION ASSESSMENT
HTS WELKOM SCHOOL**

**EXISTING BUILDINGS
REFURBISHMENT SCOPE OF WORKS**

082-HTSWEL-109

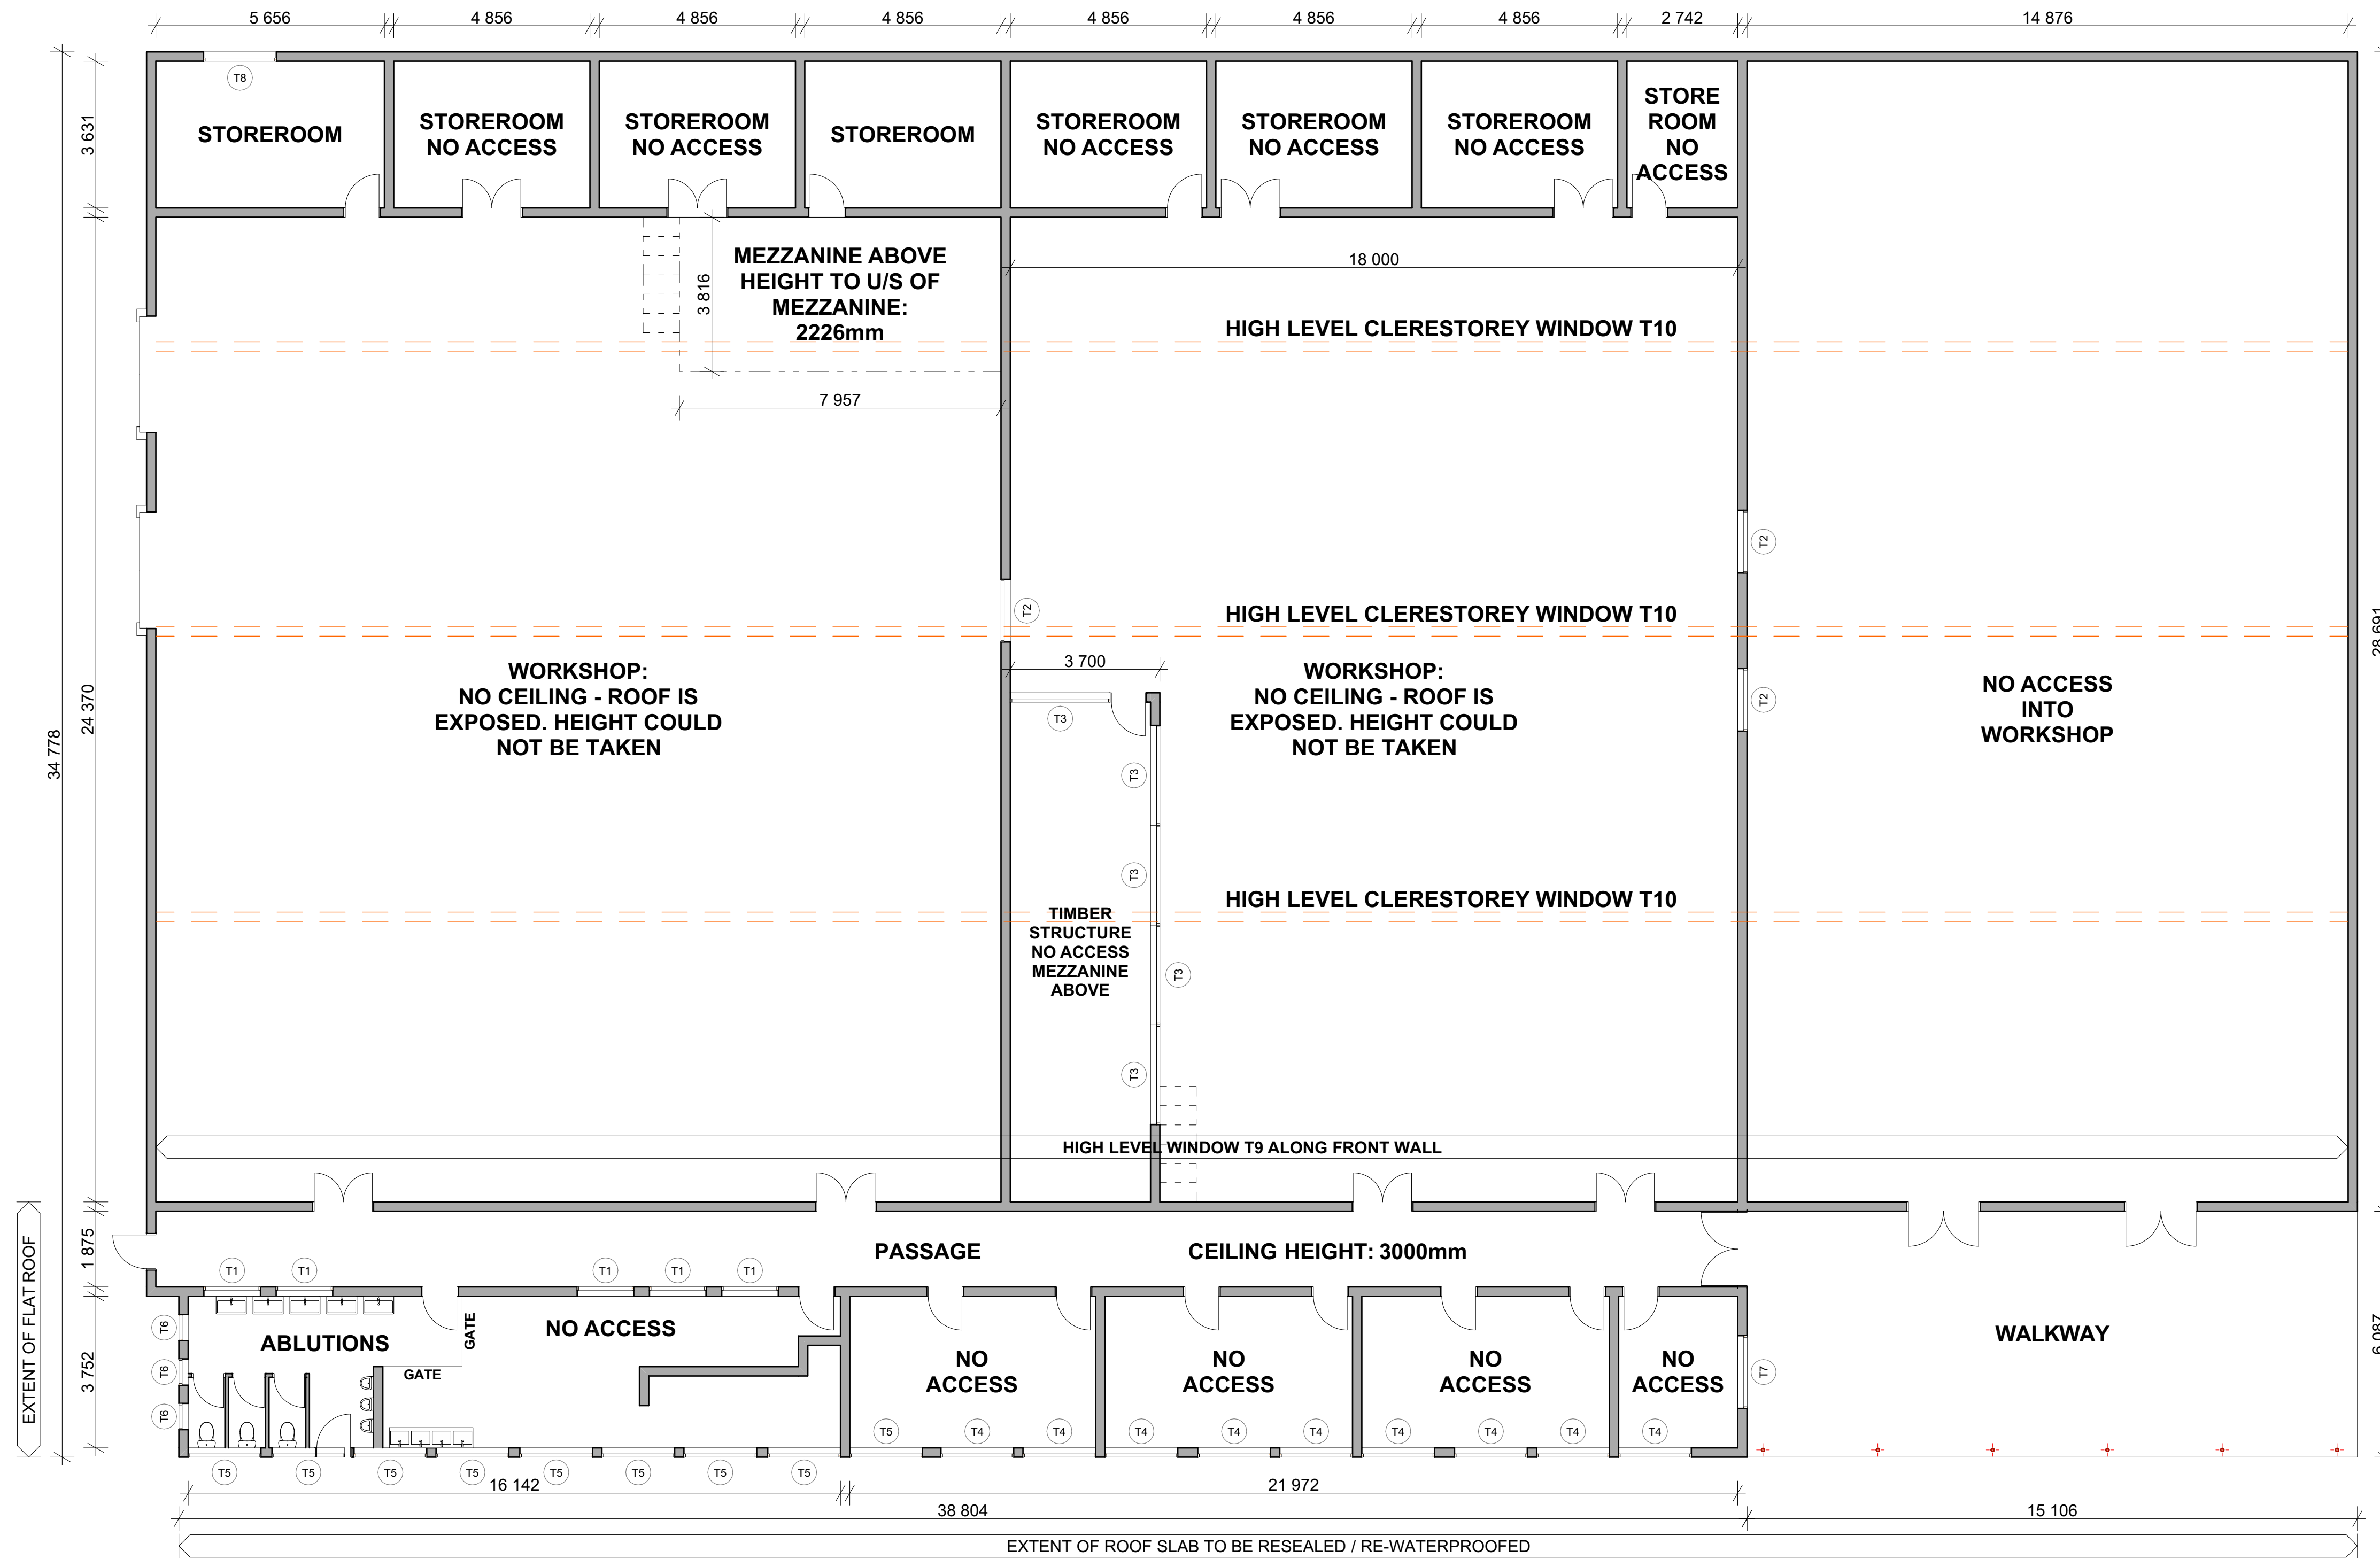
**BLOCK AB - WORKSHOPS
FLOOR PLAN - SCALE 1:100**

- Office in workshop paintwork in a poor condition and cracks noted. Walls to be rubbed down, primed and repainted. Water damage to walls - leaks / damp to be located and addressed. REFER TO IMAGE BELOW.

- Offices in workshop: water damage to ceilings - ceilings to be removed and replaced with new to match. REFER TO IMAGE BELOW.
- Sisalation is damaged at various points - recommend replacing with new. Roof to be checked for any leaks / damage and to be repaired. REFER TO IMAGES BELOW.

- Roof slab over passage / offices & ablutions is showing water damage - roof slab to be inspected for damage and to be resealed / re-waterproofed as per Structural Engineer's report. REFER TO IMAGES BELOW.

- Underside of slab (ablutions, offices and passage) to be rubbed down, primed and repainted. All light fittings are to be inspected for water damage and replaced if required. Edging along underside of slab to be removed and replaced with new. REFER TO IMAGES BELOW.

- Extensive damp and water damage to internal walls of ablutions - address leaks and waterproof walls. Rub down paint, prime and repaint.
- Internal walls tiles in ablutions to be removed and replaced with new to match. REFER TO SPEC BELOW.

- Cracked glazing in ablutions to be removed and replaced with new to match. REFER TO IMAGE BELOW.
- Recommend installing vinyl film to ablution windows.

- Extensive structural damage to floors in ablutions to be repaired as per Structural Engineer's report.
- Could not gain access to the other half of the ablutions / changerooms.

- Timber entrance doors to ablutions to be removed and replaced with new. REFER TO DETAIL BELOW.
- Timber slatted walls of office in workshop is rotting and damaged - recommend replacing timber slats with new to match.

- Corrosion to window frames, sand off as much rust as possible, apply rust inhibiting primer to restore the steel, prime and paint. Where it cannot be restored, to be replaced with new to match existing.

- Parapet capping of sawtooth roof is in a poor condition - recommend closer inspection to determine issue and make good. REFER TO IMAGE BELOW.
- No access into some of the offices & workshop for assessment.

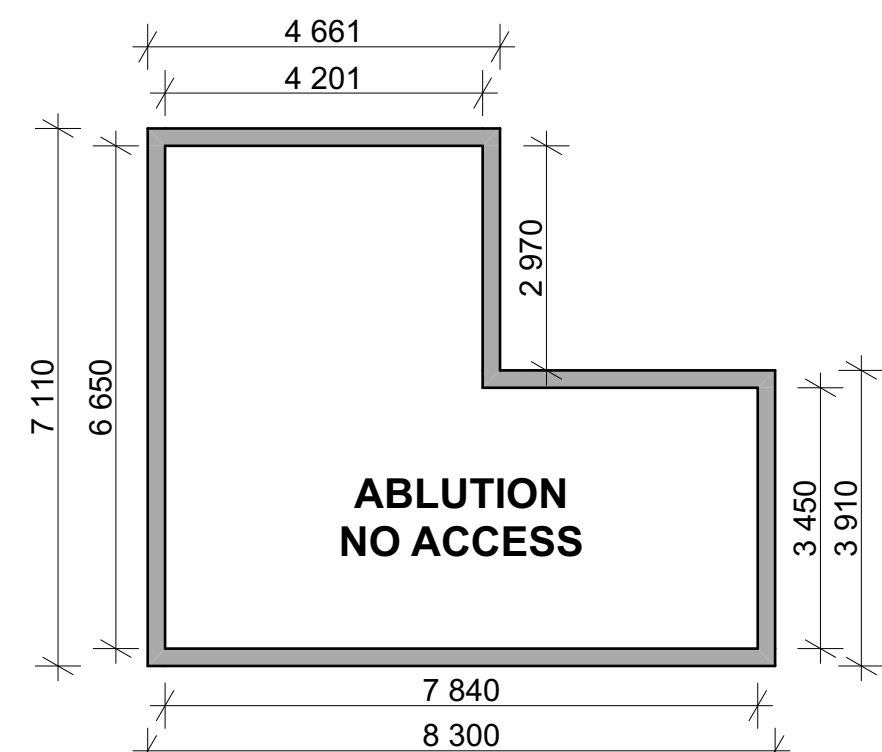
**BLOCK O1 - TOILETS
FLOOR PLAN - SCALE 1:100**

BLOCK O1 - COMBINED ABLUTIONS: Scope of Works
NO ACCESS FOR ASSESSMENT.

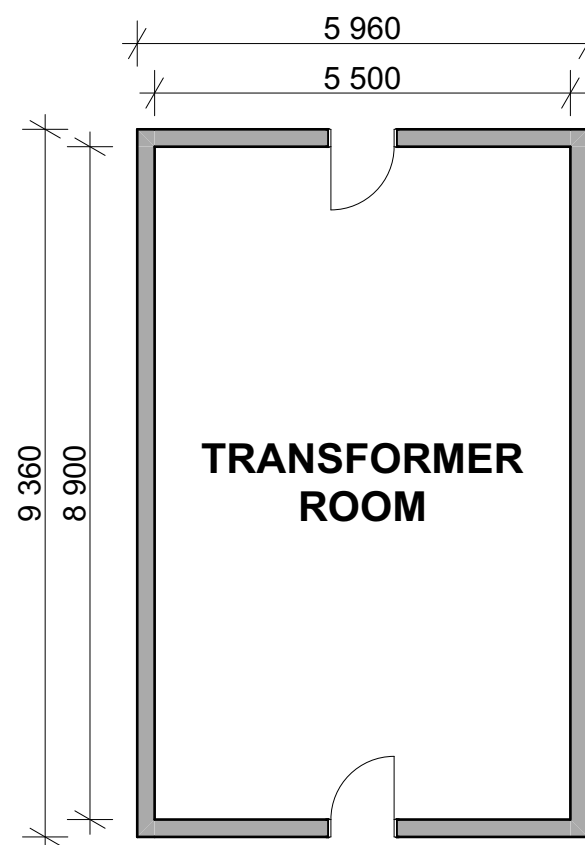
**BLOCK AG - TRANSFORMER
ROOM FLOOR PLAN - SCALE
1:100**

- Cracks noted on external walls, refer to Structural Engineer's report for repair. Once repair work is done, prime and repaint.
- External paintwork in a poor condition, rub down walls, prime and repaint. REFER TO IMAGE BELOW.
- Remove and replace 2 x damaged entrance doors. REFER TO SPEC BELOW.
- No access into internal space for assessment.
- Roof slab to be inspected for damage and repaired or waterproofed if required.

REPLACE 2 x ENTRANCE DOORS
