CONDITION ASSESSMENT
HTS WELKOM HOSTEL

EXISTING BUILDINGS
REFURBISHMENT SCOPE OF WORKS

082-HTSWEL-112

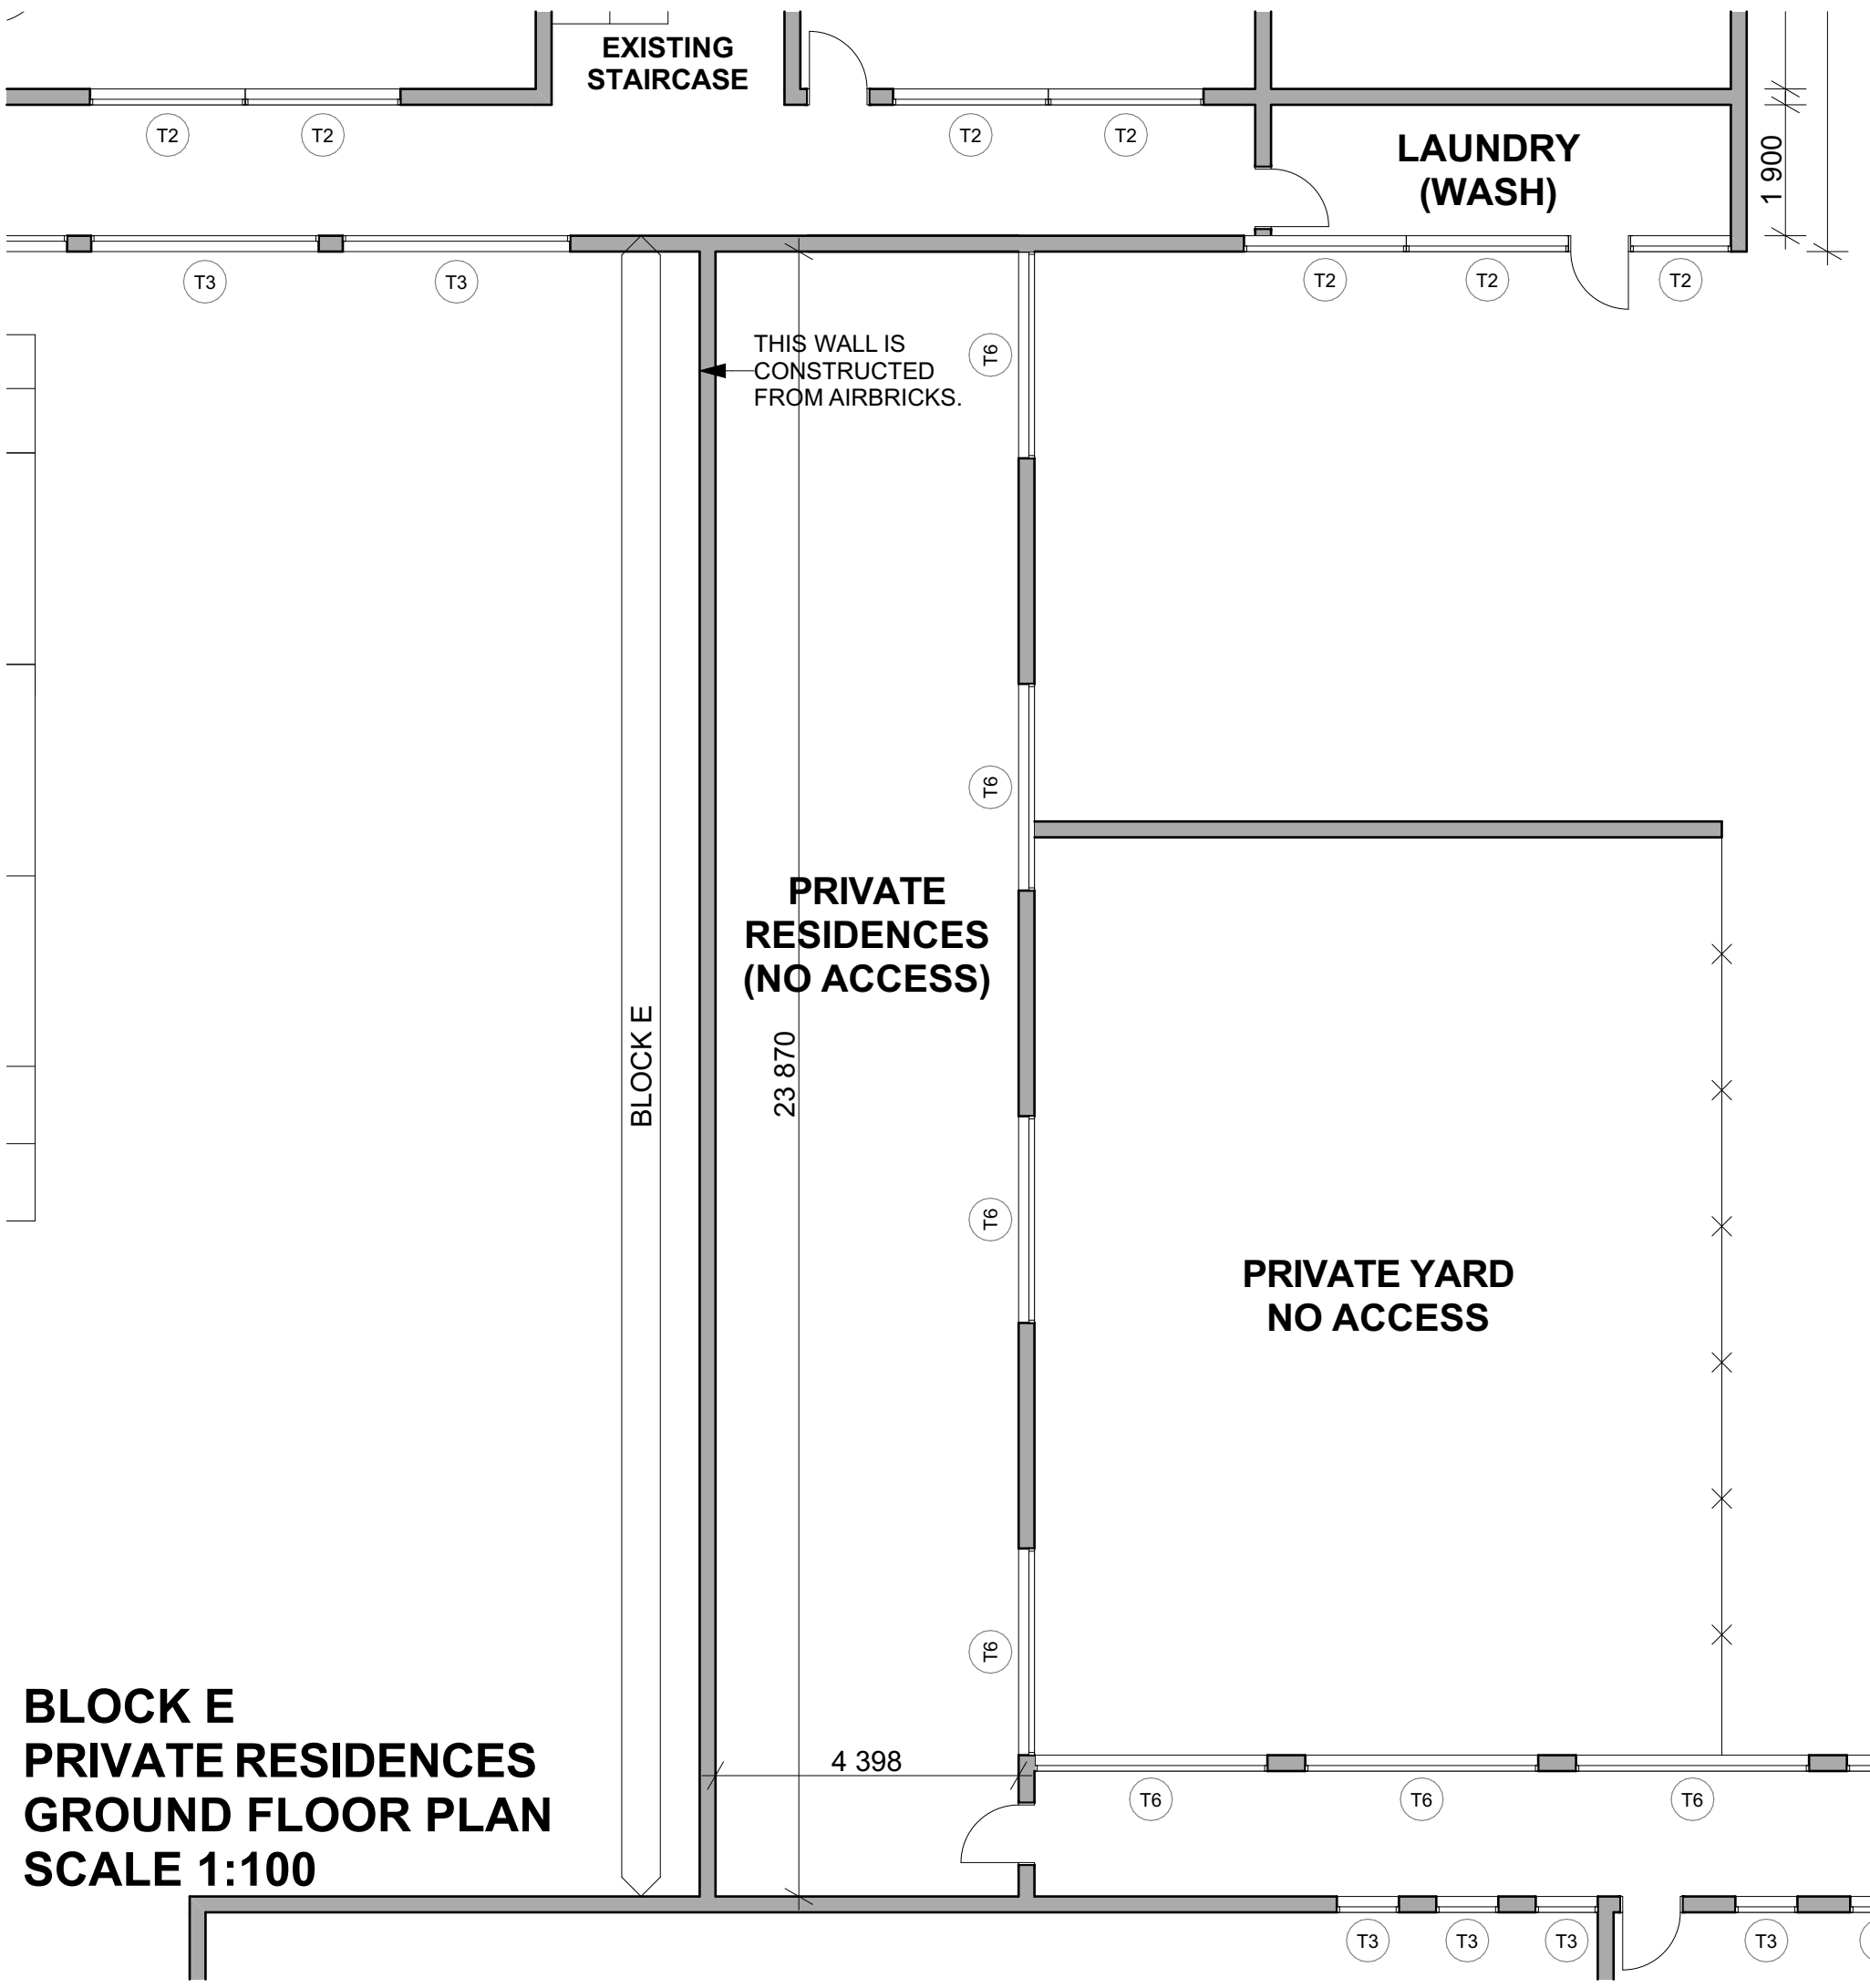
NO INTERNAL ACCESS FOR ASSESSMENT.
EXTERIOR: Refer to Engineer's report for assessment.
1. Damage to brickwork - refer to Engineer's report for replacement.
2. Missing brickwork - replace with new to match existing. REFER TO IMAGE BELOW.

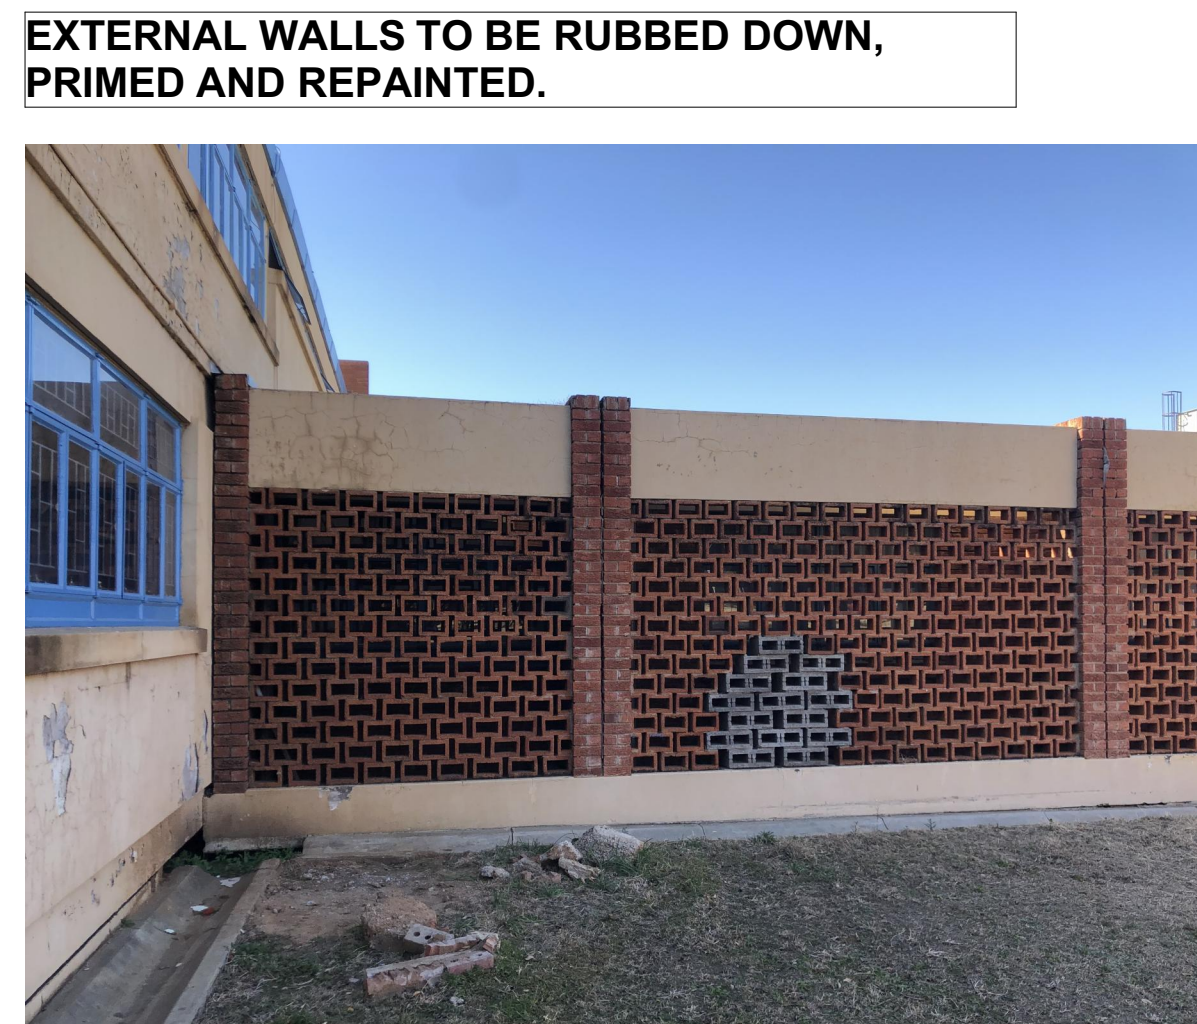
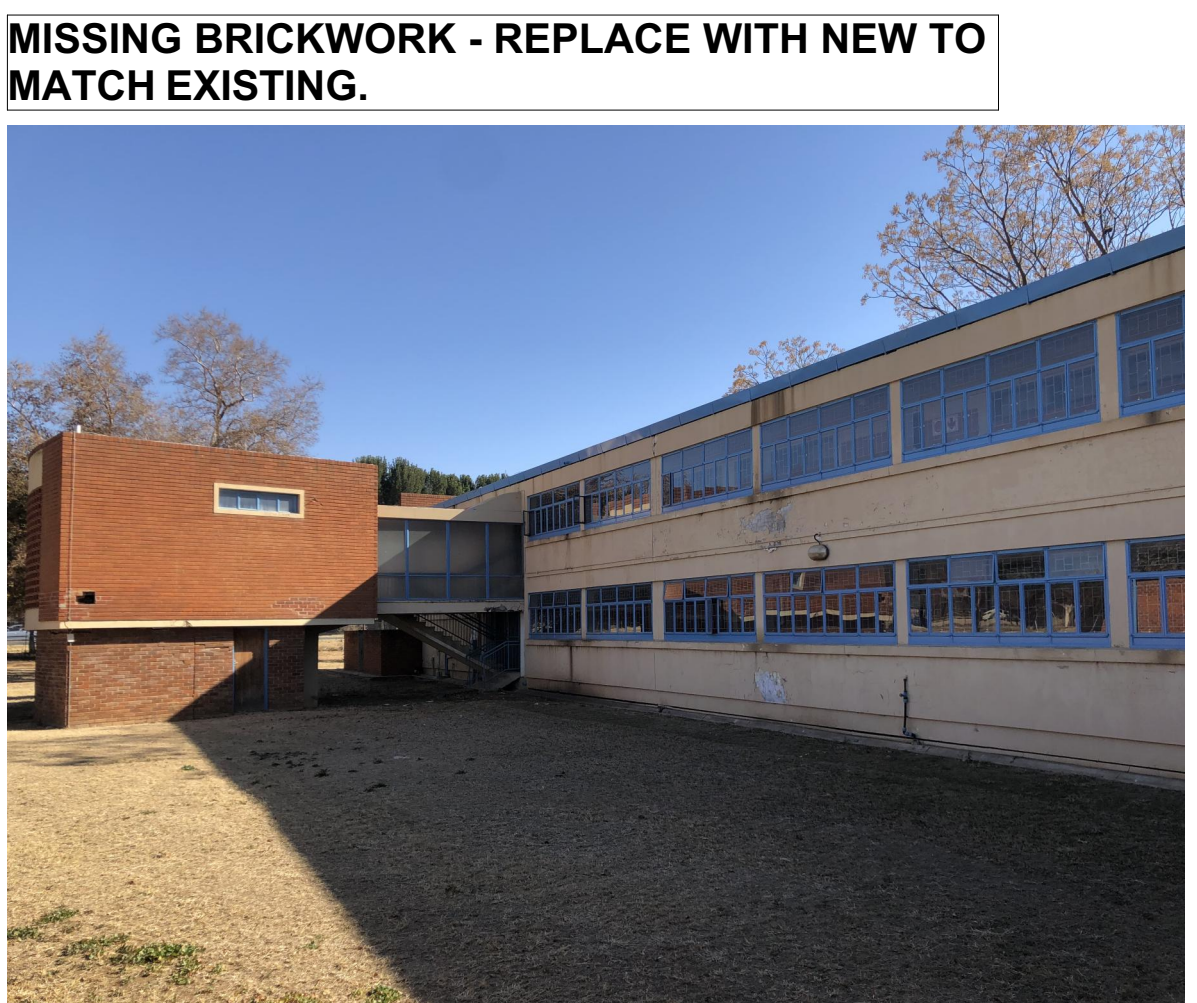
EXTERNAL PAINTWORK IN A POOR CONDITION. RECOMMEND FINDING ANY LEAKS, WATERPROOFING AND REPAINTING.
