BLOCK C - NUTRITION: Scope of Works

| Project: | CONDITION ASSESSMENT HTS WELKOM HOSTEL |

| Drawing description: | EXISTING BUILDINGS SITE DEVELOPMENT PLAN |

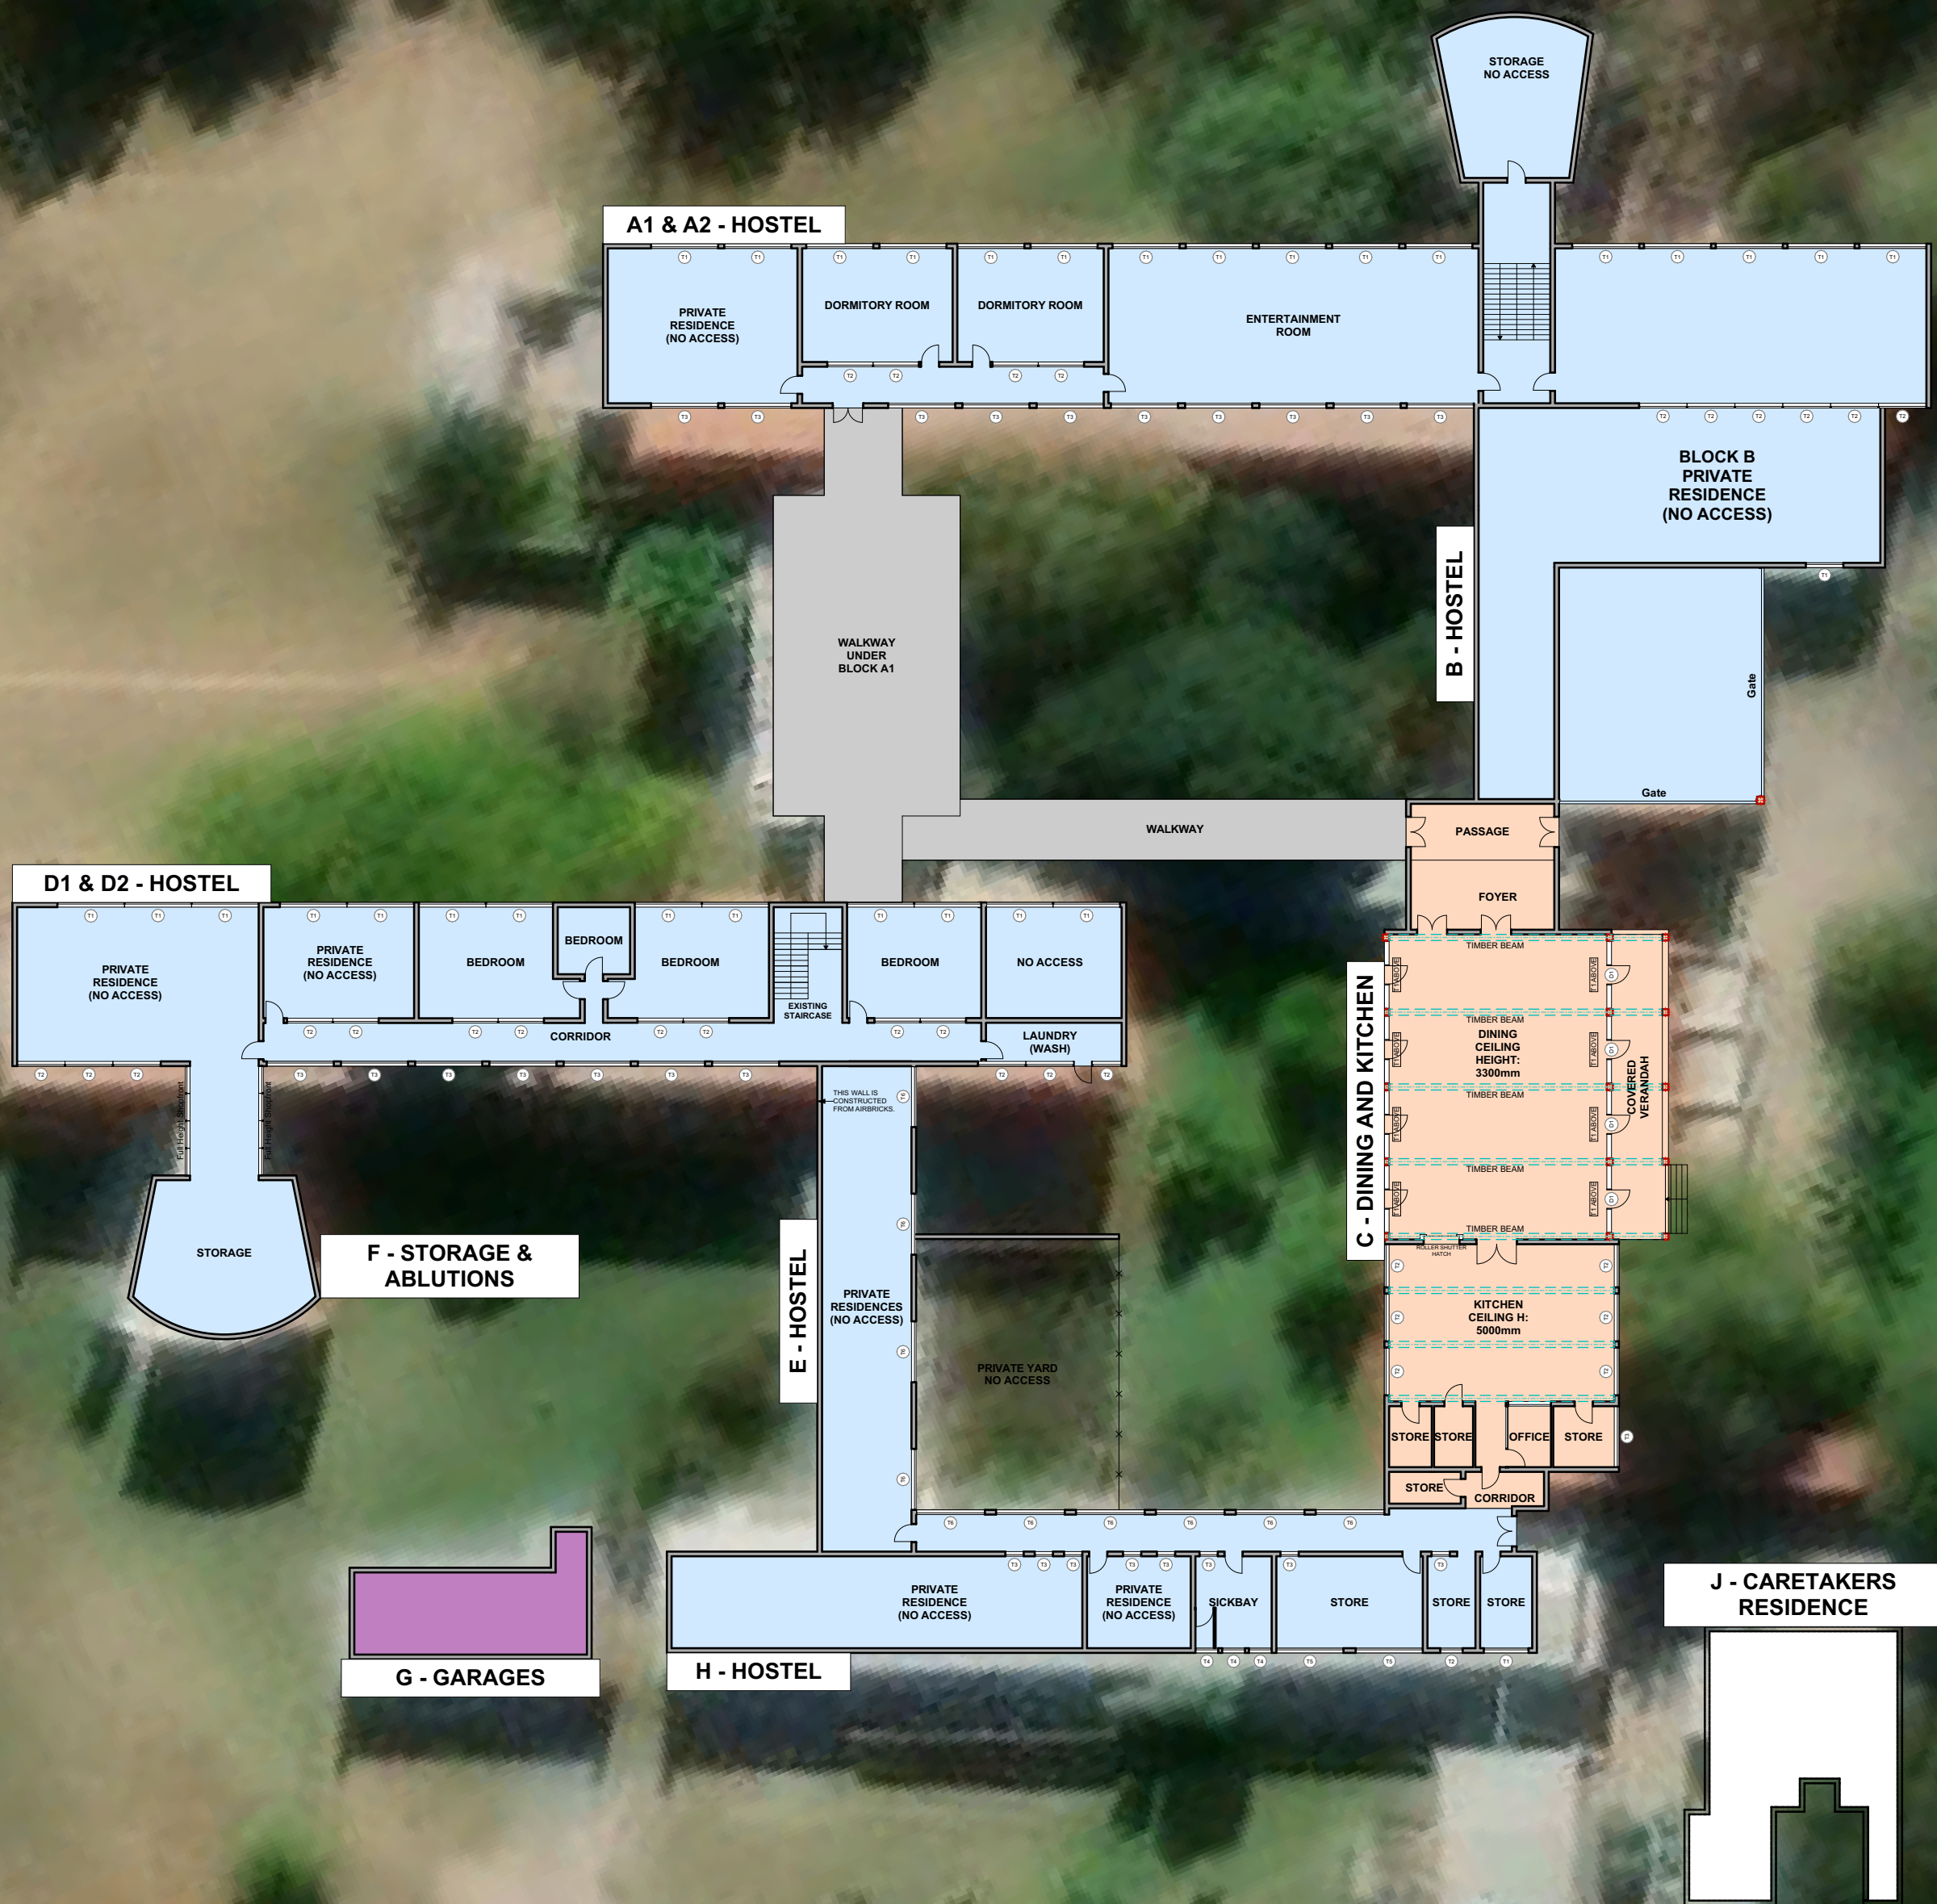
LEGEND:

- WALKWAYS
- HOSTEL
- KITCHEN AND DINING
- SPECTATOR STANDS
- GARAGES
- CARETAKERS RESIDENCE
