GEOTECHNICAL REPORT

FOR THE PROPOSED DIKIDIKINI PEDESTRIAN BRIDGE, NTABANKULU LOCAL MUNICIPALITY, PROVINCE OF THE EASTERN CAPE

31 January 2023 (Rev 1)

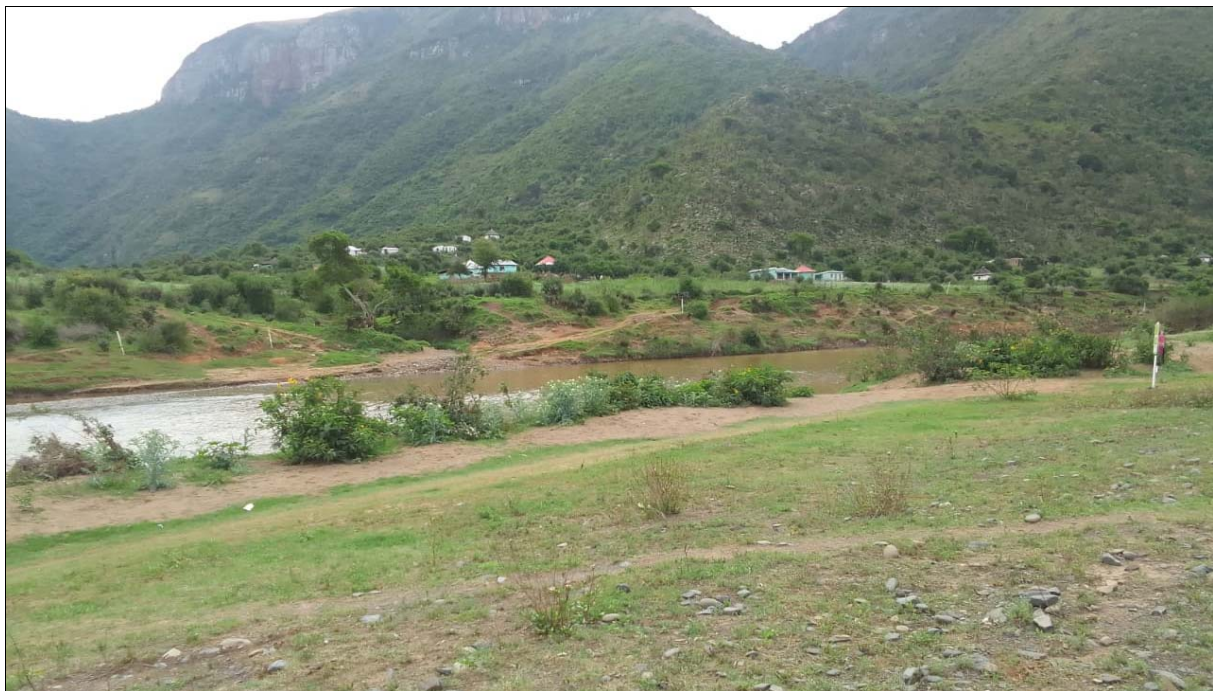
Figure 4: View of the proposed bridge site from the eastern side, looking across to the western side

The topography on the eastern side of the river was described as a gentle slope down to the rivers edge (see **Figure 4**). By contrast, the topography on the western side was characterised by a steeper incline up from the waters edge onto a flood plain at an elevation of about 3-4m above the river level. See **Figure 5**.

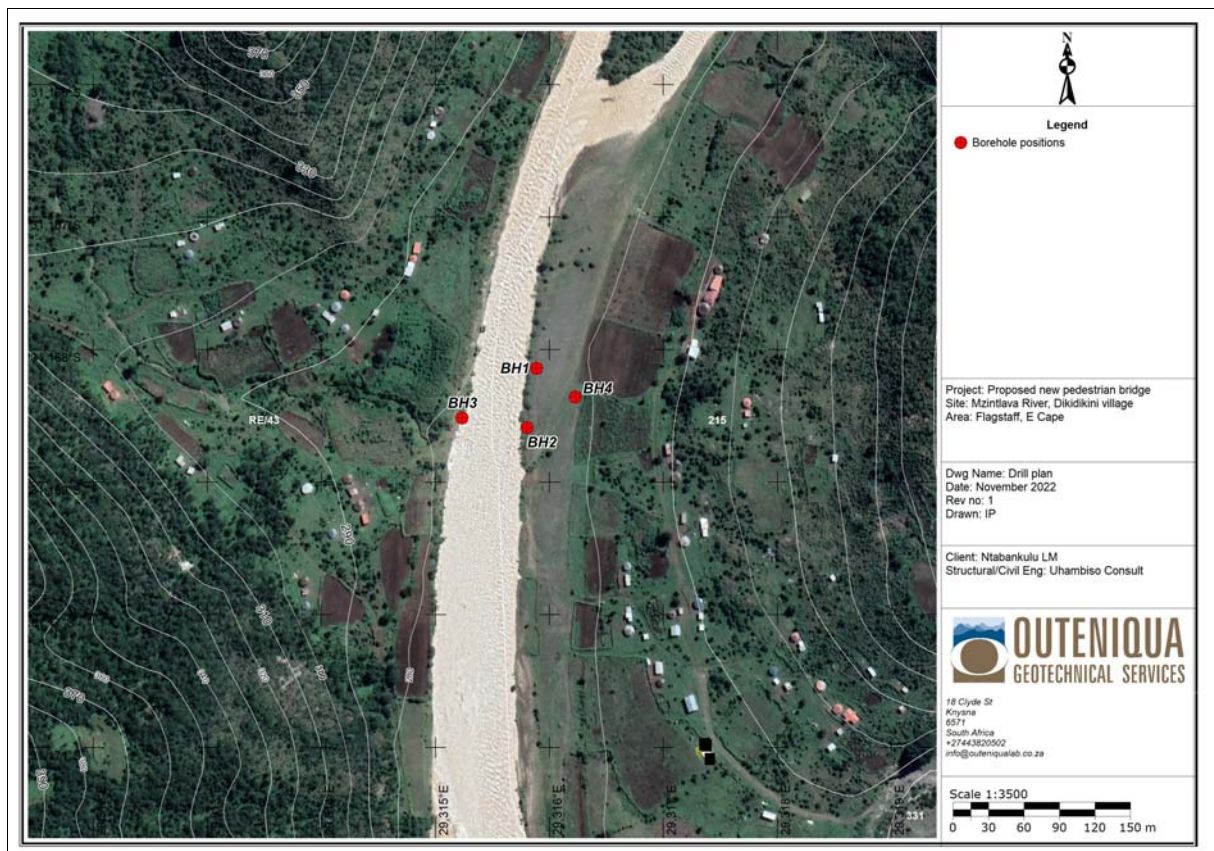
Figure 6: Map of borehole positions

An initial desk study of available information was conducted to assess the site topography, geology and any obvious geotechnical issues. This was followed by a subsurface investigation consisting of four rotary core boreholes, drilled vertically to a depth of 15m to determine the subsurface profile. Three boreholes were drilled on the east side of the river (BH1, 2 & 4) and one was drilled on the western side (BH3 - see **Figure 6**). The borehole logs were included in **Appendix 2** of this report.

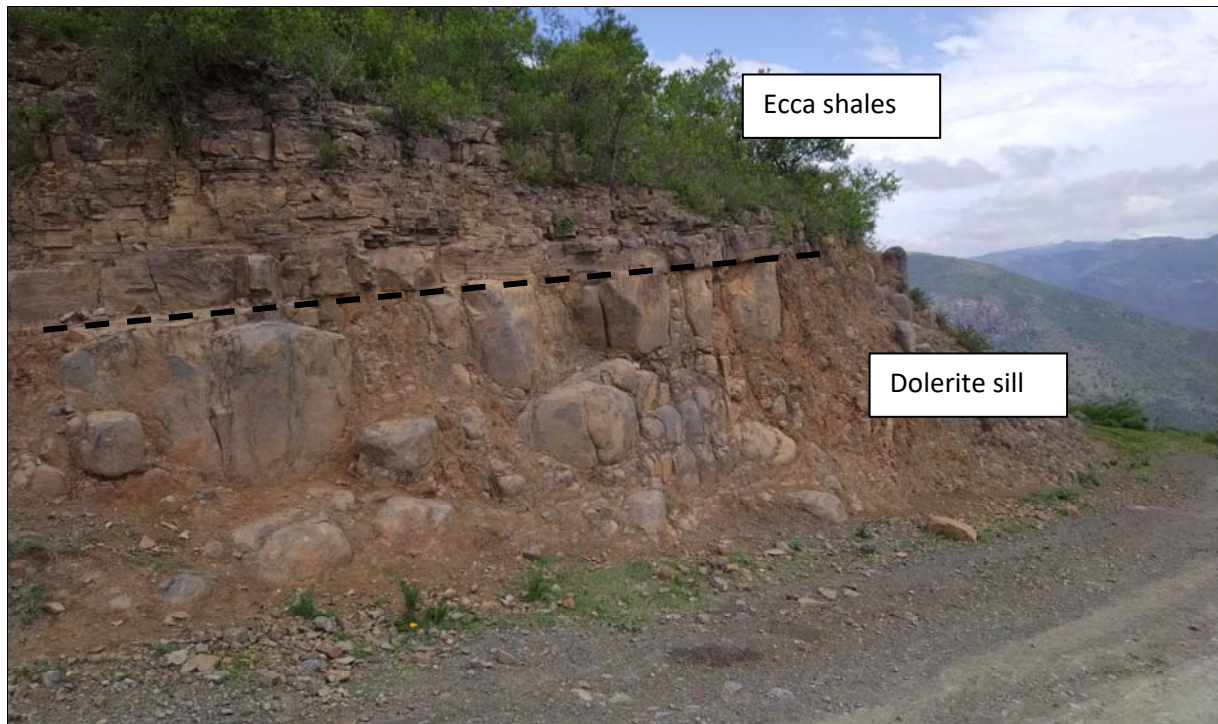
Figure 8: Dolerite sill intruded into shale of the Ecce Formation exposed in road cutting near site

The 1:250 000 geological map indicated that the area was underlain by an extensive system of dolerite sills and dykes of Jurassic age (indicated in red in **Figure 7**), which had intruded into dark grey shale of the Eccia Group (indicated in brown in **Figure 7**). The dolerite and shale were well exposed in road cuttings near the site (See **Figures 8 & 9**). Locally, thick deposits of alluvium covered the bedrock formations along the river banks (See **Figure 10**).

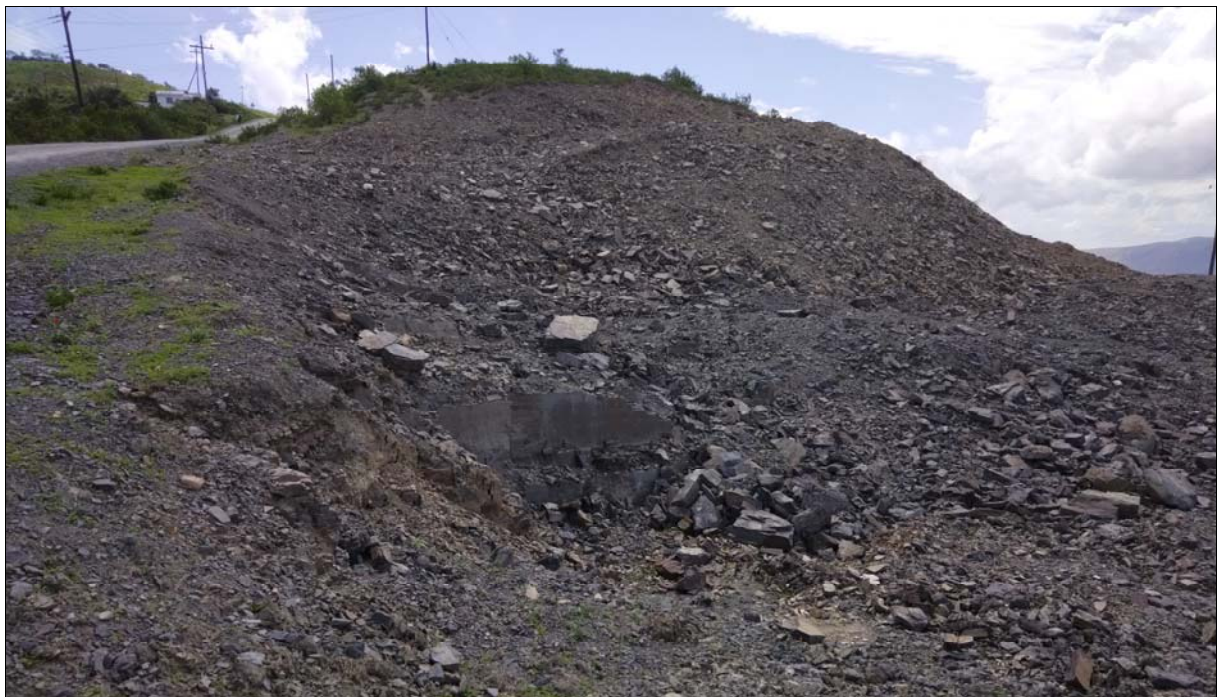
Figure 9: Grey shales of the Ecce Group exposed in local borrow pit

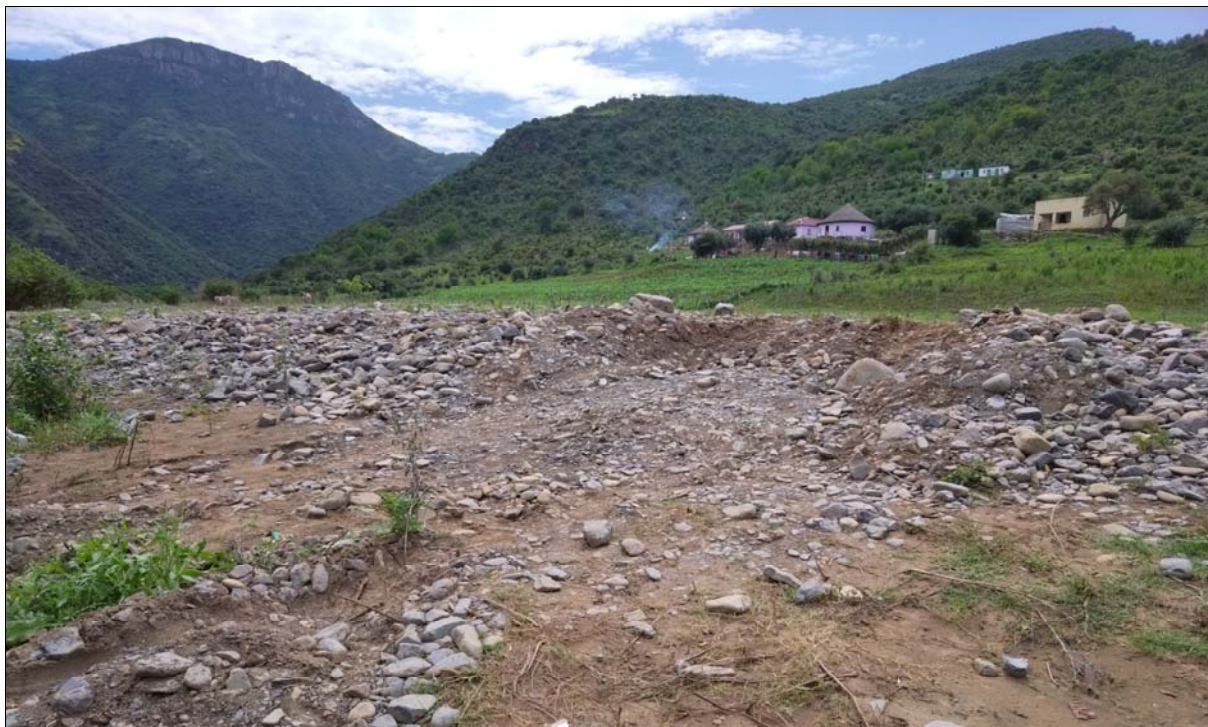
Figure 10: Alluvial cobbles and boulders covering the riverbanks

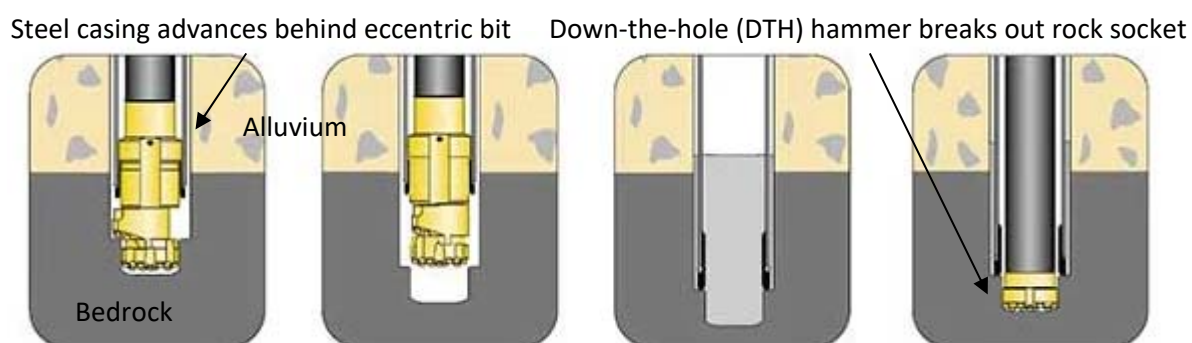
The recommendation for the bridge foundations was permanently cased, rotary bored, reinforced concrete ODEX piles, socketed into the underlying bedrock. ODEX piling is a percussion drilling system which uses an eccentric drilling system to advance a steel casing through the overburden soil and also allows hammering of rock to form the required socket (See **Figure 11**). The steel casing being necessary to isolate the concrete from the groundwater. A minimum 1.5m rock socket and minimum pile length of 10m was estimated for preliminary costing purposes but should be checked by the pile designer against the calculated moments and shear forces.

Figure 11: Odex piling system (www.prdrigs.com/odex-drilling)

Due to access restrictions to the western side, consideration should be given to the size of the rig (and therefore the diameter of the piles) as the rig may have to be floated across the river on a barge or across a temporary jetty (A possible alternative if the river is shallow enough at the time of construction, is that the rig be driven across the river). In such cases, pile diameters in the order of 200-300mm should be considered. A Casagrande C6 rig would be appropriate for such applications, but again this would have

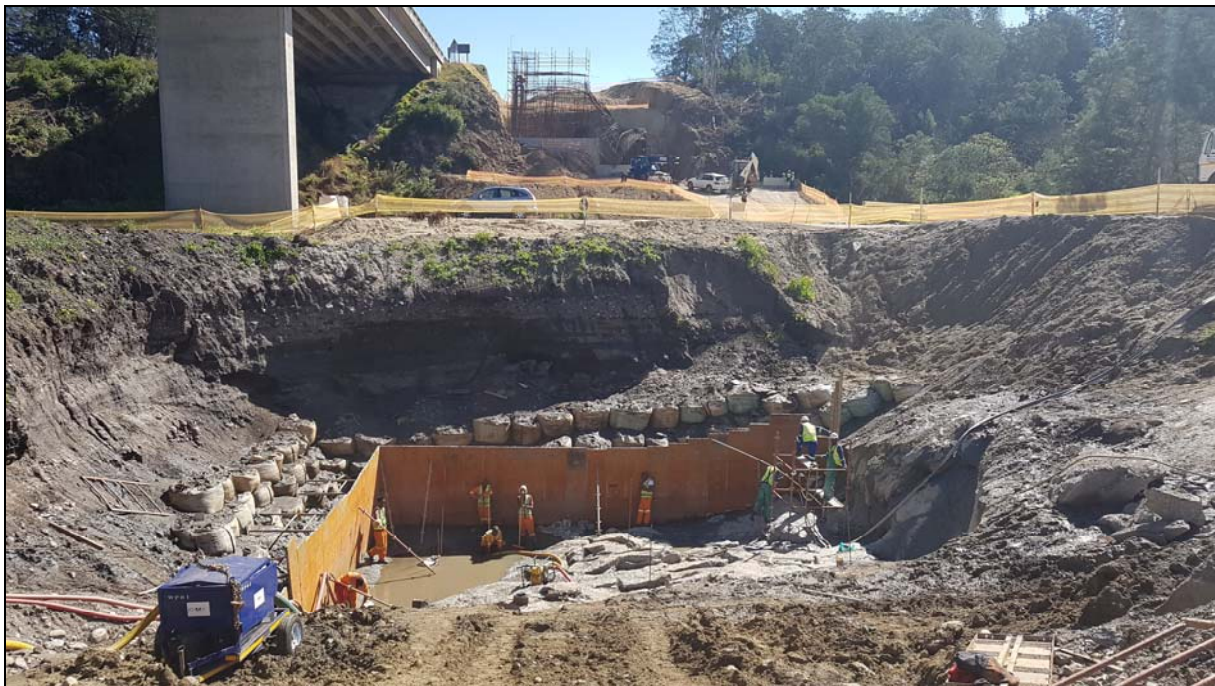
Alternative shallow foundation systems, such as RC spread/base footings, would likely involve deep excavations with attendant lateral stability problems, mainly due to shallow groundwater tables, requiring significant dewatering systems which may be difficult to achieve (See **Figure 12**).

Figure 12: Deep excavations, lateral support and dewatering for bridge pad foundations

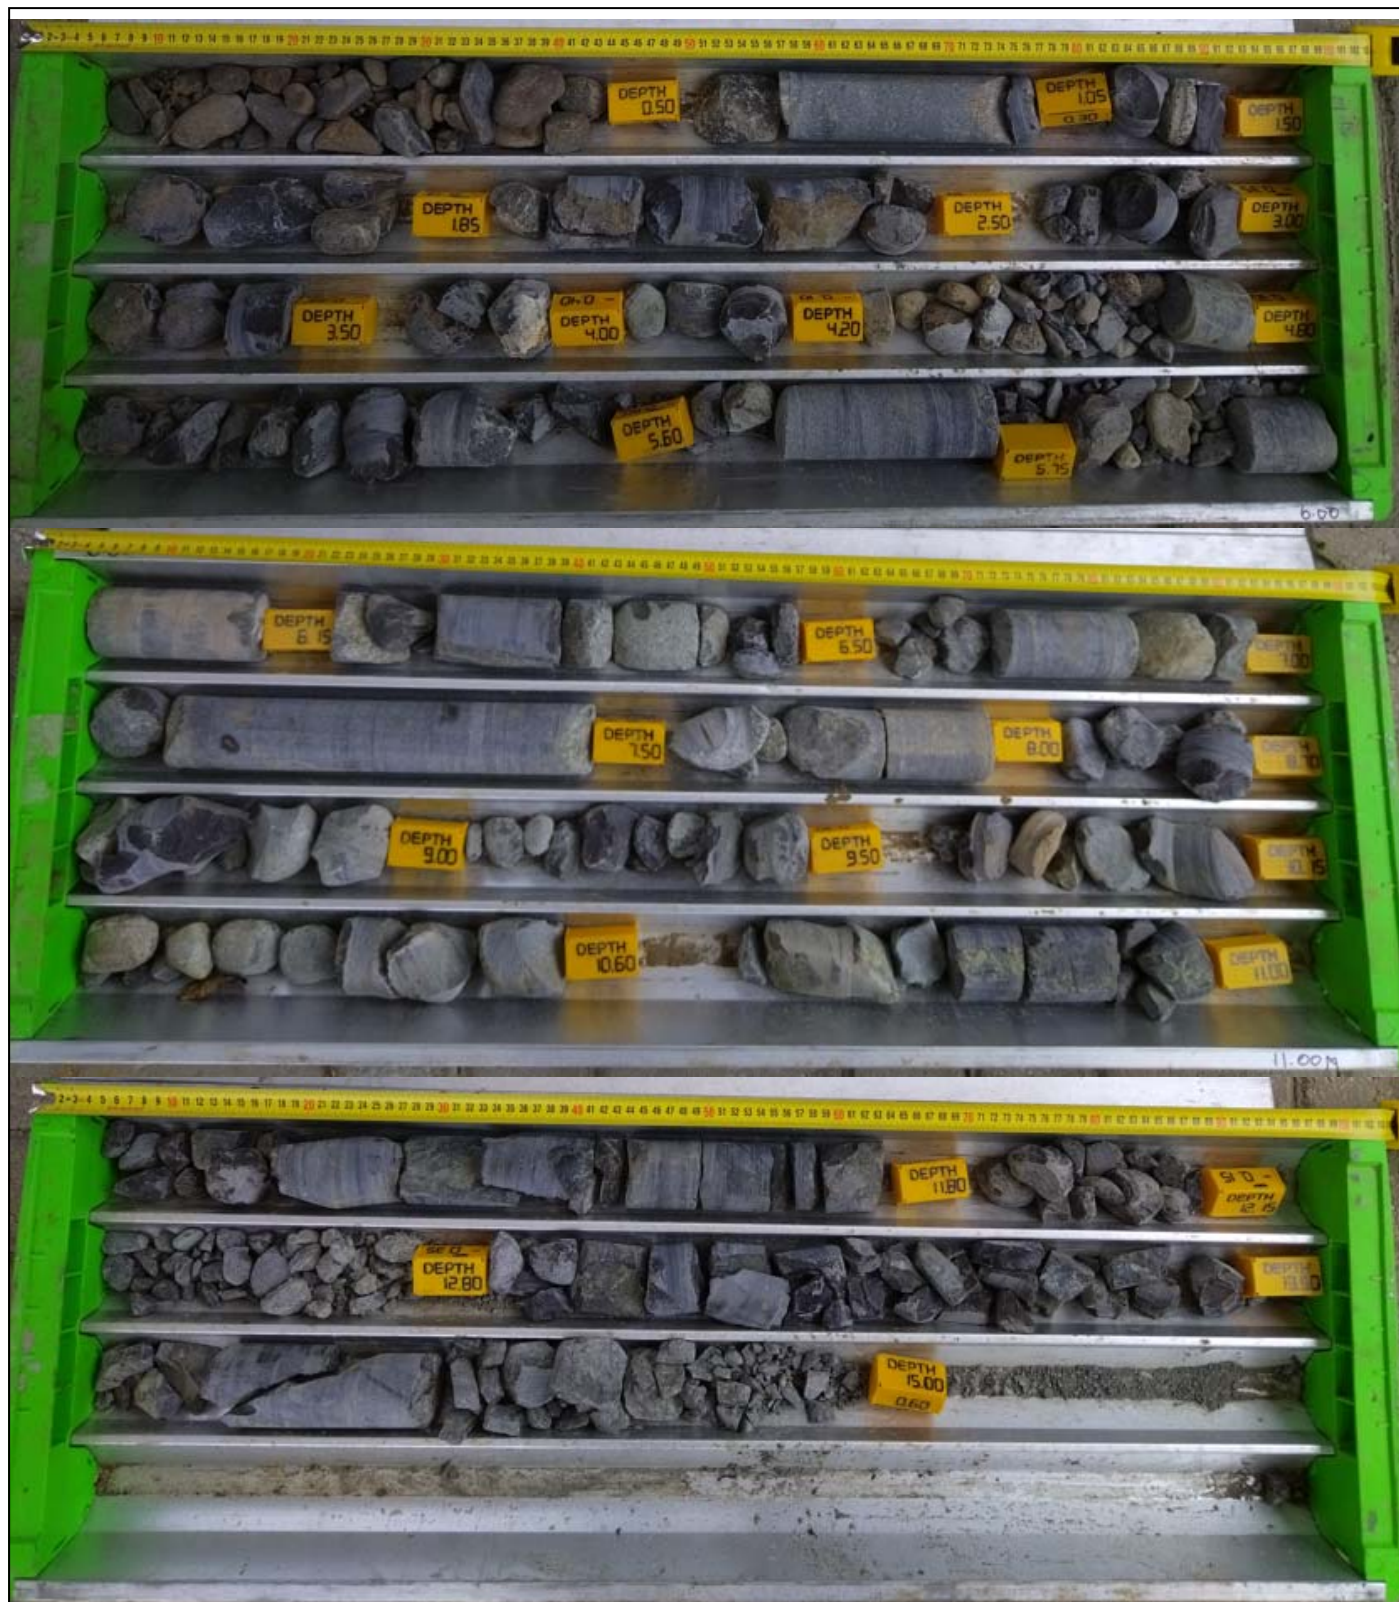
HOLE No: BH4
Sheet 1 of 1

REDUCED LEVEL	Core size	Mat. recov. (%)	Core recov. (%)	RQD (%)	Frac. Freq.	PLT/ Is50 (MPa)	UCS/ UCM (MPa)	Hard-ness	Weath-ering	DEPTH Scale 1:75	CONTRACTOR : Earthtech MACHINE : XY DRILLED BY : Carel PROFILED BY : S Gallant TYPE SET BY : S Gallant SETUP FILE : OGS_BH-3.SET	INCLINATION : -90° DIAM : DATE : 09/12/2022-18/12/2022 DATE : 11/01/2023 DATE : 05/02/2023 15:09 TEXT : ..ing\DrillingData\BH4.txt	ELEVATION : X-COORD : -3449682.95 Y-COORD : 30147.95
---------------	-----------	-----------------	-----------------	---------	-------------	-----------------	----------------	-----------	-------------	------------------	---	---	--

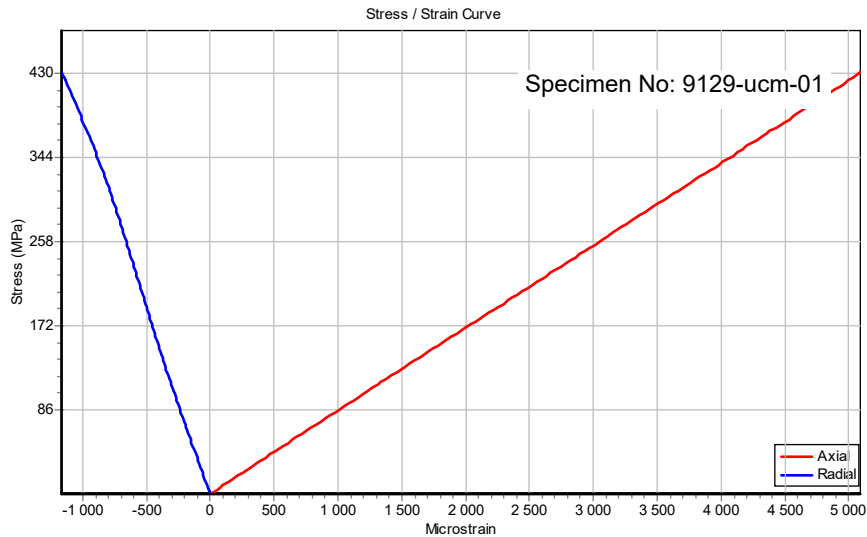
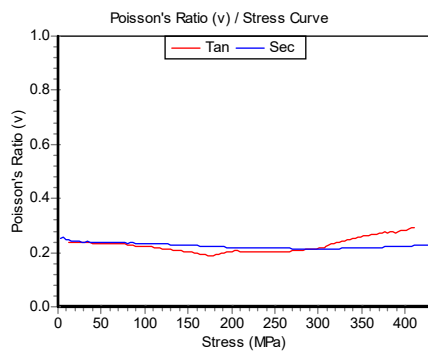
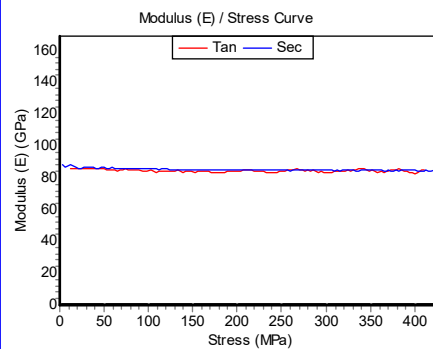
WITH ELASTIC MODULUS AND POISSON'S RATIO MEASUREMENTS BY MEANS OF STRAIN GAUGES

Failure Load: 1228 kN

Peak Strength: 430.7 MPa

Axial Strain at Failure: 5091 microstrain

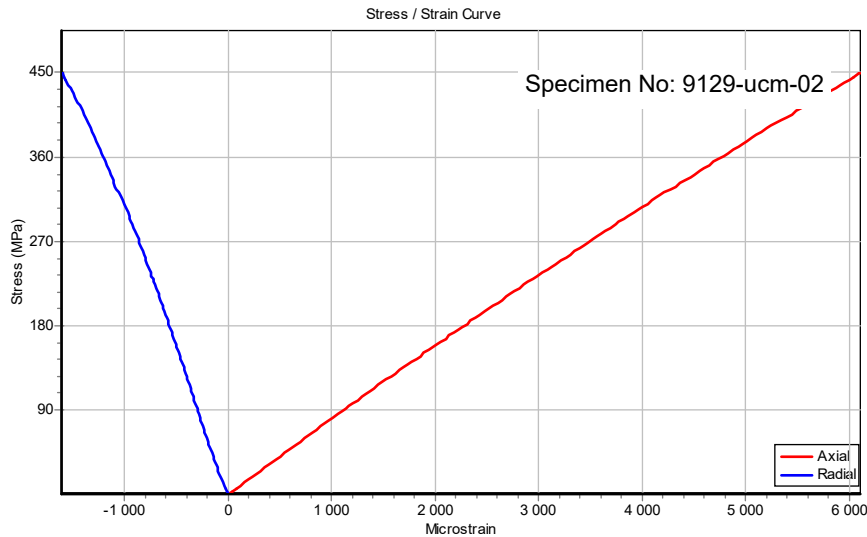
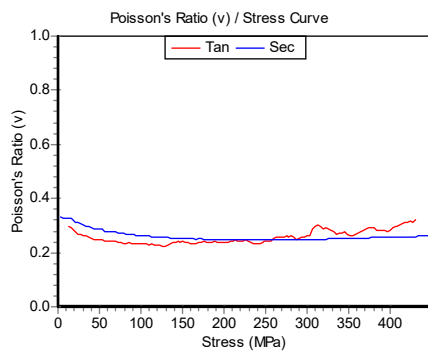
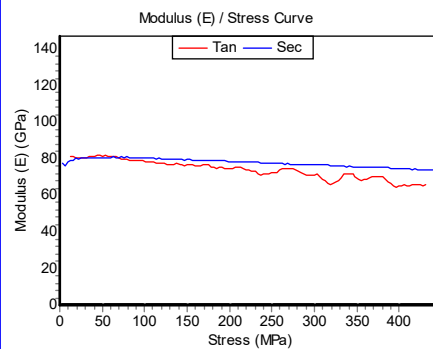
WITH ELASTIC MODULUS AND POISSON'S RATIO MEASUREMENTS BY MEANS OF STRAIN GAUGES

Failure Load: 1277 kN

Peak Strength: 449.8 MPa

Axial Strain at Failure: 6109 microstrain

SPECIMEN DETAILS				SPECIMEN DIMENSIONS						SPECIMEN TEST RESULTS								
Rocklab Specimen No	Borehole No	Depth		Description	Diameter	Height	Ratio of Height to diameter	Mass	Density	Failure Load	Strength (UCS)	Tangent Elastic Modulus @ 50% UCS GPa	Secant Elastic Modulus @ 50% UCS GPa	Poisson's Ratio Tangent @ 50% UCS	Poisson's Ratio Secant @ 50% UCS	Linear Axial Strain at Failure mm/mm	Failure Code	Note
		From..	To..															
9129-		m	m		mm	mm		g	g/cm³	kN	MPa							
UCM-01	BH1	8.84	9.05	Shale	60.25	128.24	2.1	977.15	2.67	1228.0	430.7	84.7	84.7	0.20	0.22	0.005091	YA	
UCM-02	BH1	12.00	12.17	Shale	60.12	130.87	2.2	1011.03	2.72	1277.0	449.8	73.5	78.2	0.25	0.25	0.006109	YA

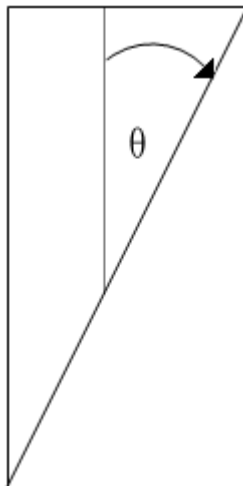
CLASSIFICATION OF ROCK SPECIMEN FAILURE MODE INFLUENCED / NOT INFLUENCED BY DISCONTINUITIES DURING COMPRESSION TESTING

FAILURE NOT INFLUENCED BY DISCONTINUITIES (INTACT)

TYPE CODE	DESCRIPTION OF SUB CODES	
	A	B
X	SINGLE SLIDING SHEAR FAILURE	COMPLETE CONE DEVELOPMENT
Y	SPLITTING

FAILURE INFLUENCED BY DISCONTINUITIES

TYPE CODE	DESCRIPTION OF SUB CODES	
	A	B
	PARTIAL FAILURE ON DISCONTINUITY	FAILURE COMPLETELY ON DISCONTINUITY
1	AT 0-10° TO AXIS	AT 0-10° TO AXIS
2	AT 11-20° TO AXIS	AT 11-20° TO AXIS
3	AT 21-30° TO AXIS	AT 21-30° TO AXIS
4	AT 31-40° TO AXIS	AT 31-40° TO AXIS
5	AT 41-50° TO AXIS	AT 41-50° TO AXIS
6	AT 51-70° TO AXIS	AT 51-70° TO AXIS
7	AT 71-90° TO AXIS	AT 71-90° TO AXIS
0	Multiple Discontinuities	Multiple Discontinuities

Example: Failure Type3B: Failure completely on a discontinuity with an orientation of between 21° and 30° to the specimen axis.

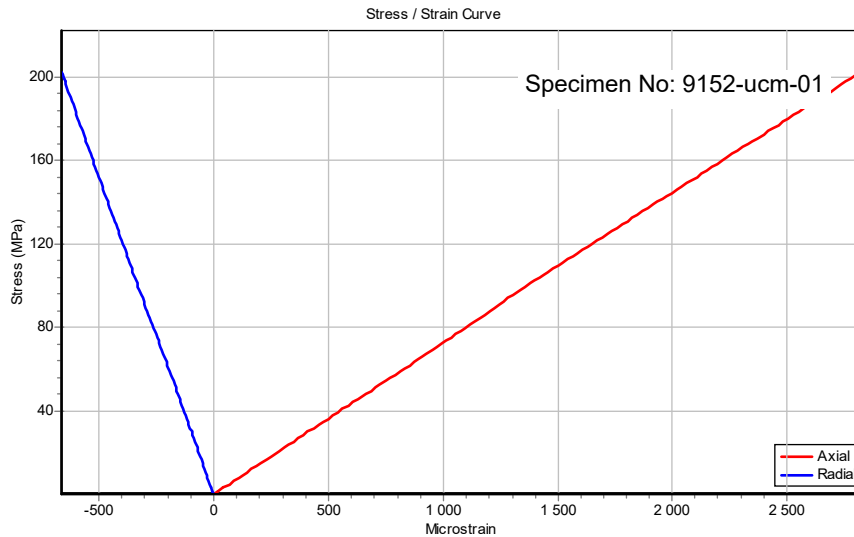
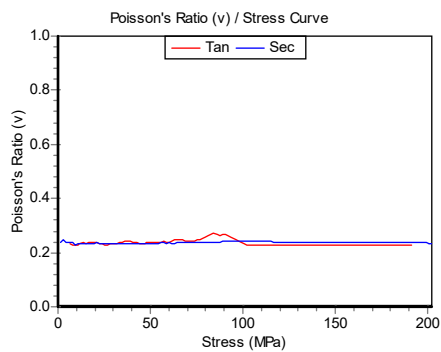
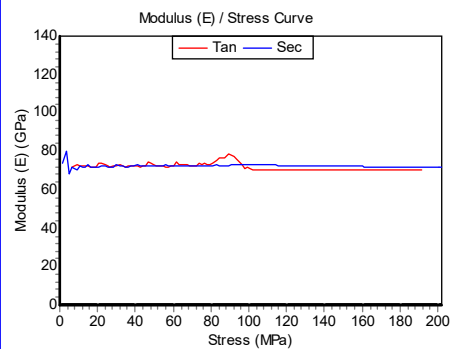
WITH ELASTIC MODULUS AND POISSON'S RATIO MEASUREMENTS BY MEANS OF STRAIN GAUGES

Failure Load: 471.3 kN

Peak Strength: 202.2 MPa

Axial Strain at Failure: 2819 microstrain

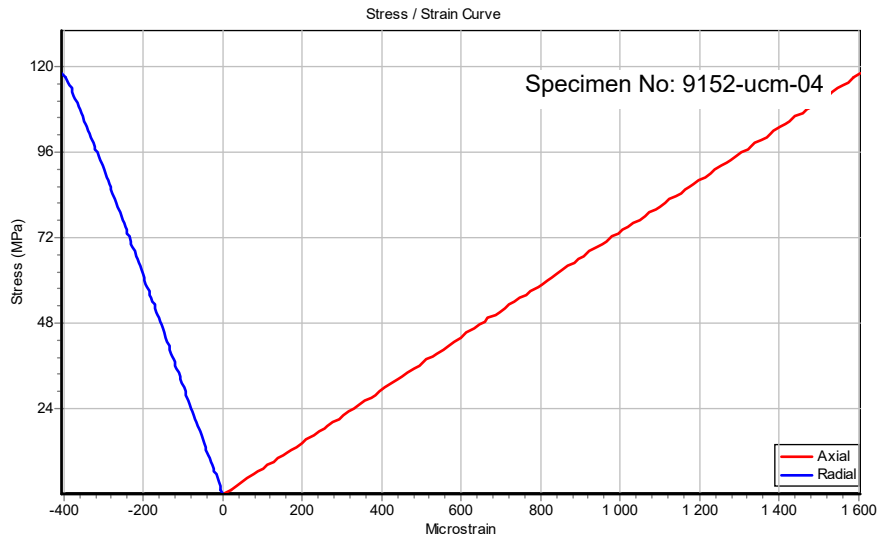
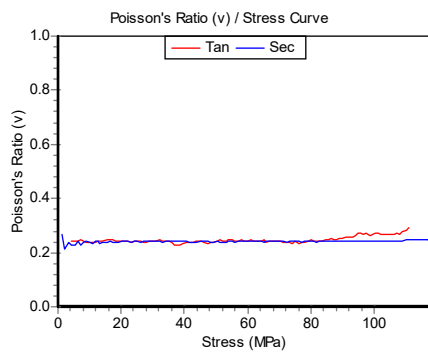
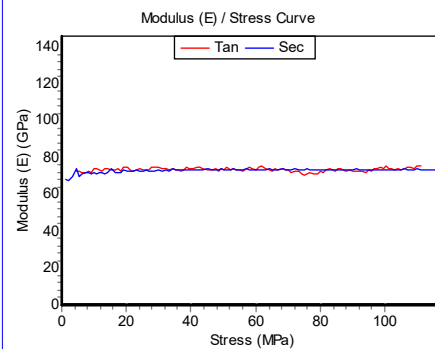
WITH ELASTIC MODULUS AND POISSON'S RATIO MEASUREMENTS BY MEANS OF STRAIN GAUGES

Failure Load: 275.8 kN

Peak Strength: 118.2 MPa

Axial Strain at Failure: 1605 microstrain

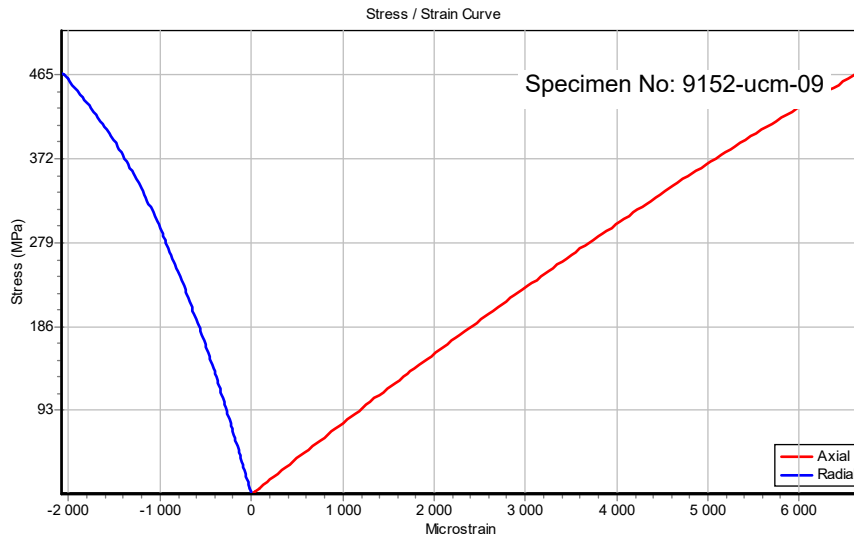
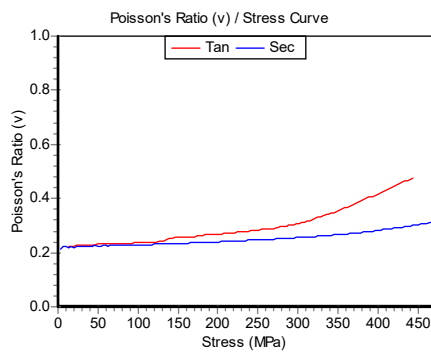
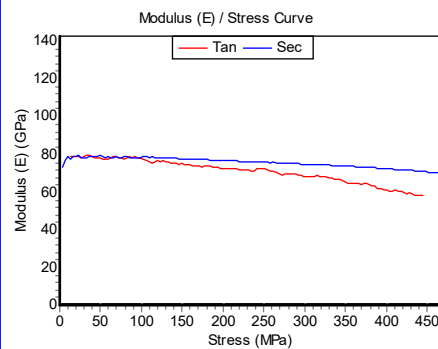
WITH ELASTIC MODULUS AND POISSON'S RATIO MEASUREMENTS BY MEANS OF STRAIN GAUGES

Failure Load: 1091 kN

Peak Strength: 467.3 MPa

Axial Strain at Failure: 6667 microstrain

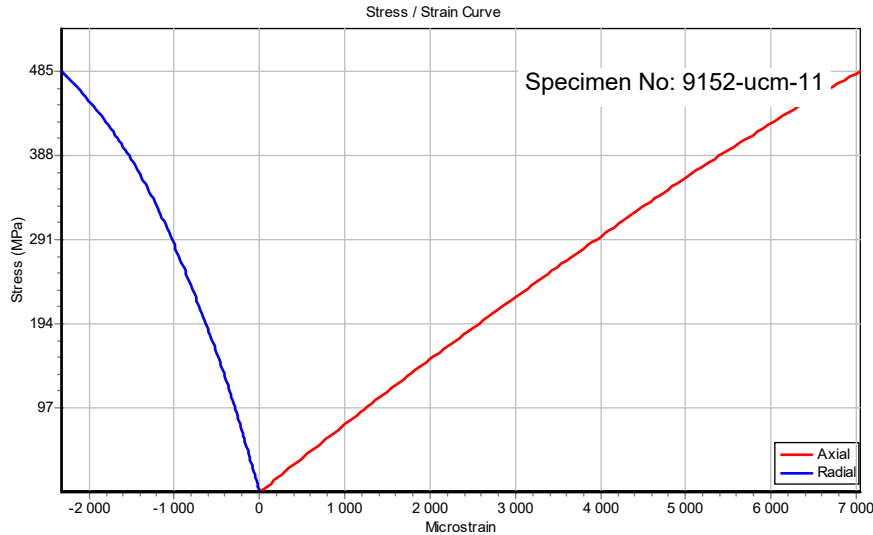
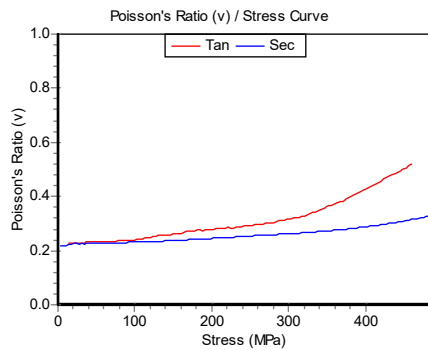
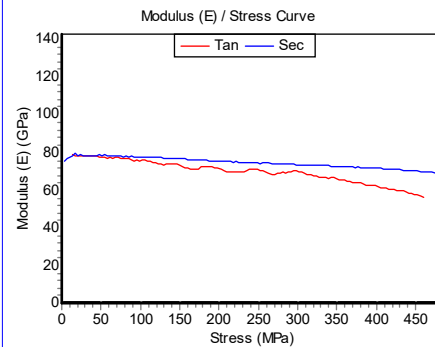
WITH ELASTIC MODULUS AND POISSON'S RATIO MEASUREMENTS BY MEANS OF STRAIN GAUGES

Failure Load: 1134 kN

Peak Strength: 485.7 MPa

Axial Strain at Failure: 7045 microstrain

SPECIMEN DETAILS					SPECIMEN DIMENSIONS						SPECIMEN TEST RESULTS								
Rocklab Specimen No	Borehole ID	Sample No	Depth		Rock Type	Diameter mm	Height mm	Ratio of Height to diameter	Mass g	Density g/cm³	Failure Load kN	Strength (UCS) MPa	Tangent Elastic Modulus @ 50% UCS GPa	Secant Elastic Modulus @ 50% UCS GPa	Poisson's Ratio Tangent @ 50% UCS	Poisson's Ratio Secant @ 50% UCS	Linear Axial Strain at Failure mm/mm	Failure Code	Note
			From.. m	To.. m															
9152-																			
UCM-01	BH2	BH2A	10.00	10.12	Shale	54.48	94.64	1.7	606.03	2.75	471.3	202.2	70.1	73.1	0.23	0.24	0.002819	2B	
UCM-04	BH2	BH2D	10.68	10.86	Shale	54.50	152.00	2.8	953.00	2.69	275.8	118.2	73.2	73.5	0.24	0.24	0.001605	2B	
UCM-09	BH2	BH3C	8.60	8.77	Shale	54.52	114.98	2.1	730.19	2.72	1091.0	467.3	71.4	76.2	0.28	0.25	0.006667	YA	
UCM-11	BH2	BH3F	10.80	11.00	Shale	54.52	147.55	2.7	941.65	2.73	1134.0	485.7	71.5	74.5	0.29	0.25	0.007045	YA
