Project: POPANO SECONDARY SCHOOL  
UPGRADE EXISTING LAB & CONSTRUCT  
NEW BLOCKS & LANDSCAPING

Drawing description:  
SITE DEVELOPMENT PLAN  
SDP

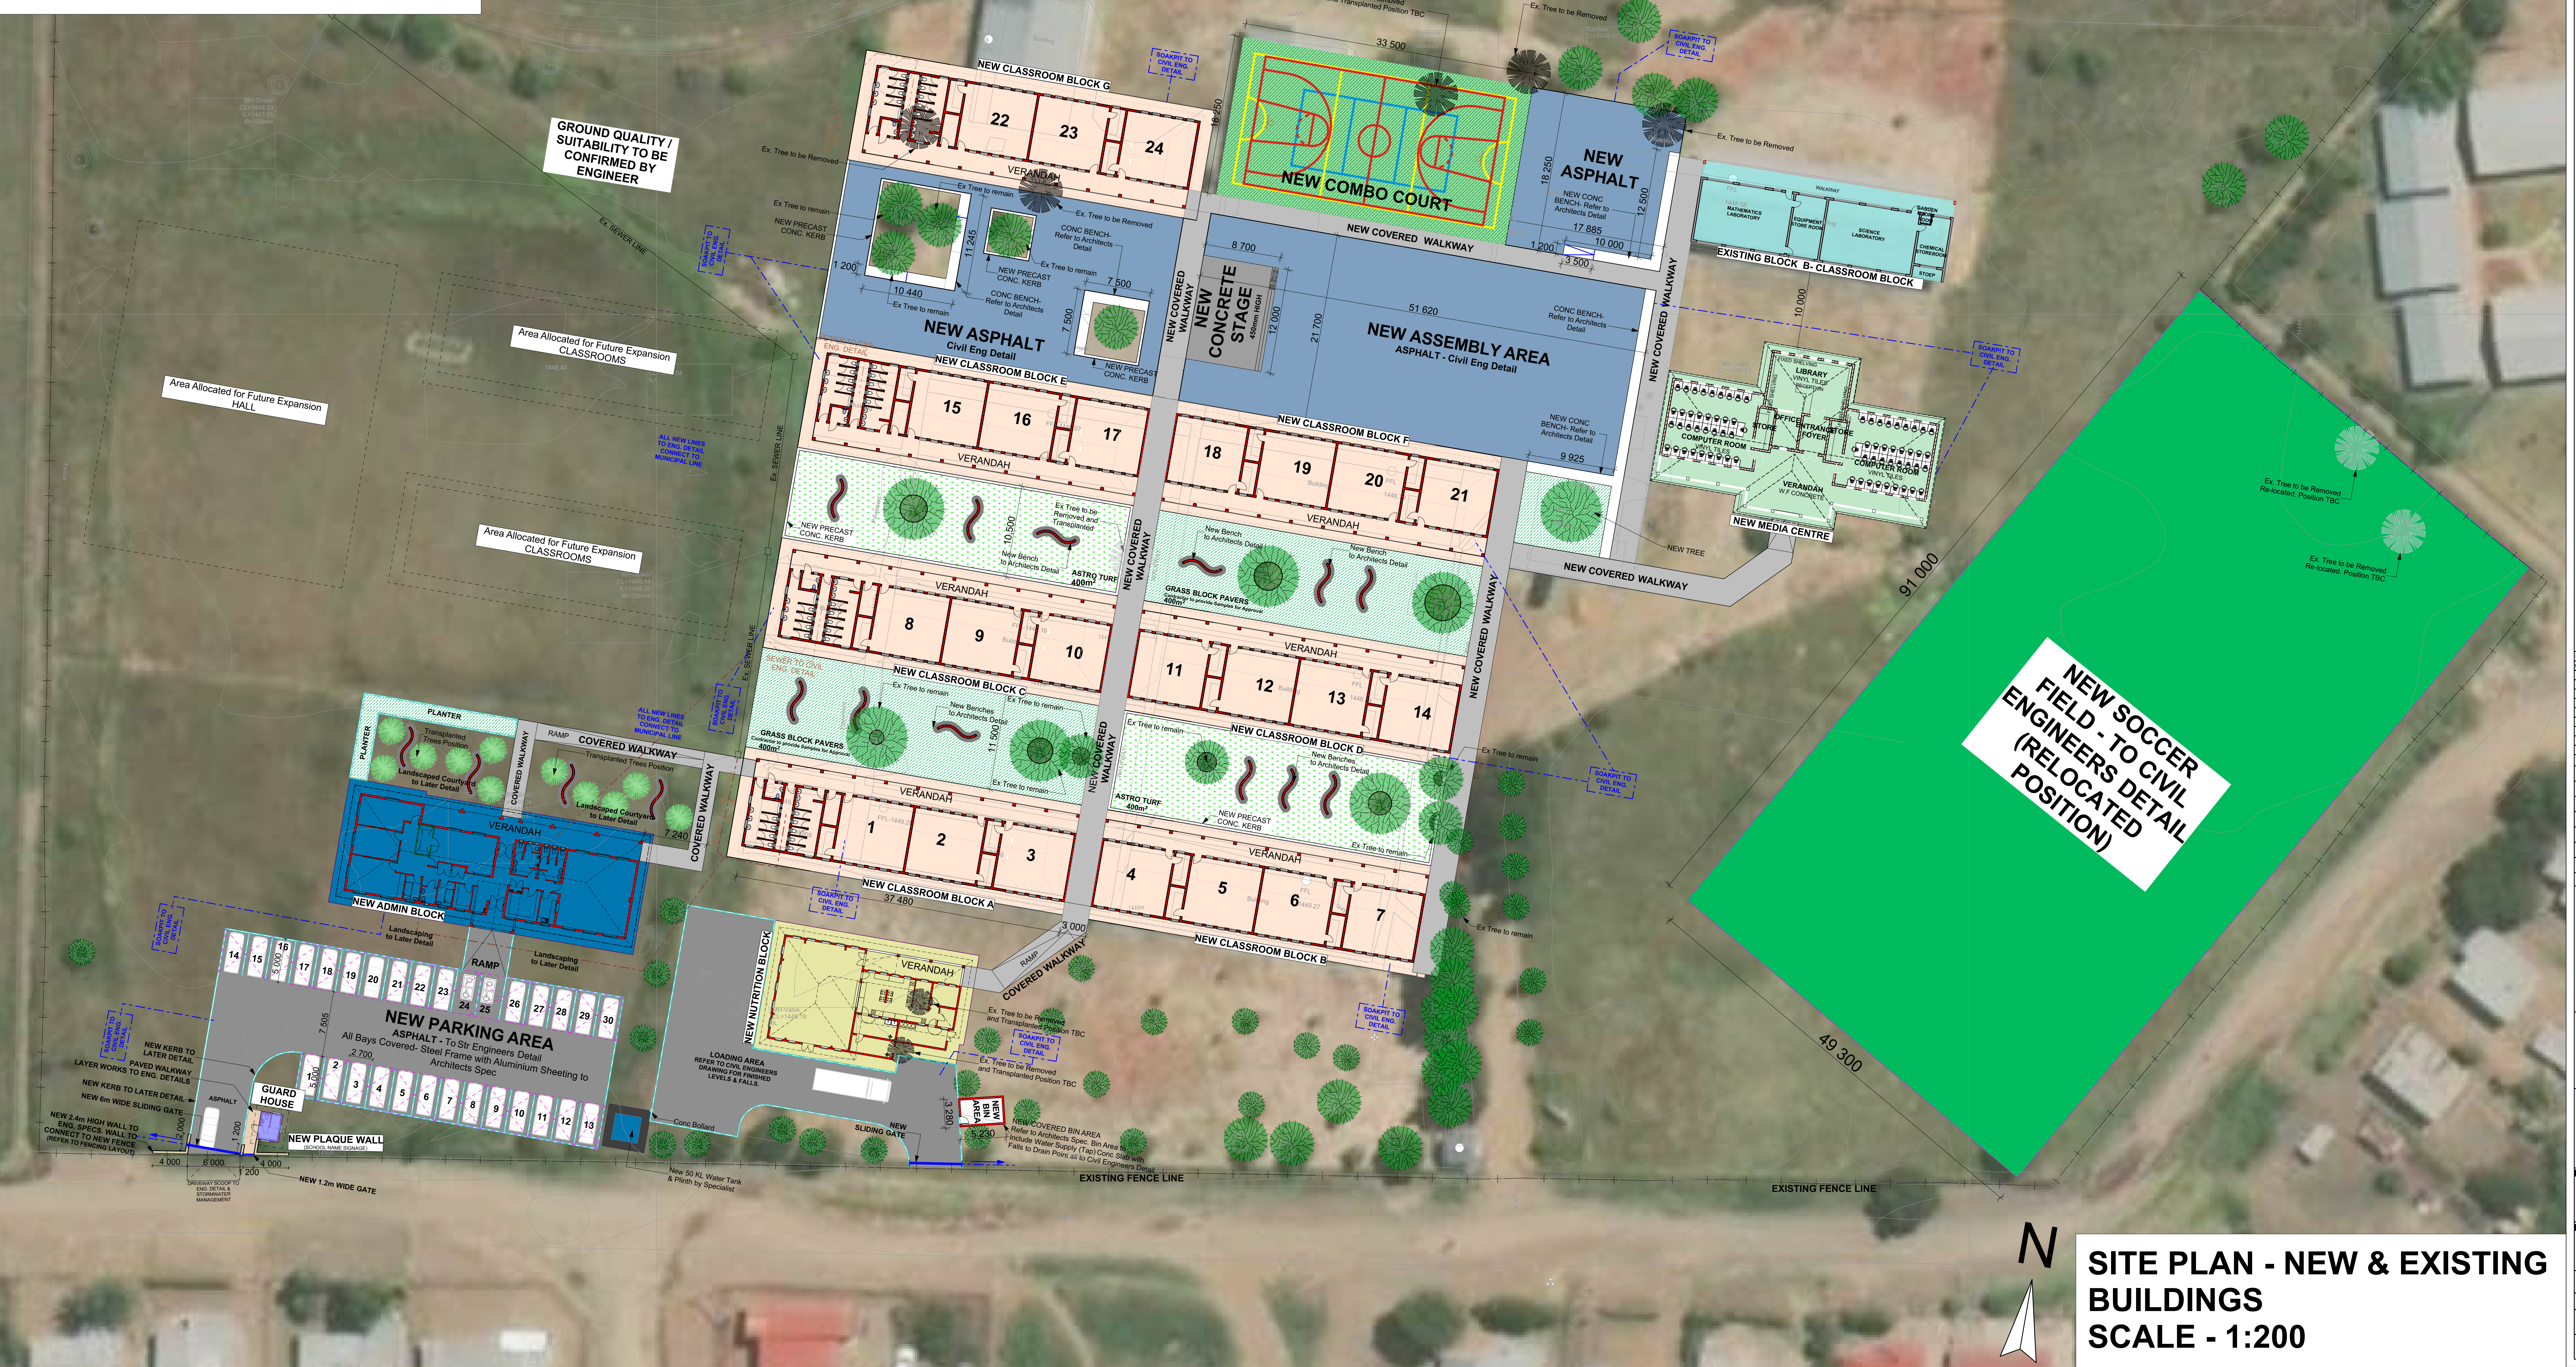
NEW ADMINISTRATION BLOCK

NEW NUTRITION BLOCK

NEW MEDIA CENTRE BLOCK

NEW CLASSROOM BLOCKS

NEW COVERED WALKWAYS

NEW GUARD HOUSE
